Department of Homeland Security Federal Emergency Management Agency

Project #	123407	PW #	9549	Project Type	Standard
Project Category	G - Parks, Recreational Facilities, and Other Items			Applicant	Department of Natural & Environmental Resources (000-UW1XD-00)
Project Title	Balneario de Punta Salinas			Event	4339DR-PR (4339DR)
Project Size	Large			Declaration Date	9/20/2017
Activity Completion Date	9/20/2024			Incident Start Date	9/17/2017
Process Step	Obligated			Incident End Date	11/15/2017

Damage #355538; Balneario de Punta Salinas Lifeguard Towers

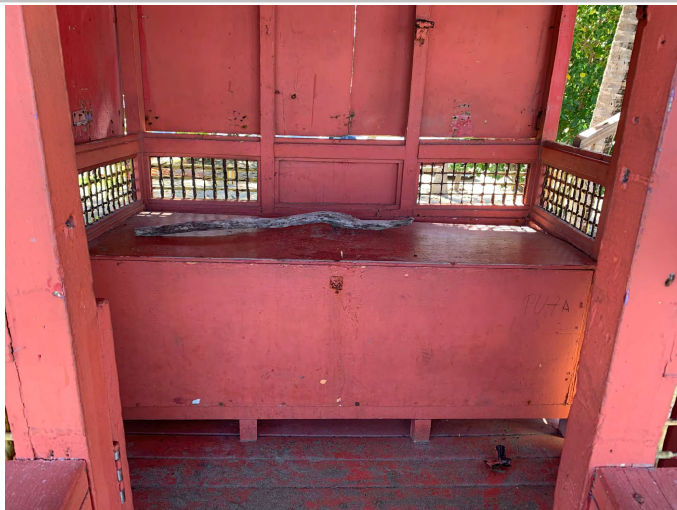
Damage Description	Photo# 8
Lifeguard Tower #3: Interior storage box got detached from the base due to high wind.

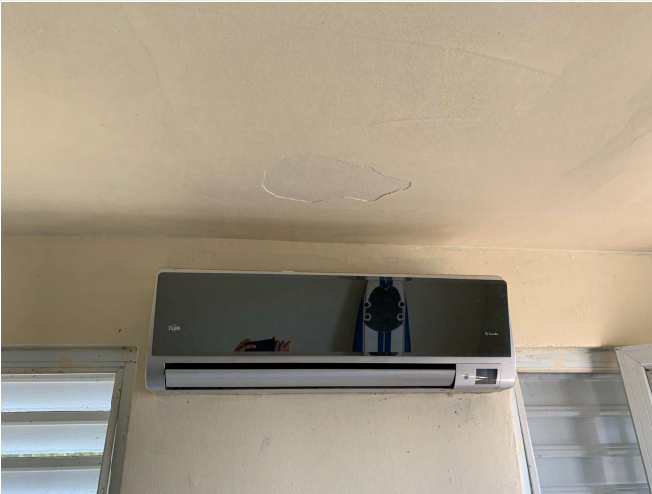
Damage Description:		Photo# 27		Damage Description	
Kitchen room a/c unit that got damage during the event due to the high winds. Condensor got flooded and blades were detached.				Photo# 16	
				A/C unit specifications.

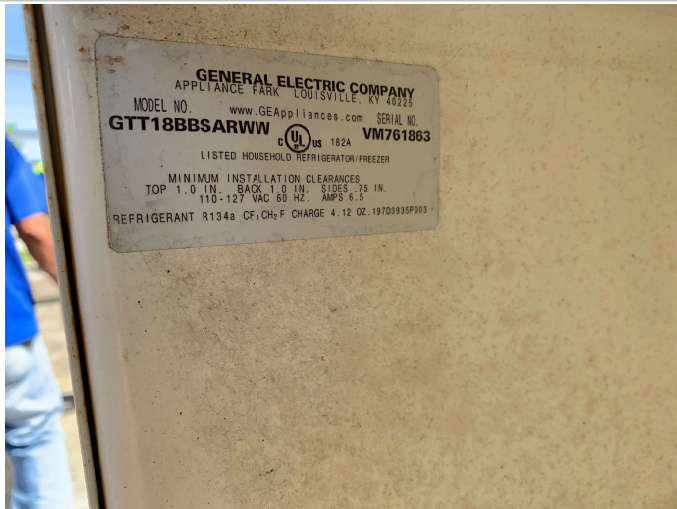
Damage Description:		Photo#		20	
Refrigerator label.

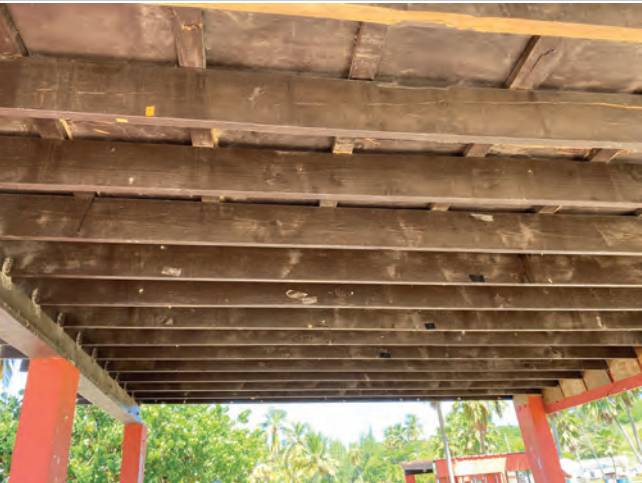
Damage Description:		Photo# 11		Damage Description	
				Photo# 12	
Booth #1: Treated wooden roof Fallen tree tilted the 2 in x10 in wood beam and broke some wood elements		Booth #1: Treated wooden roof Fallen tree tilted the 2 in x10 in wood beam and broke some wood elements

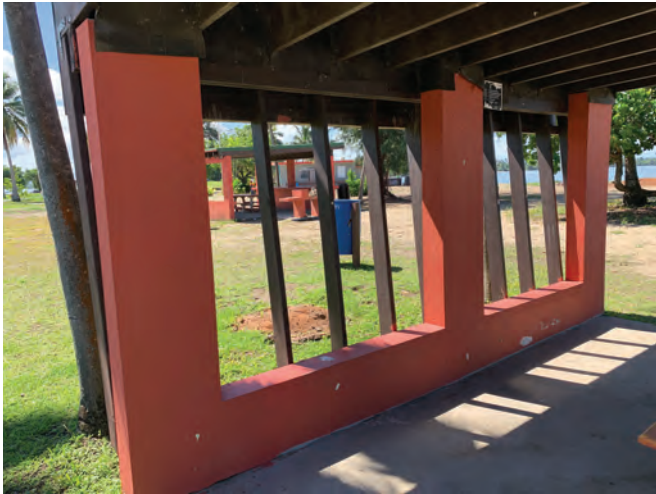
Damage Description:		Photo#		16	
Booth #3: 330 SF of Paint, Surface area, Damaged due to heavy rains and high winds

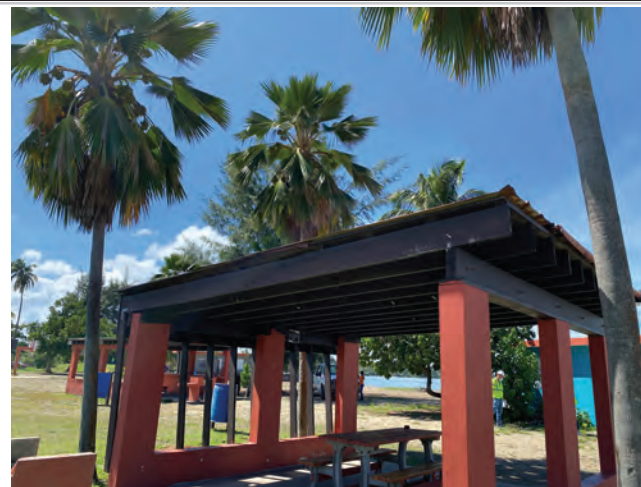
Damage Description	Photo# 18
Booth #3: 330 SF of Treated wooden roof consist, High winds tilted the 2 in x10 in wood beam causing the roof to be unstable

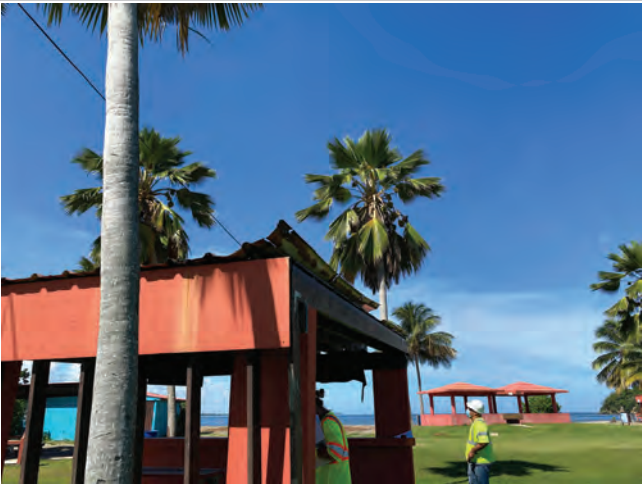
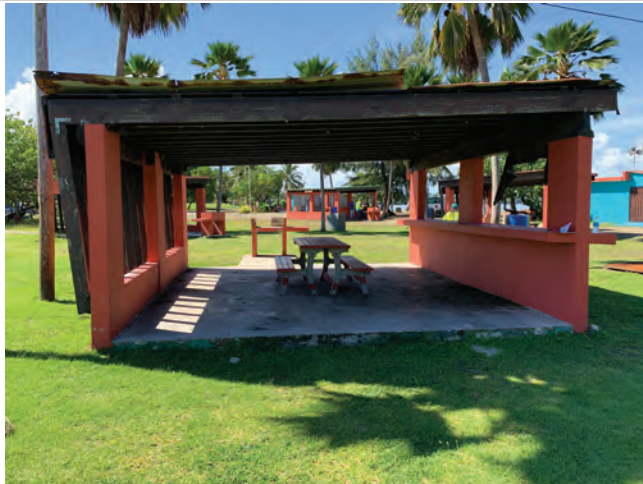
Damage Description:		Photo# 23		Damage Description	
Booth #4: 24 gauge pre-painted steel roofing panel , 21 FT long x 23 FT wide, Partially detached and displaced due to high winds				Booth #4: 600 SF of Paint, Surface area, Damaged due to heavy rains and high winds

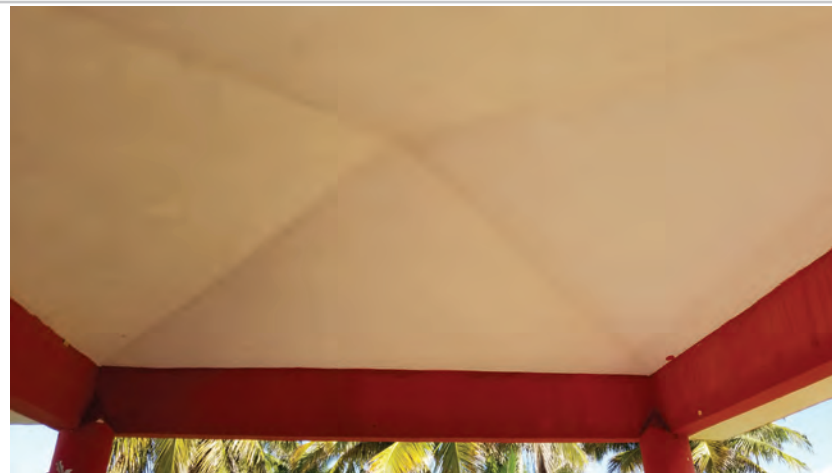
Damage Description	Photo# 2
Gazebo: 12.3457 CY of Roof - Reinforced Concrete , 40 FT long x 20 FT wide x 5 IN thick, Storm surge (interior view)

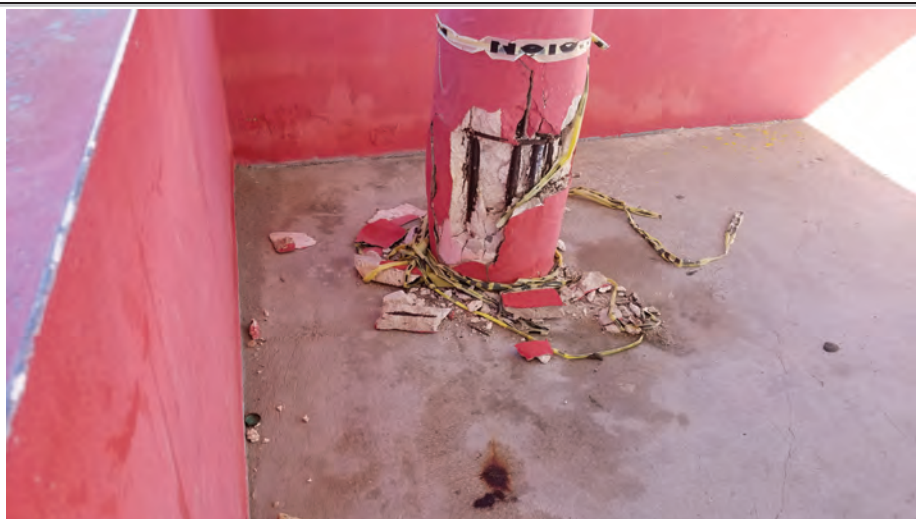
Damage Description:	Photo# 3
Gazebo: 8 each of Columns - Reinforced Concrete, 8 FT long x 1 FT in diameter, storm surge

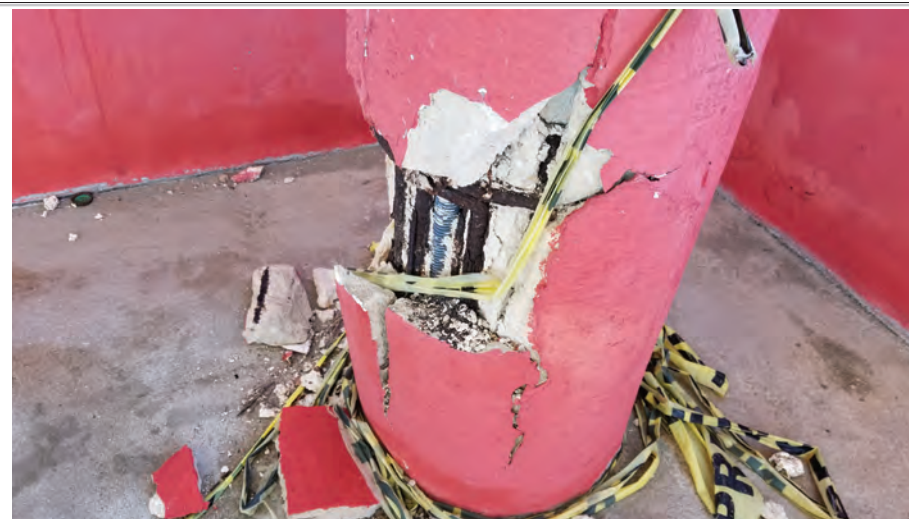
Damage Description	Photo# 4
Gazebo: 8 each of Columns - Reinforced Concrete, 8 FT long x 1 FT in diameter, storm surge. Lateral and close view

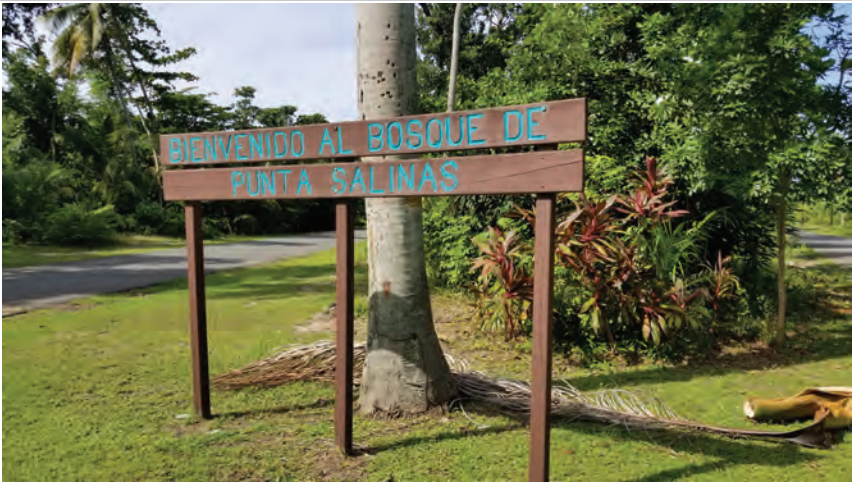
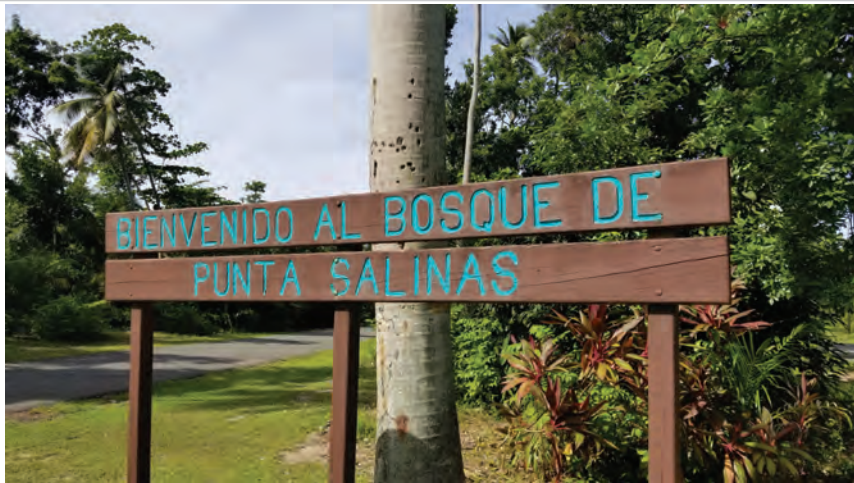
Damage Description:		Photo# 11		Damage Description	
Entrance: Signage, 2 each of Metal Pole 3 IN x 3 IN Galvanized, 12 FT long, Storm surge and high winds				Entrance: Signage, 2 each of Metal Pole 3 IN x 3 IN Galvanized, 12 FT long, Storm surge and high winds

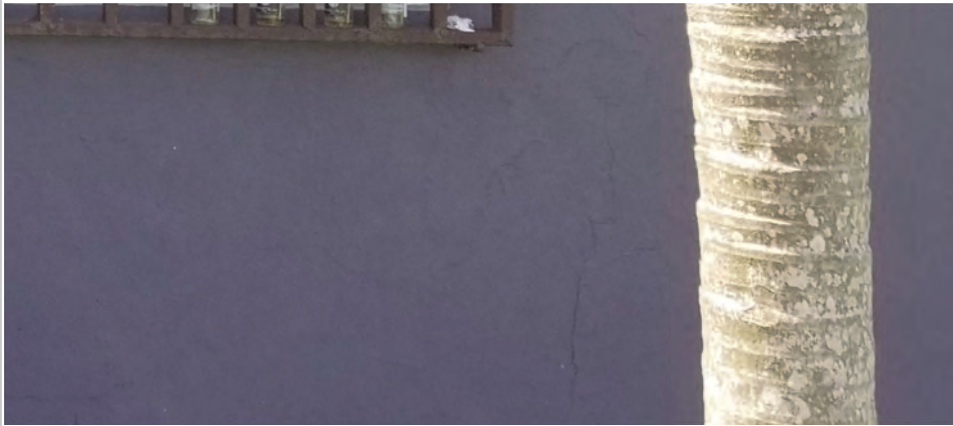
Damage Description	Photo# 4
Activities Room - 1 each of Walls Cement Plaster (multiple cracks from 1/8 IN to 1/4 IN), 136 FT long, high winds and earthquake. (close view)

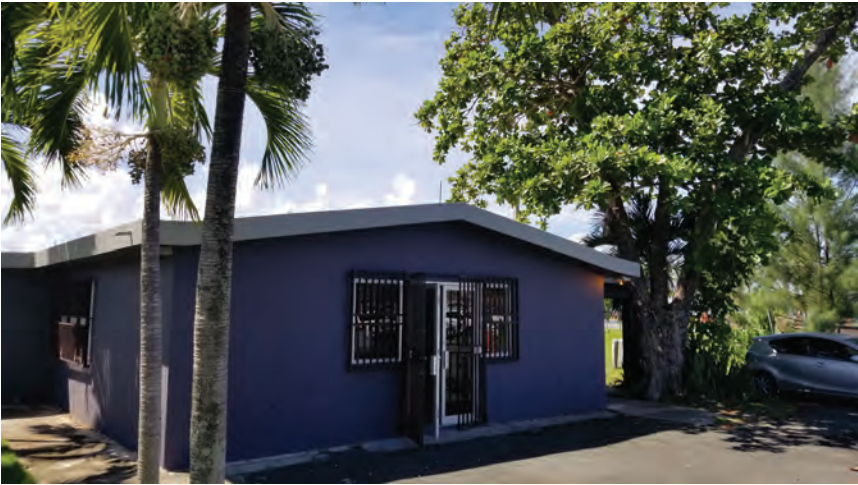
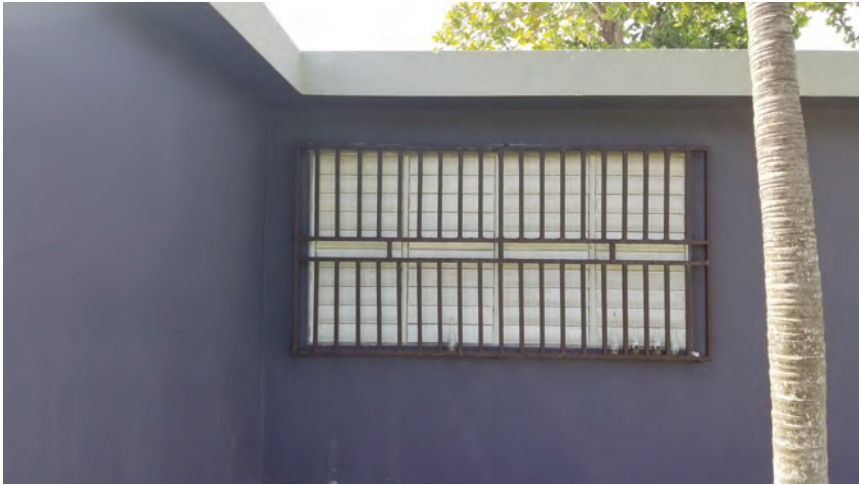
Photo# 7		Photo# 8	
Damage Description:		Damage Description			
Activities Room - 1,092 SF of Ceiling Cement Plaster (multiple cracks and detachment) approximately 50 % damaged, 42 FT long x 26 FT wide, high winds and earthquake.		Activities Room - 1,092 SF of Ceiling Cement Plaster (multiple cracks and detachment) approximately 50 % damaged, 42 FT long x 26 FT wide, high winds and earthquake. (close view)

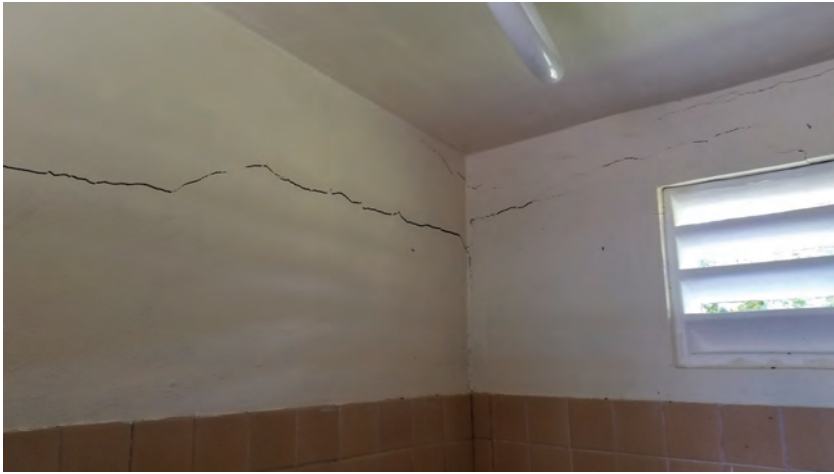
Damage Description:		Photo#		14	
Activities Room Restrooms - 1 each of Walls Cement Plaster (multiple cracks from 1/8 IN to 1/4 IN), 30 FT long, high winds and earthquake.

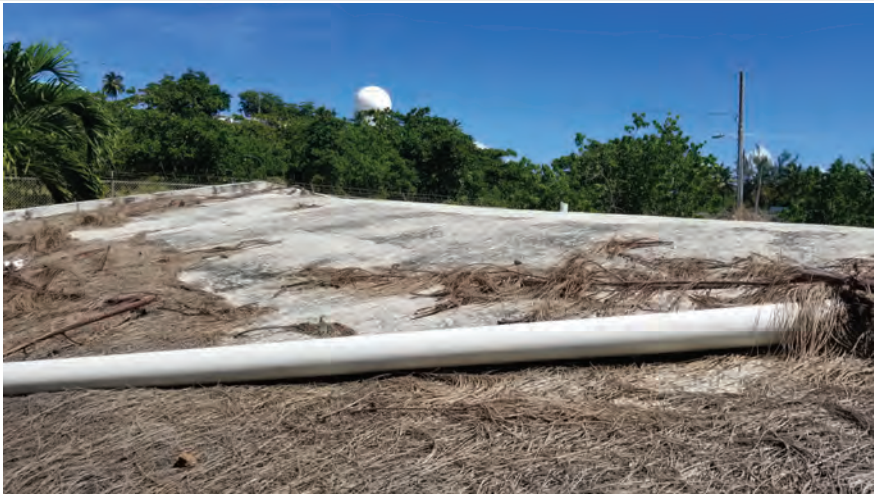
Damage Description:		Photo#		15	
Activities Room Restrooms - 280 SF of Roof Sealer , 20 FT long x 14 FT wide, high winds and wind driven rain,

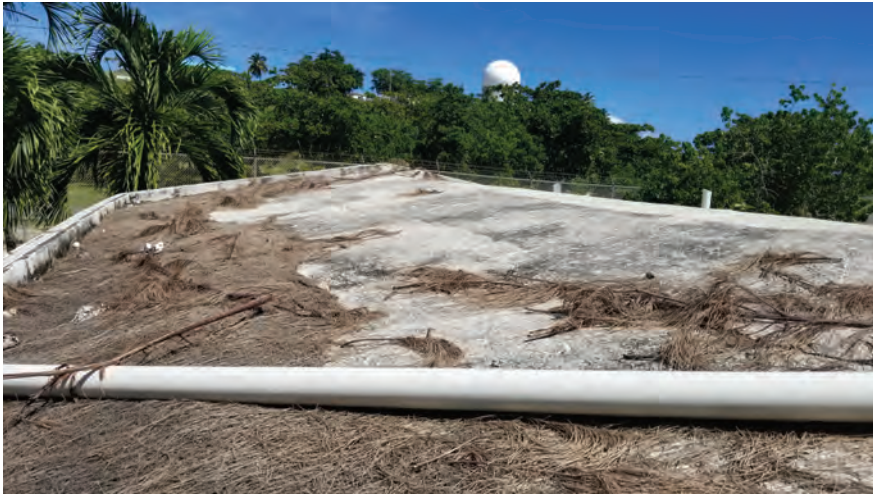
Damage Description:		Photo#		16	
Activities Room Restrooms - 280 SF of Roof Sealer , 20 FT long x 14 FT wide, high winds and wind driven rain. (close view).

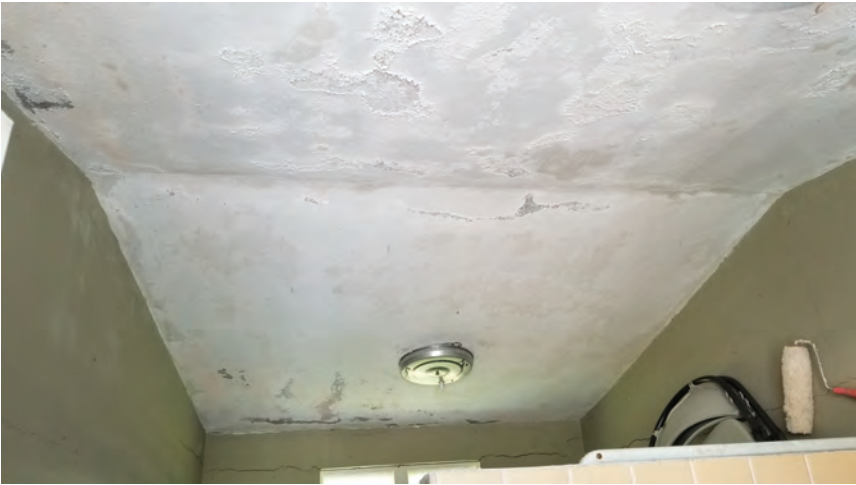
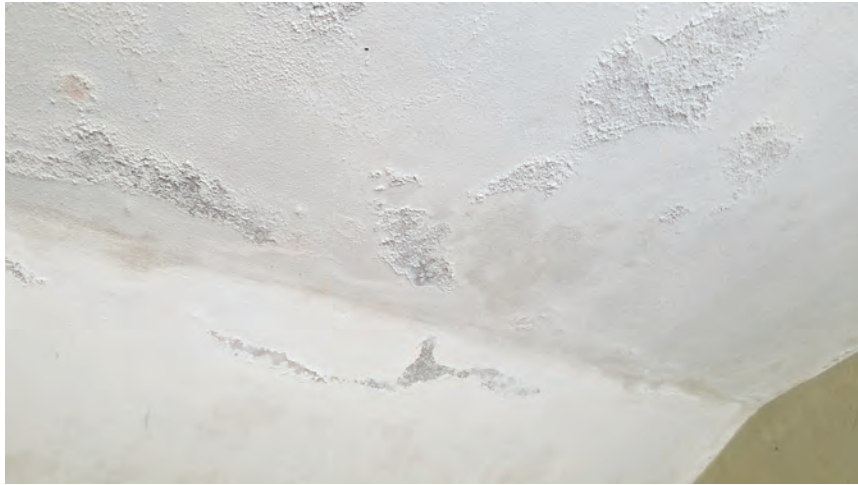
Damage Description:		Photo# 18	
Activities Room Restrooms - 544 SF of Paint, 68 FT long x 8 FT high, wind blown debris and high winds.

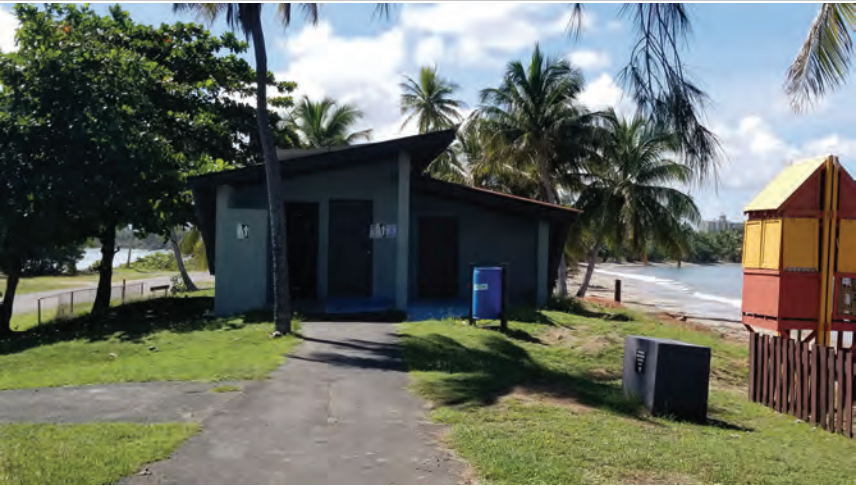
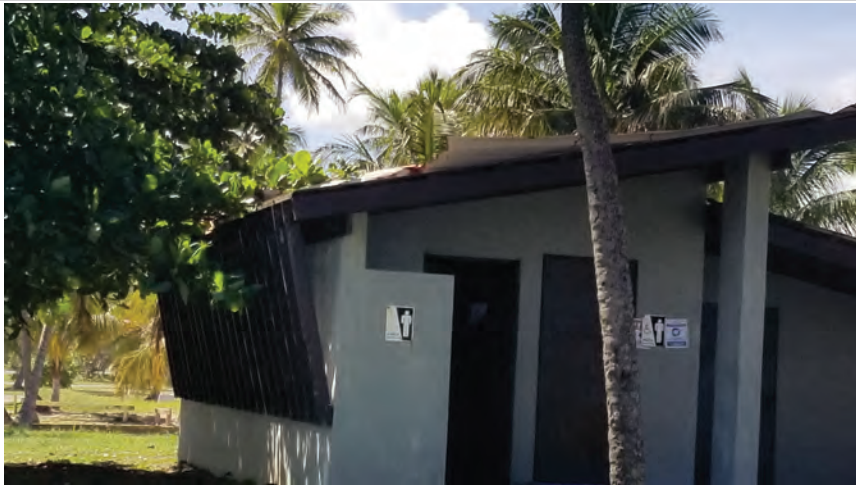
Damage Description:		Photo# 23		Damage Description	
Men Restrooms - 858 SF of Roof (Plywood 3/4 IN P/T), 33 FT long x 26 FT wide, wind blown debris and high winds				Men Restrooms - 858 SF of Roof (Plywood 3/4 IN P/T), 33 FT long x 26 FT wide, wind blown debris and high winds. (close view).

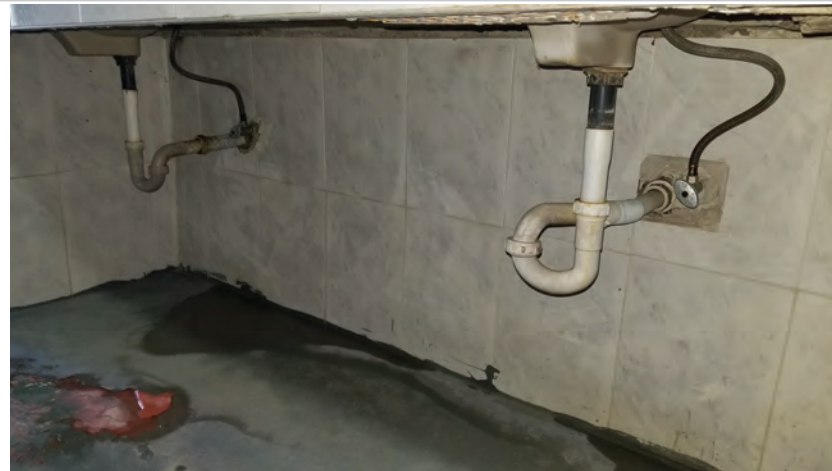
Damage Description	Photo# 2
Men Restrooms - 396 SF of Walls Ceramic Tile (size 10 IN x 14 IN). Area #1 (22 FT L x 6 FT H), Area #2 (18 FT L x 3 FT H) , 31 FT long x 6 FT high, high winds and earthquake.

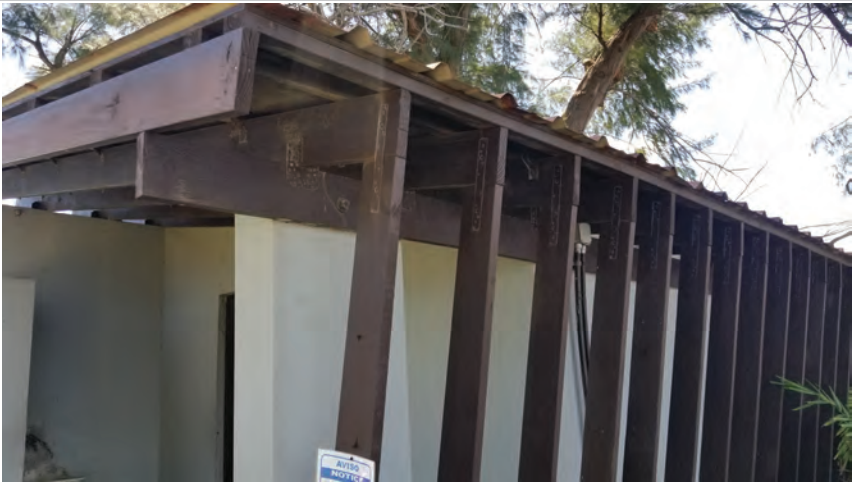
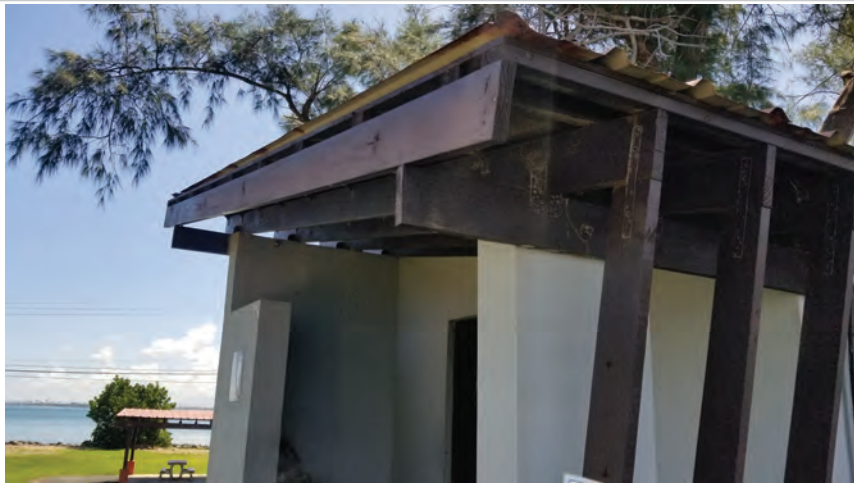
Damage Description:		Photo# 11		Damage Description	
Women Restrooms - 680 SF of Roof (Plywood 3/4 IN P/T), 40 FT long x 17 FT wide, wind blown debris and high winds.				Women Restrooms - 680 SF of Roof (Plywood 3/4 IN P/T), 40 FT long x 17 FT wide, wind blown debris and high winds.
