## EXHIBIT S: Site Visit Reports

HURRICANE MARIA RECONSTRUCTION  
Category E (Buildings and Equipment)

FEMA PROJECT NUMBER # 77979 & 118695

**EHP SITE VISIT  
COMPANY FOR THE INTEGRATED DEVELOPMENT  
OF CANTERA'S PENINSULA**

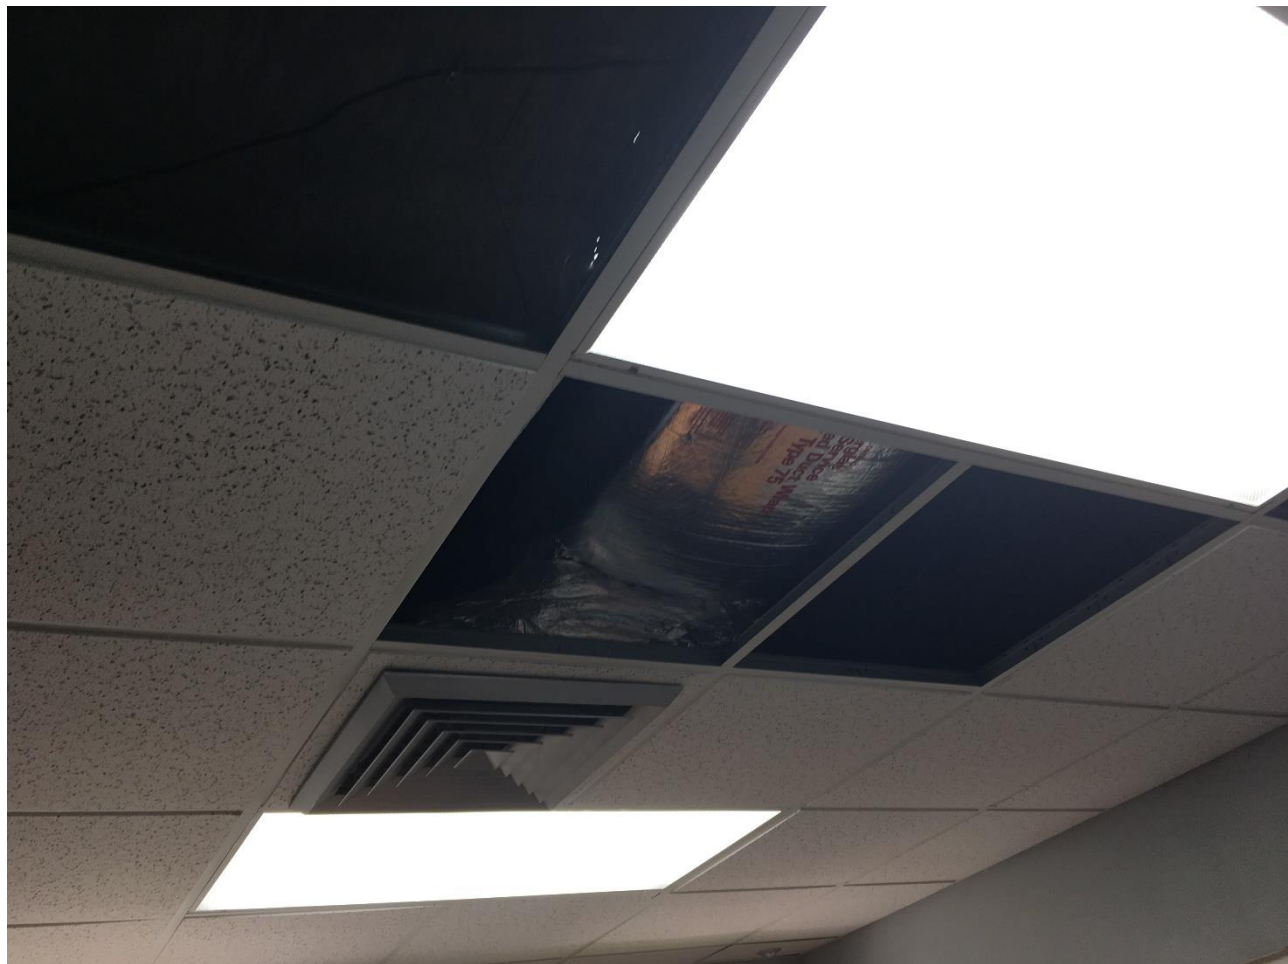
**Photo 1. Community Center A/C and Acoustical Ceiling Damages**

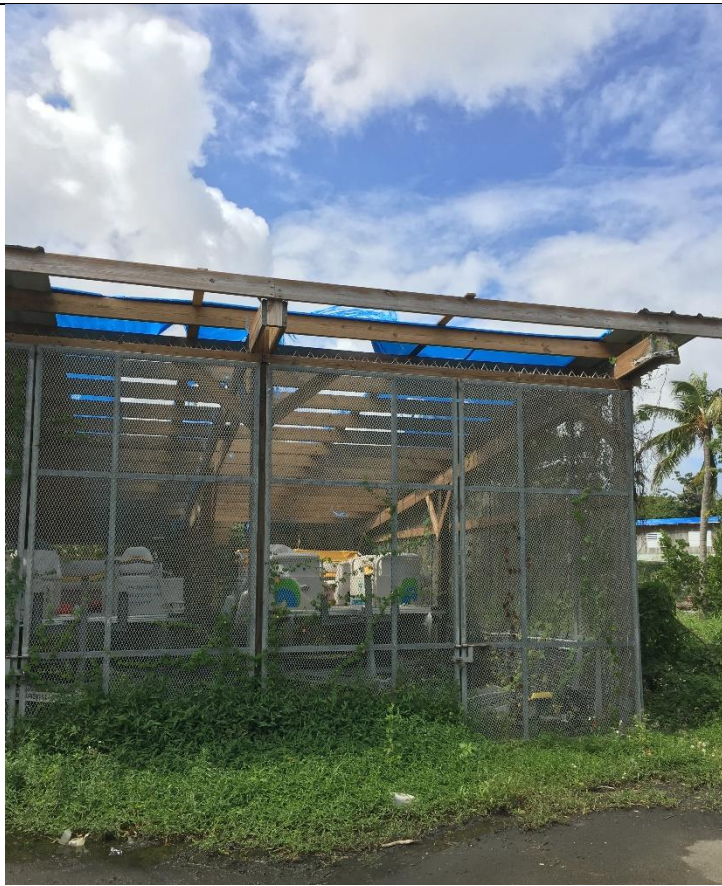
**Photo 2. Utility building's roof damages**

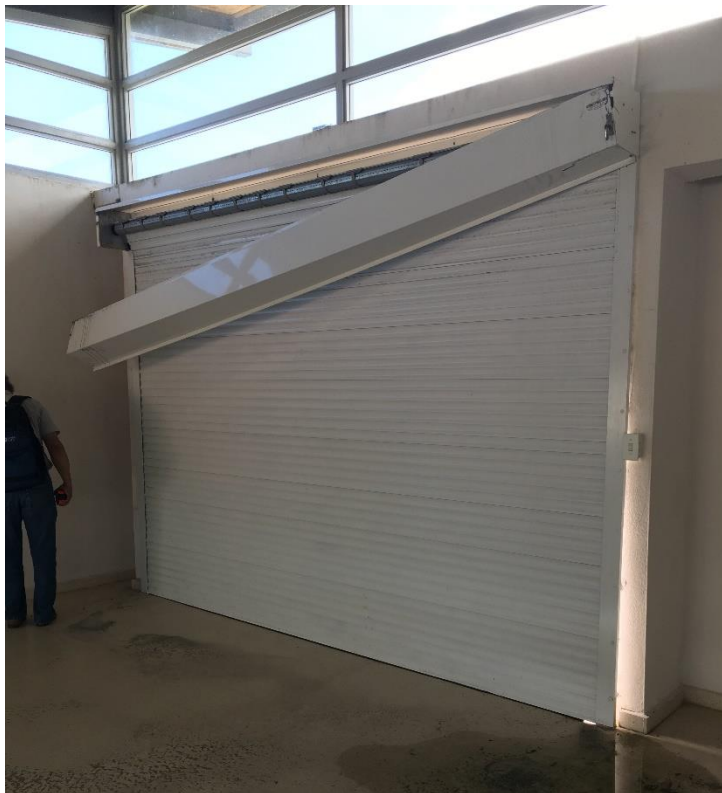
**Photo 3. Restaurant's rolling doors damaged**

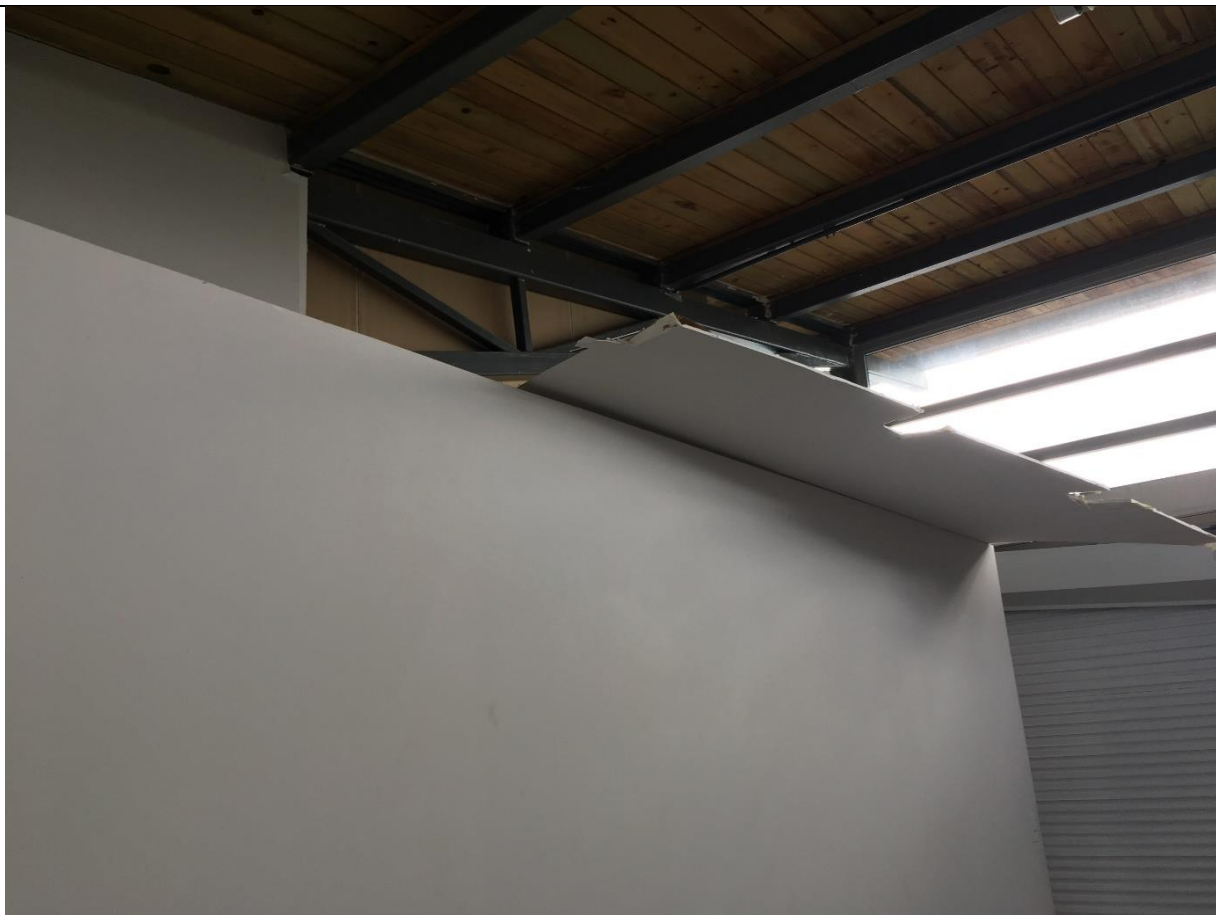
**Photo 4. Audiovisual Center gypsum board wall damaged**

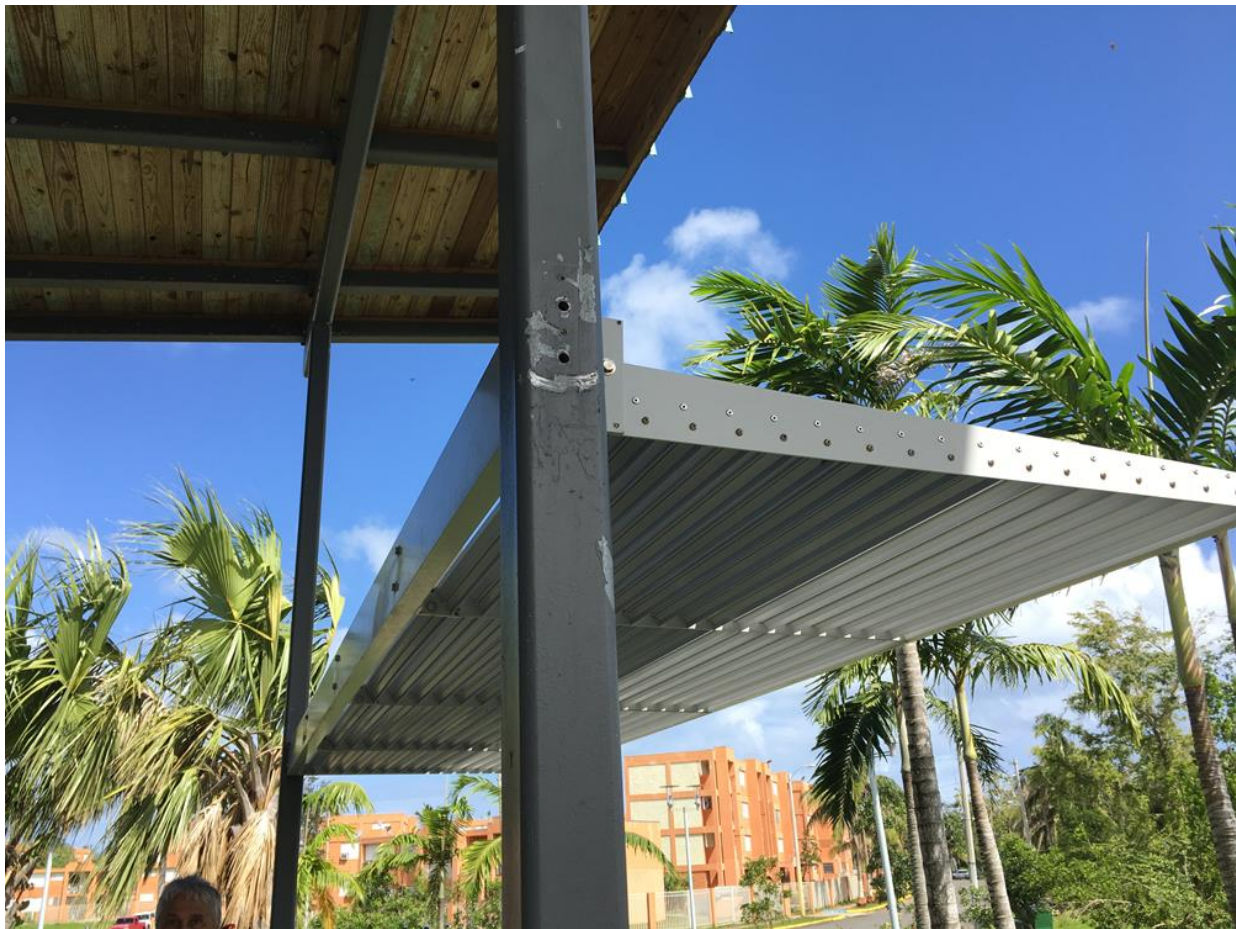
**Photo 5. Exhibition Center's trellis broken**

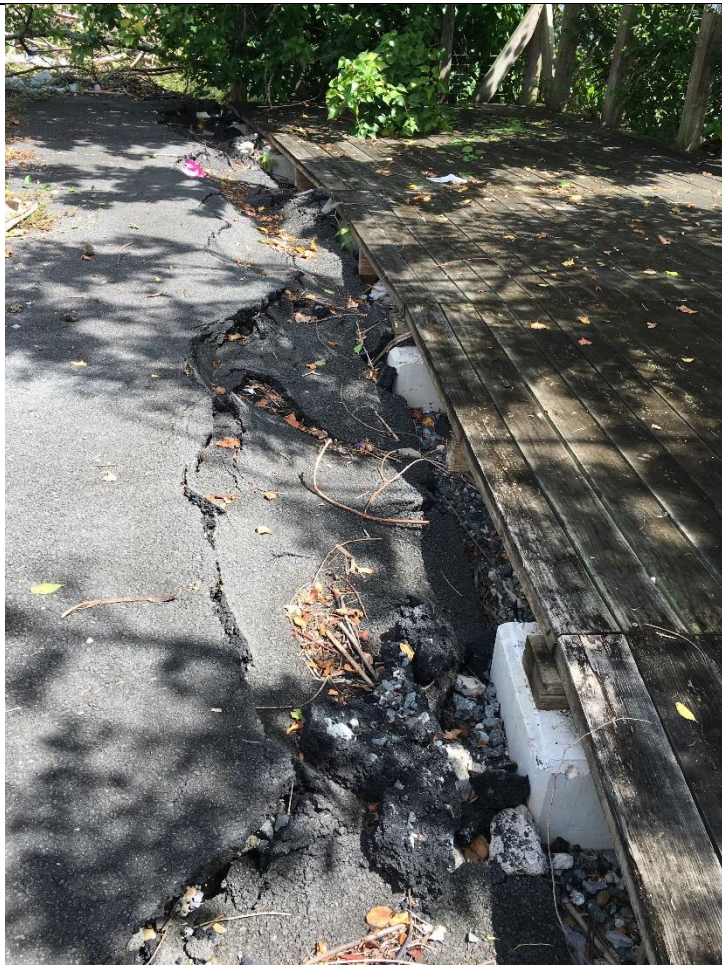
**Photo 6. Water and flood undermined pavement**

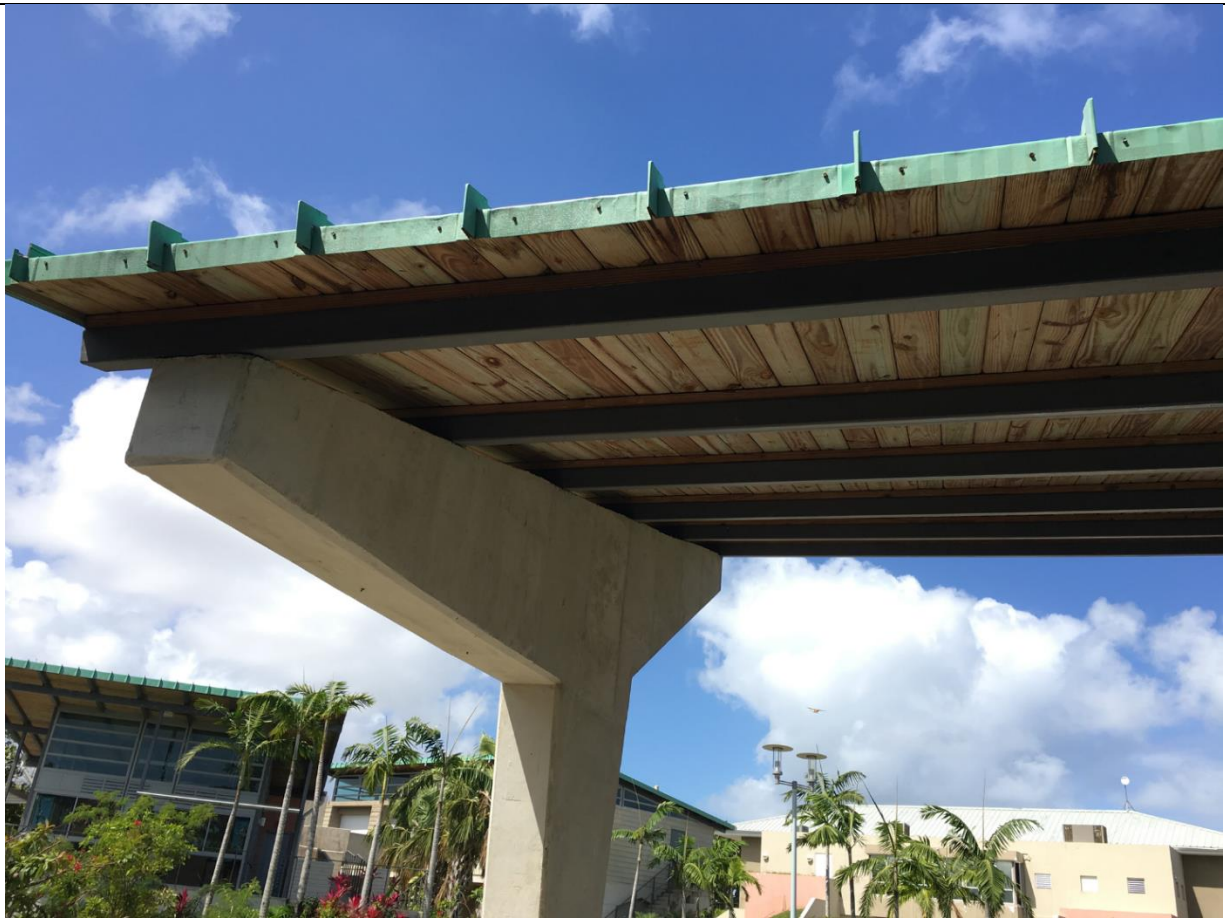
Heavy Winds damaged 14'W x 2'L aluminum roof

**Photo 8. Gazebo 2 metal roof was damaged**

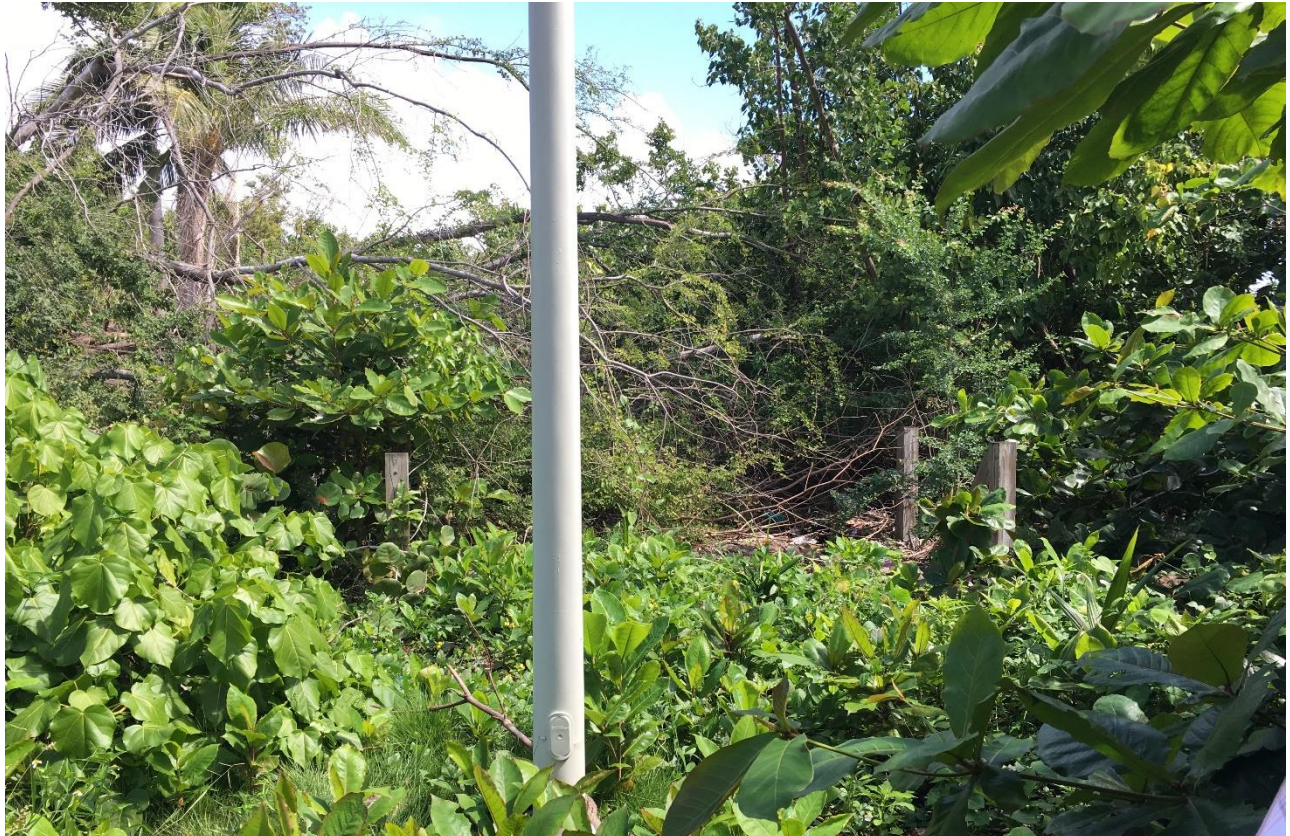
**Photo 9. Wood pedestrian bridge was destroyed**

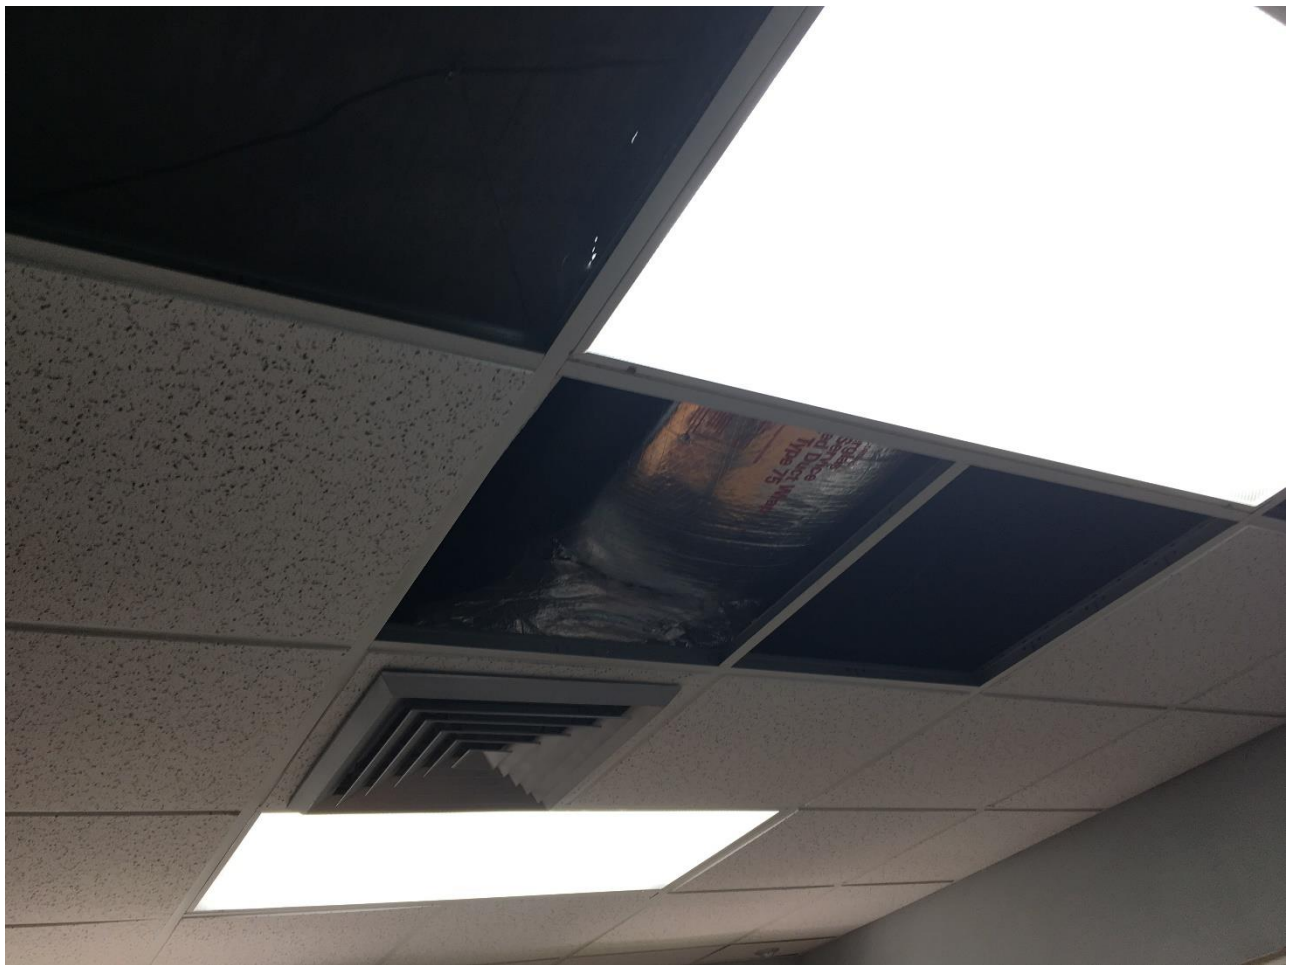
**Photo 1. Community Center A/C and Acoustical Ceiling Damages**

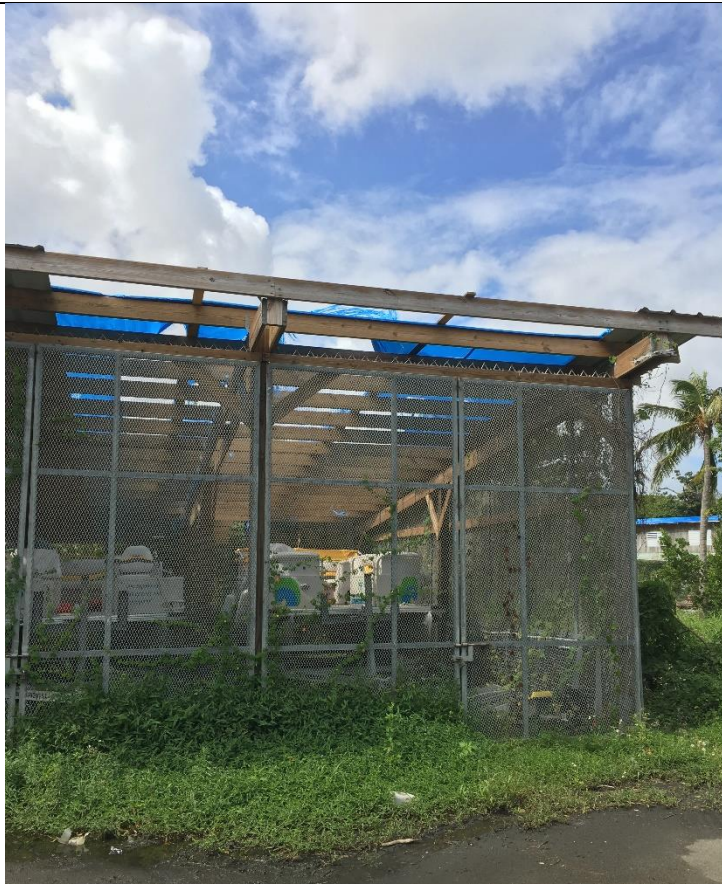
**Photo 2. Utility building's roof damages**

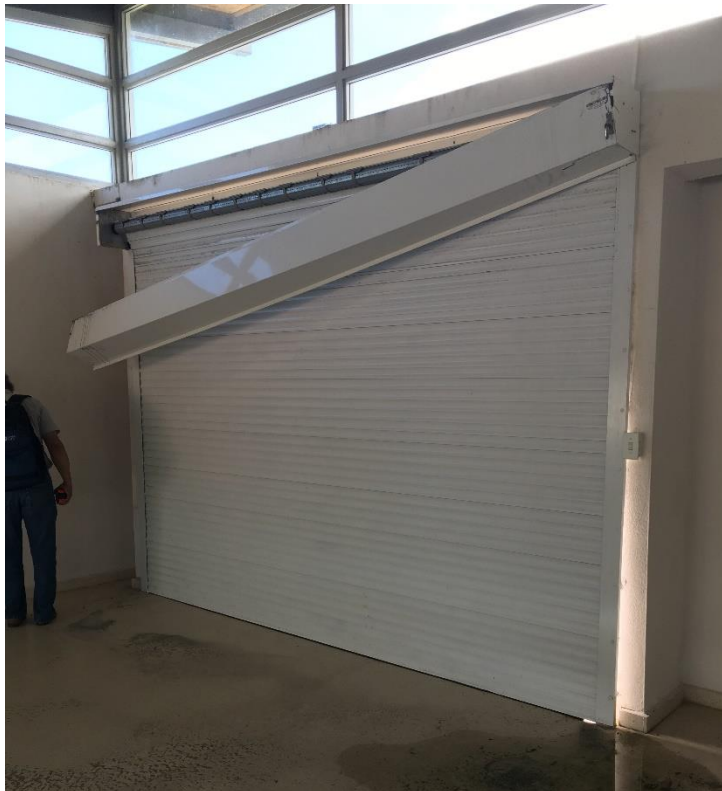
**Photo 3. Restaurant's rolling doors damaged**

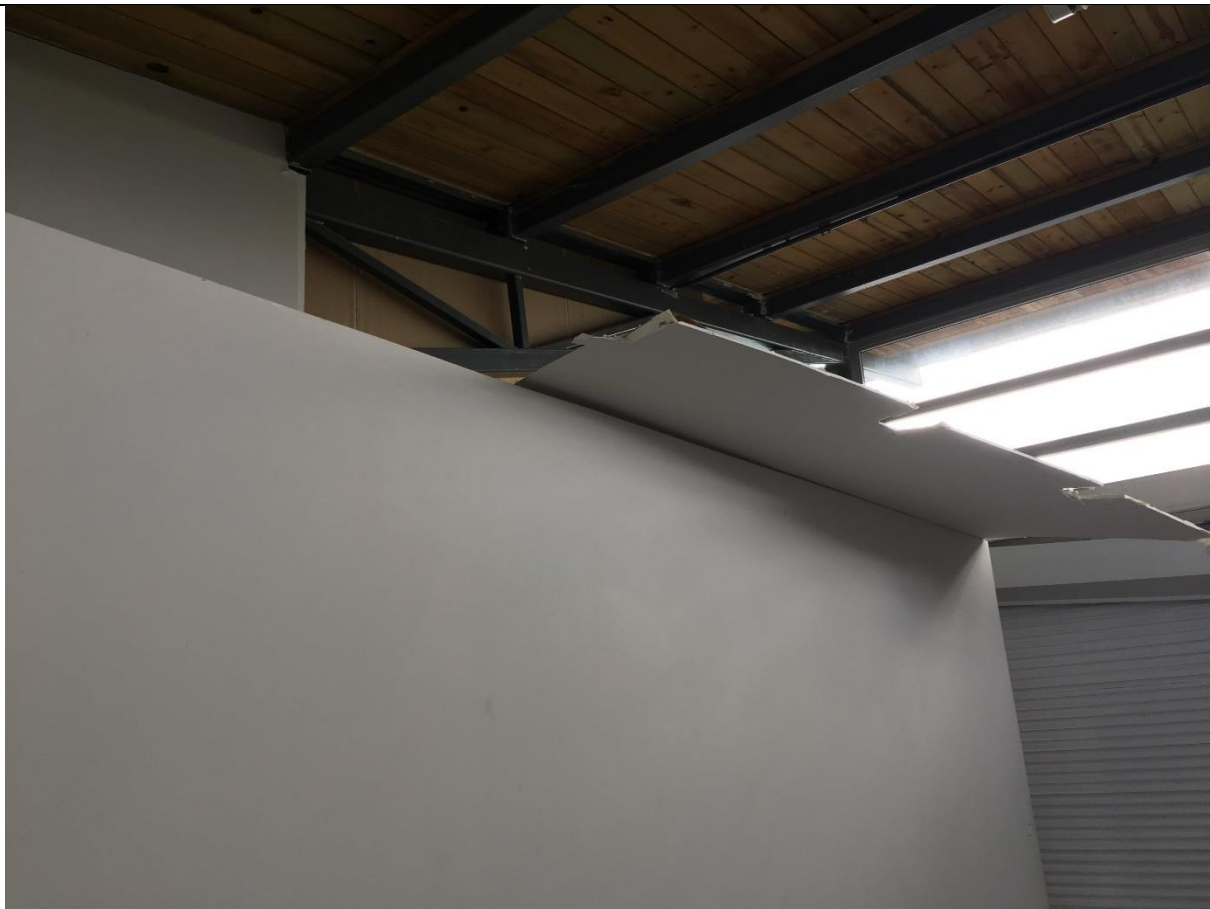
Photo

4. Audiovisual Center gypsum board wall damaged

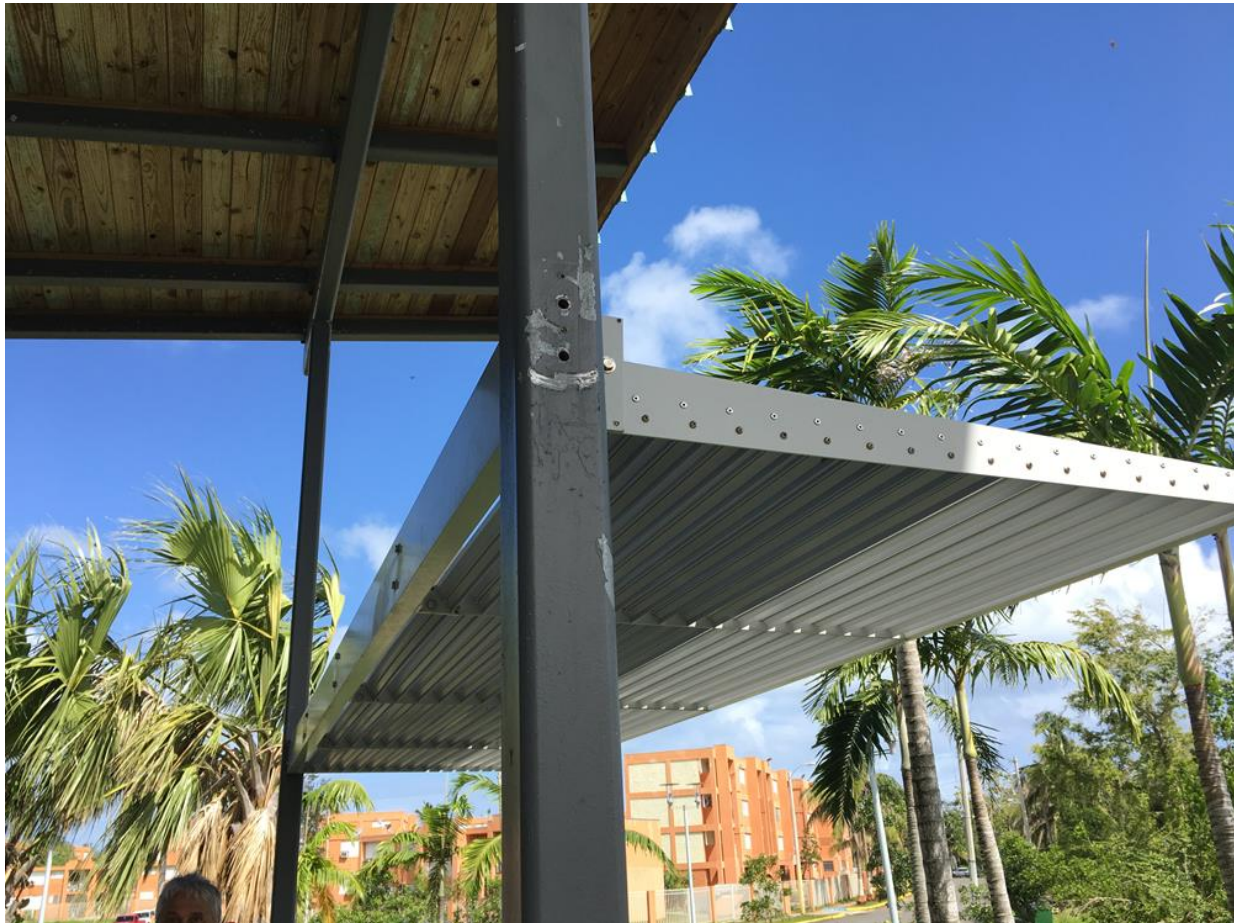
Photo 5. Exhibition Center's trellis broken

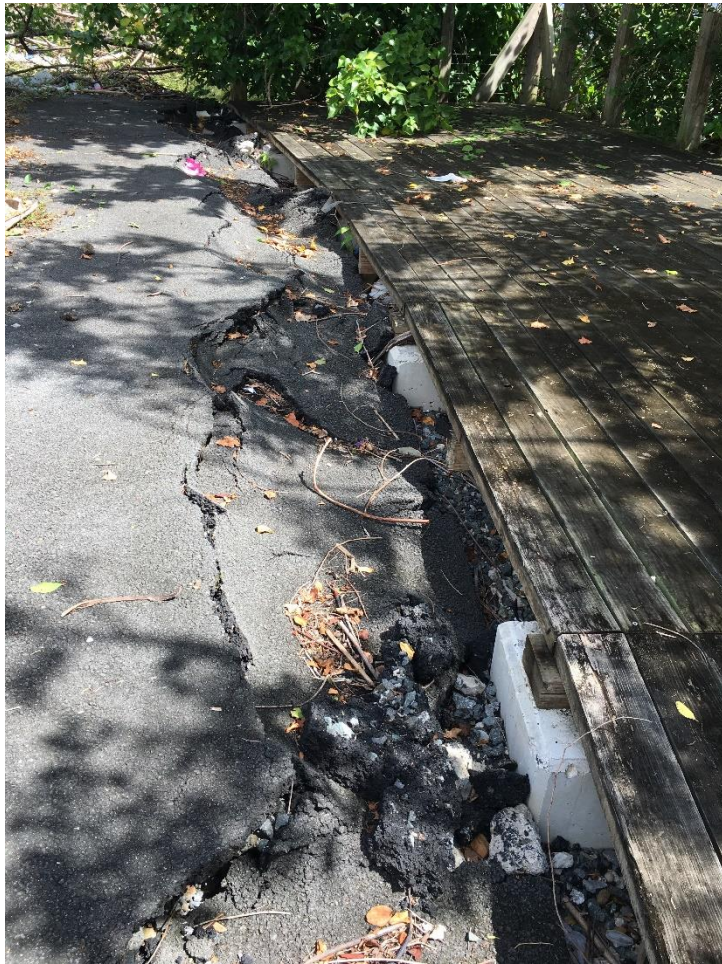
**Photo 6. Water and flood undermined pavement**

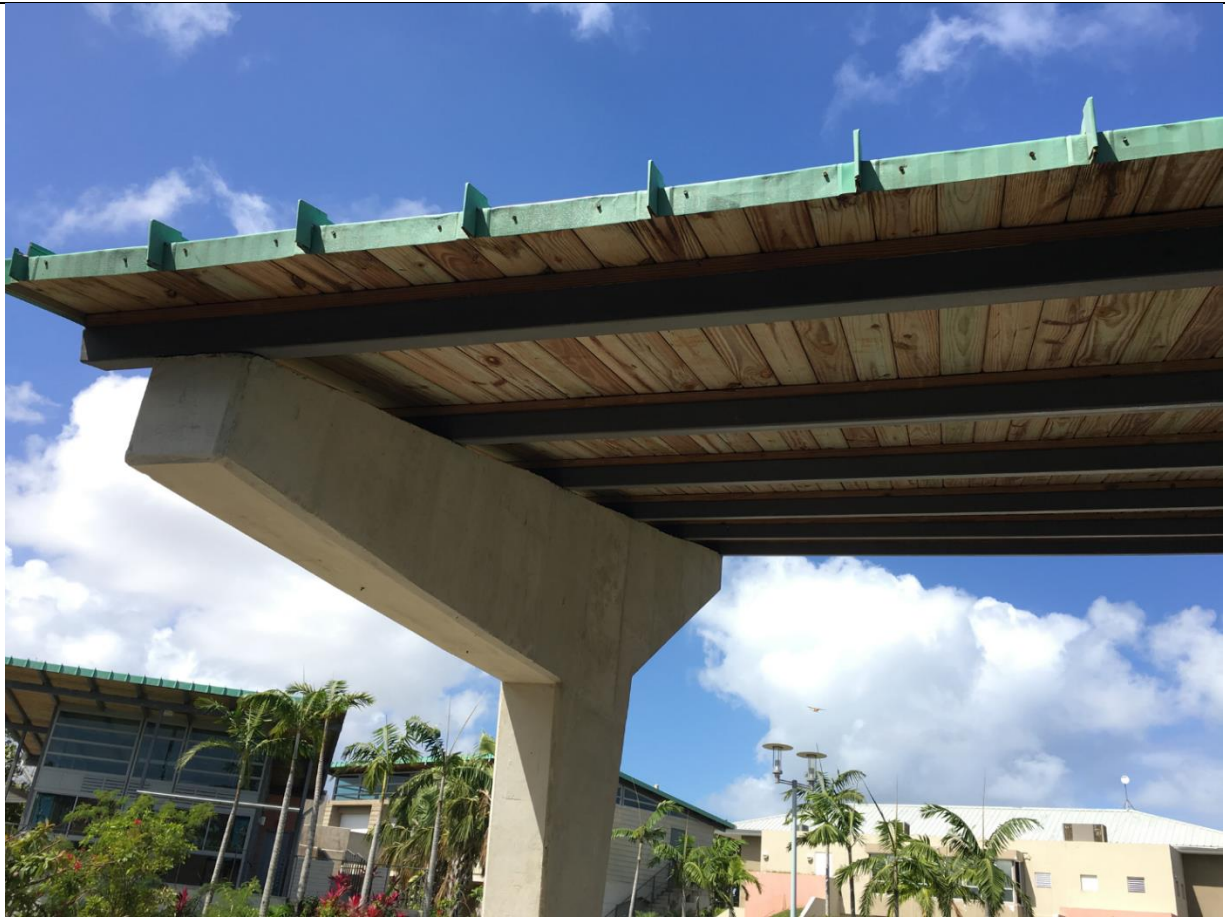
**Photo 8. Gazebo 2 metal roof was damaged**

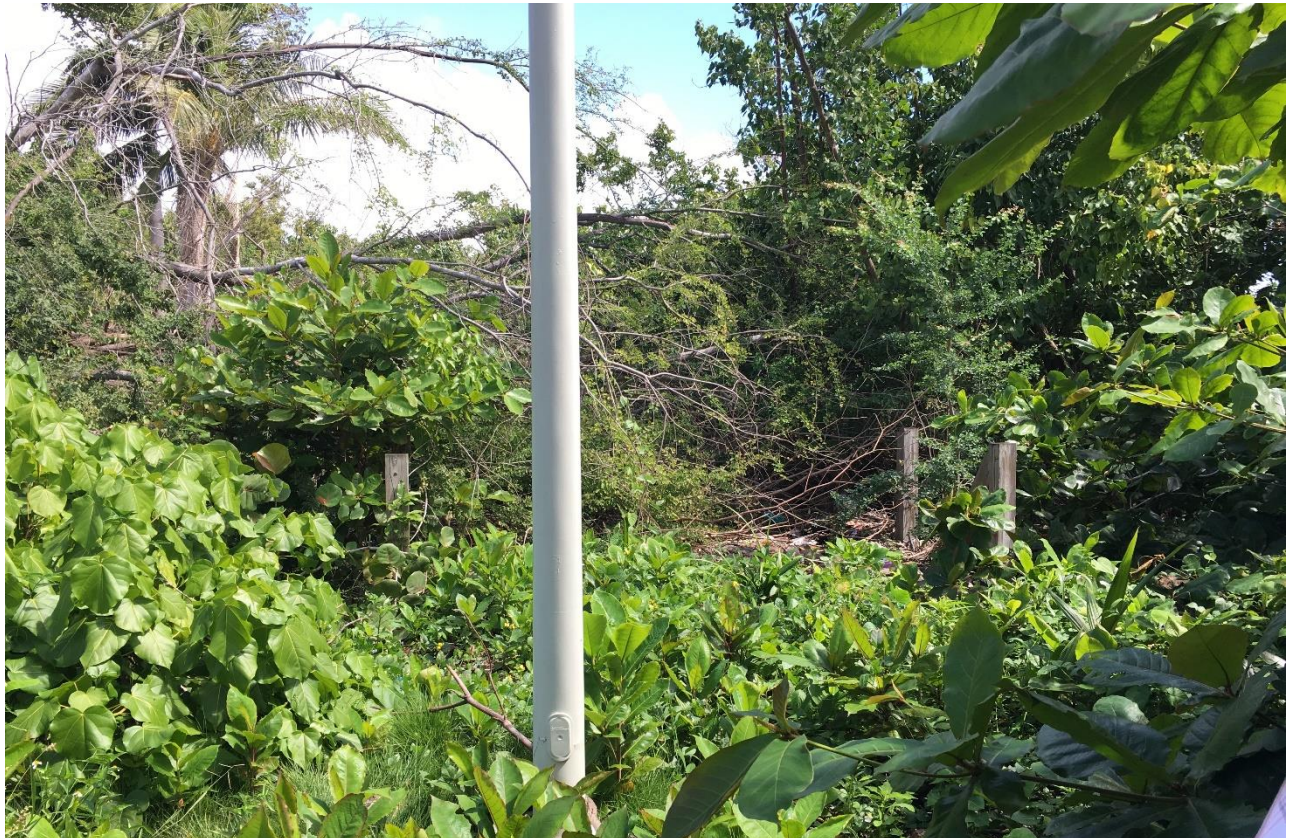
**Photo 9. Wood pedestrian bridge was destroyed**
