**SUBASTA FORMAL 22J-11819
PARA EL SERVICIO DE DEMOLICIÓN DE ESTRUCTURA Y RECOGIDO DE
ESCOMBROS DEL CDT DE MAUNABO, ADSCRITO AL DEPARTAMENTO DE SALUD
DEL GOBIERNO DE PUERTO RICO**

ASUNTO: ESTUDIO DE ASBESTO Y PLOMO

ASBESTOS CONTAINING MATERIALS INSPECTION REPORT

CDT Maunabo

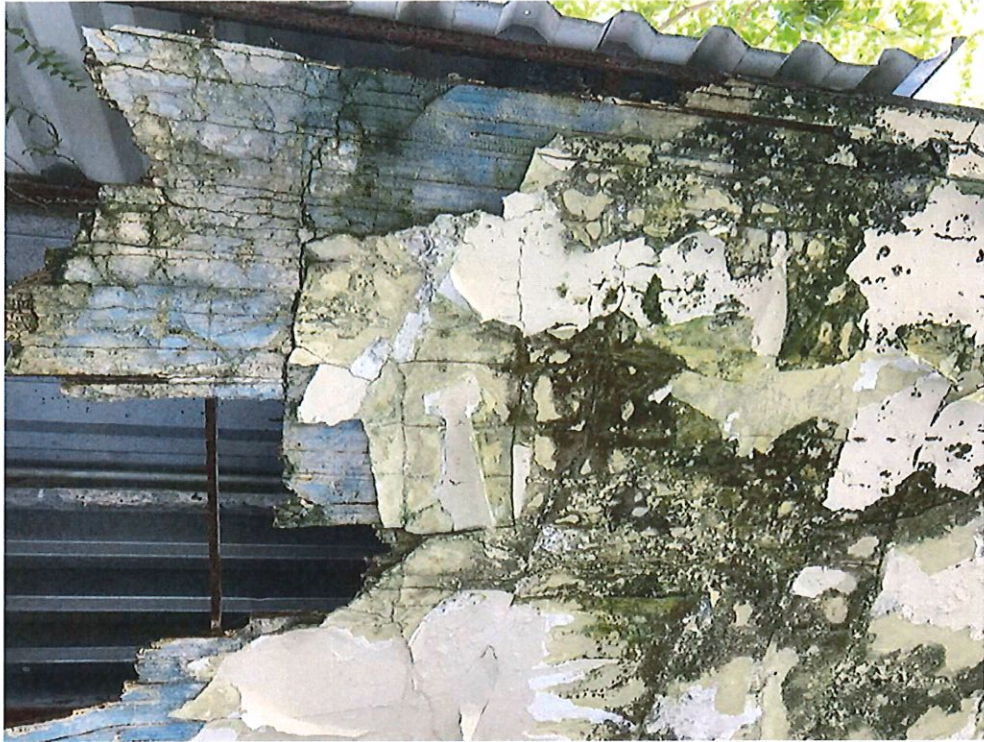
Photo Number 1 – Alero Building exterior, Wall “B”

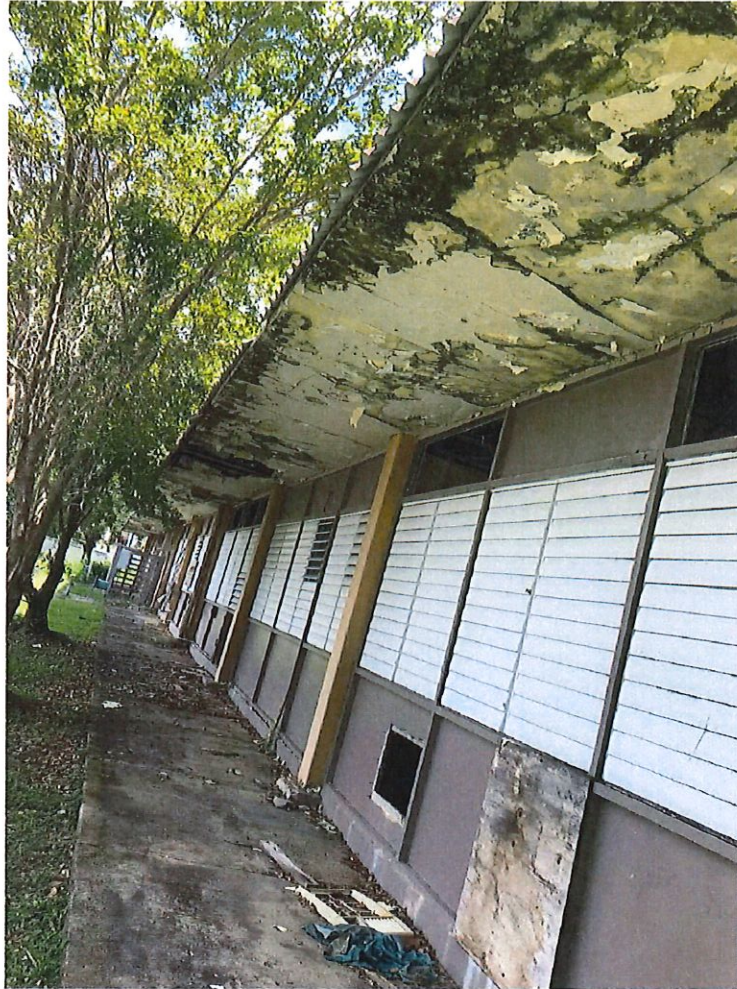
Photo Number 2 – Alero Building Exterior, Wall “C”

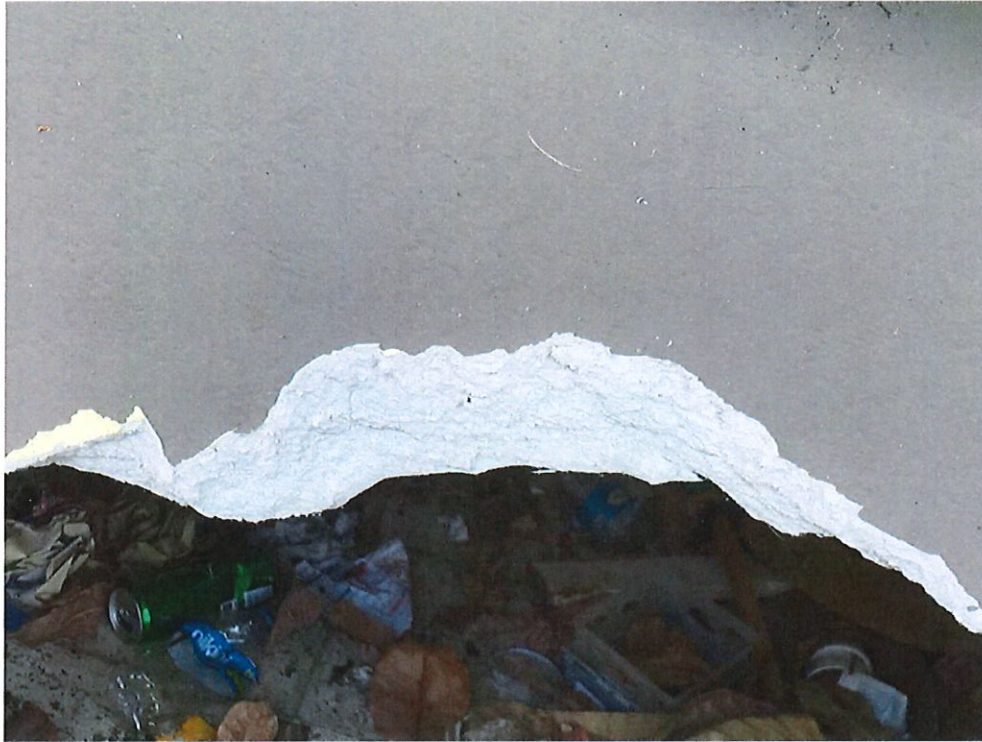
Photo Number 3 – Drywall Building Exterior, Wall “D”

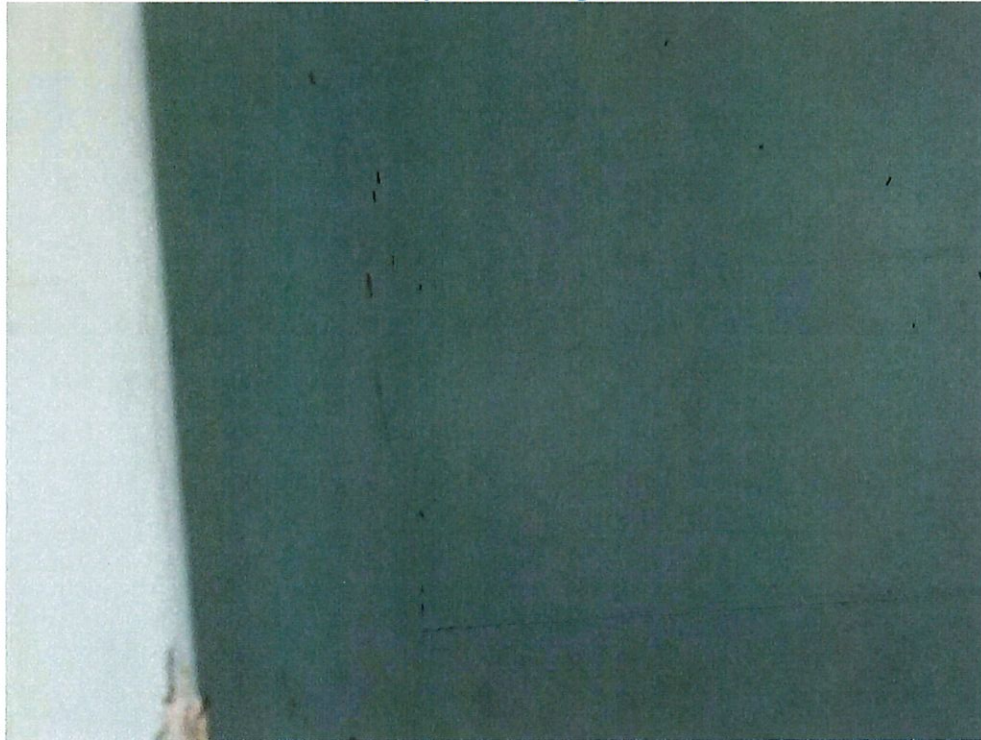
Photo Number 4 – Clinical Dental X-Ray Room Wall “C”

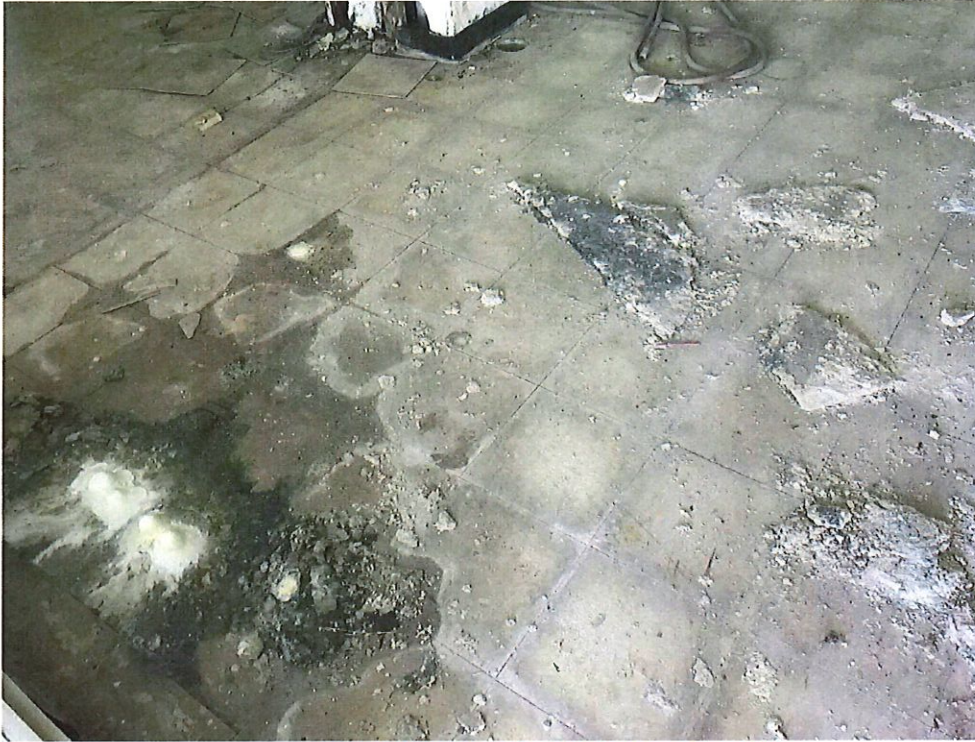
Photo Number 5 – Work Area Floor Tiles

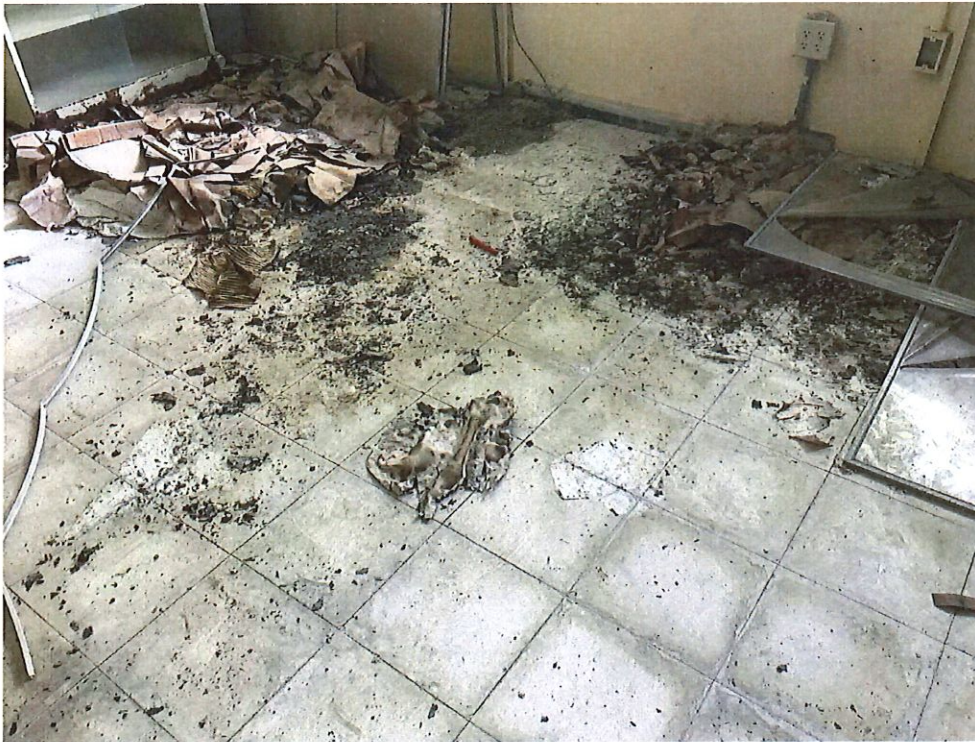
Photo Number 6 – Information Room Floor Tiles

Laboratory analysis confirmed the presence of asbestos in the red mastic air ducts at exam and treatment room (79C) and vinyl floor tiles bulk samples, from the information area (97C). Refer Appendix A & B Lay-out Plan Drawings and Laboratory Results.

If the materials with ACM will be impacted during the future projects, the ACM shall be removed prior to start the construction activity. The ACM abatement shall be carried out by a Licensed Asbestos Contractor with Certified Asbestos Supervisors and Workers. This report shall be kept by the owner and all future owners for the life of the building. A copy of the report shall be given to each tenant, buyer, or lessor, as to comply with federal requirements for disclosure under section 1018 of Title X and lead disclosure rule of 1996.

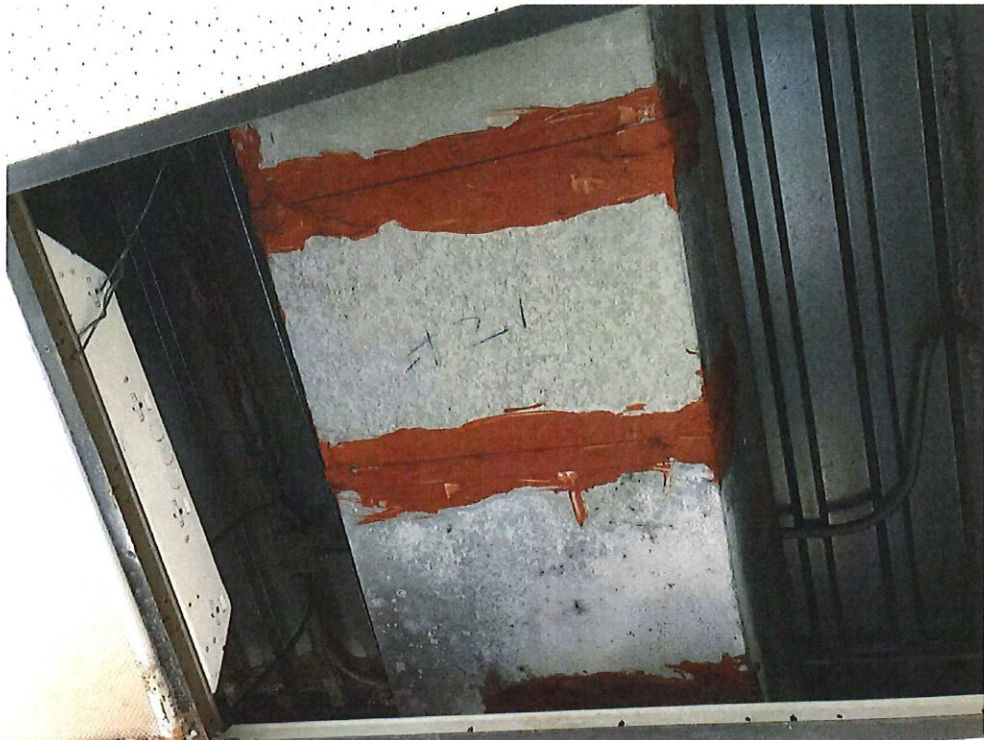
Photo Number 7 – Exam & Treatment Room Red Mastic Duct Air

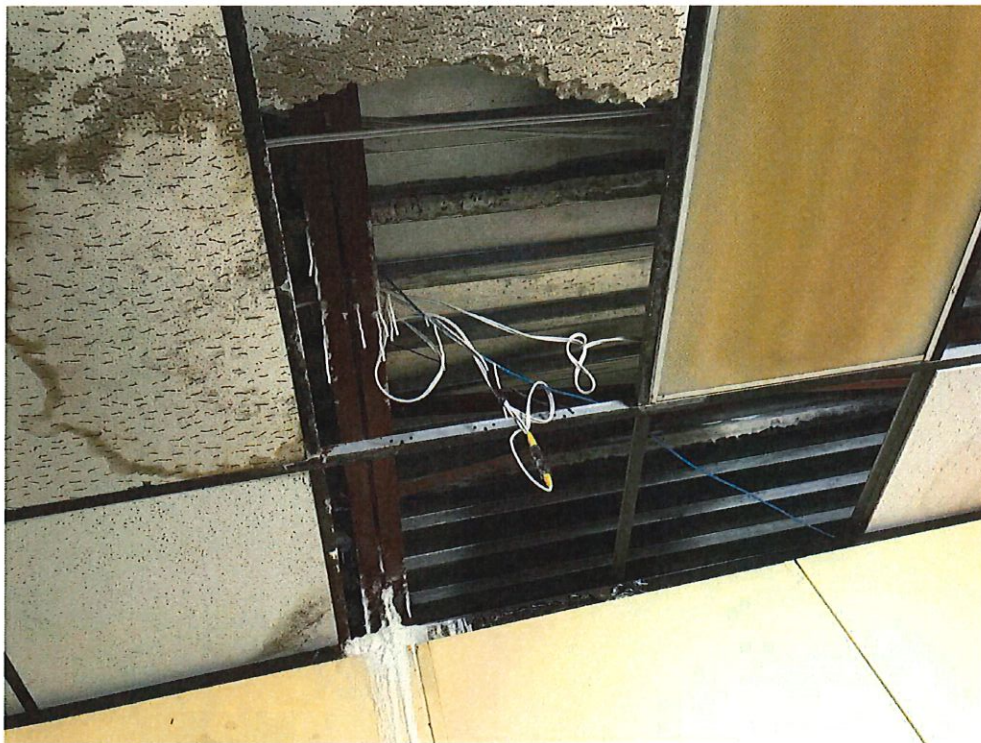
Photo Number 8 – Exam & Treatment Room Acoustic Ceiling

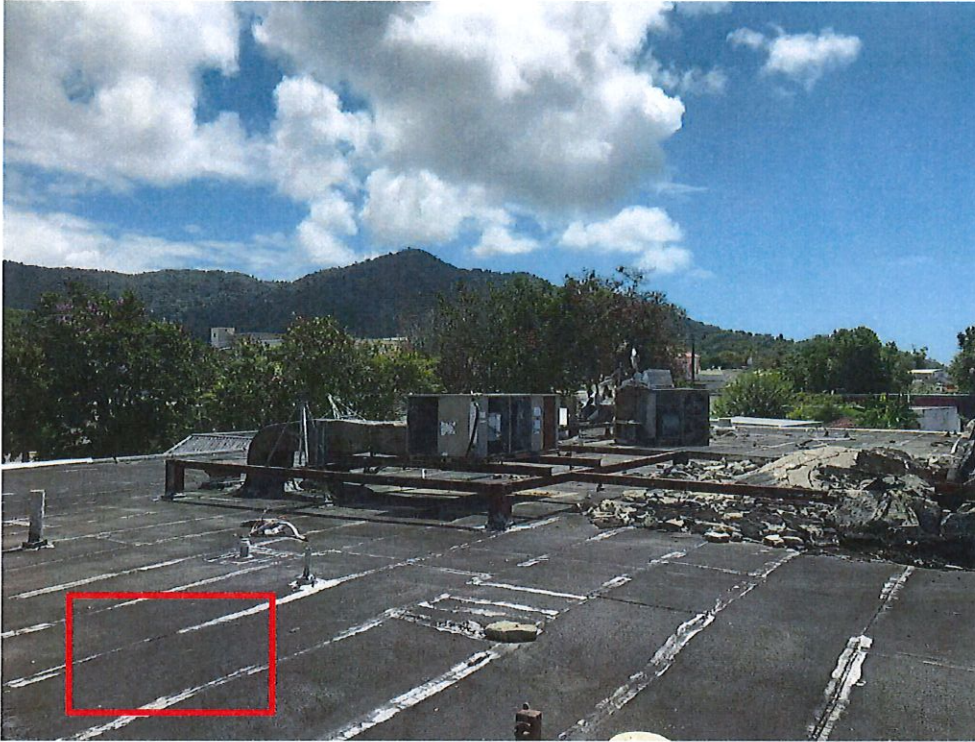
Photo Number 10 – Roof Treatment

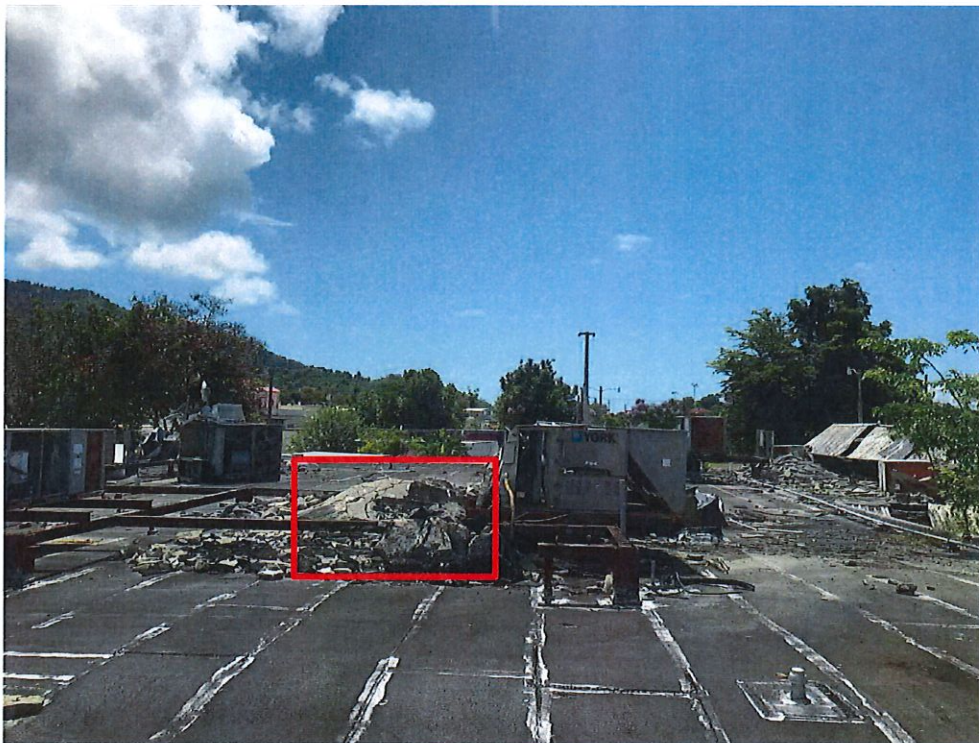
Photo Number 11- Roof Concrete

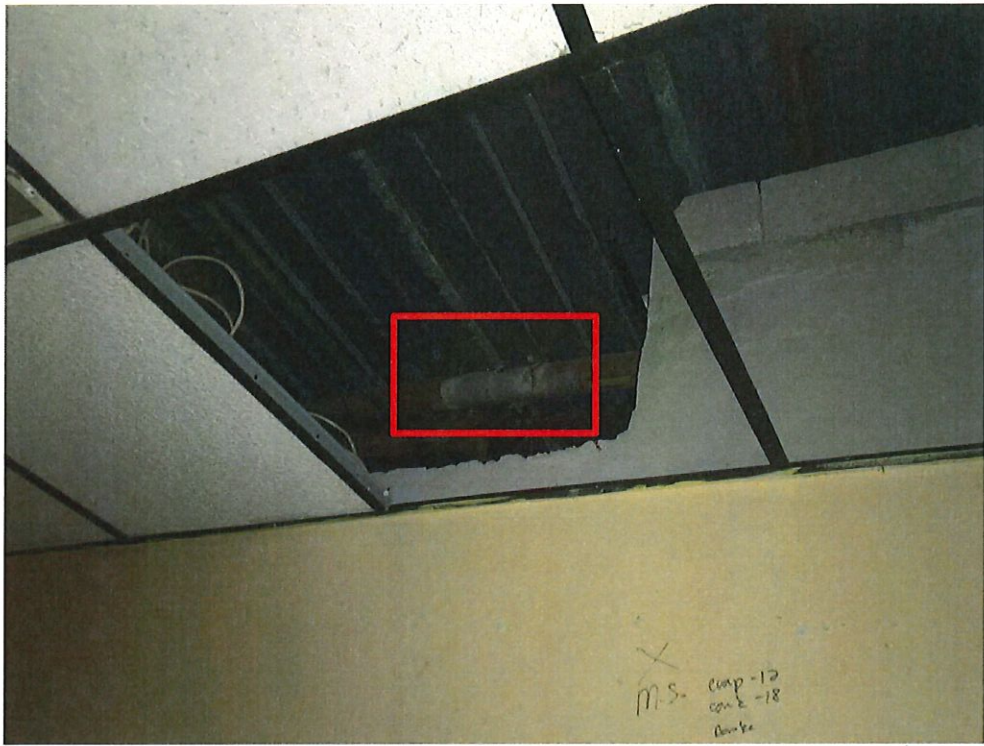
Photo Number 12- Hot Water Return Pipe Insulation

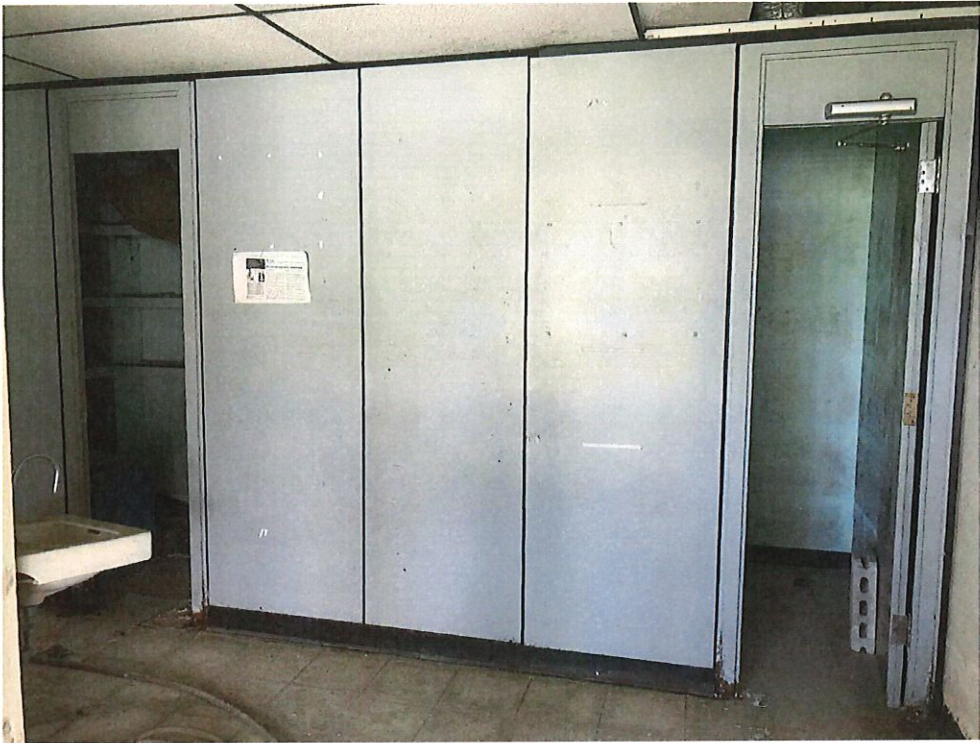
LBP positive testing combinations are shown at the following photos.

Photo Number 6 – X-Ray room Clinical Dental Wall

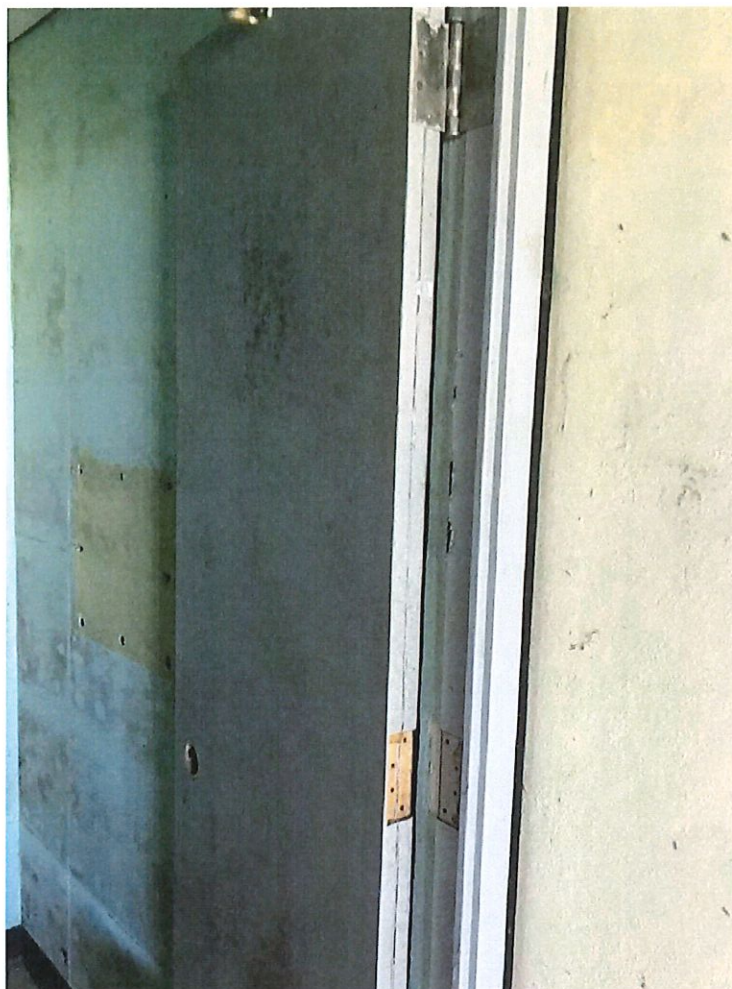
Photo Number 7 – Door X-Ray Room Clinical Dental

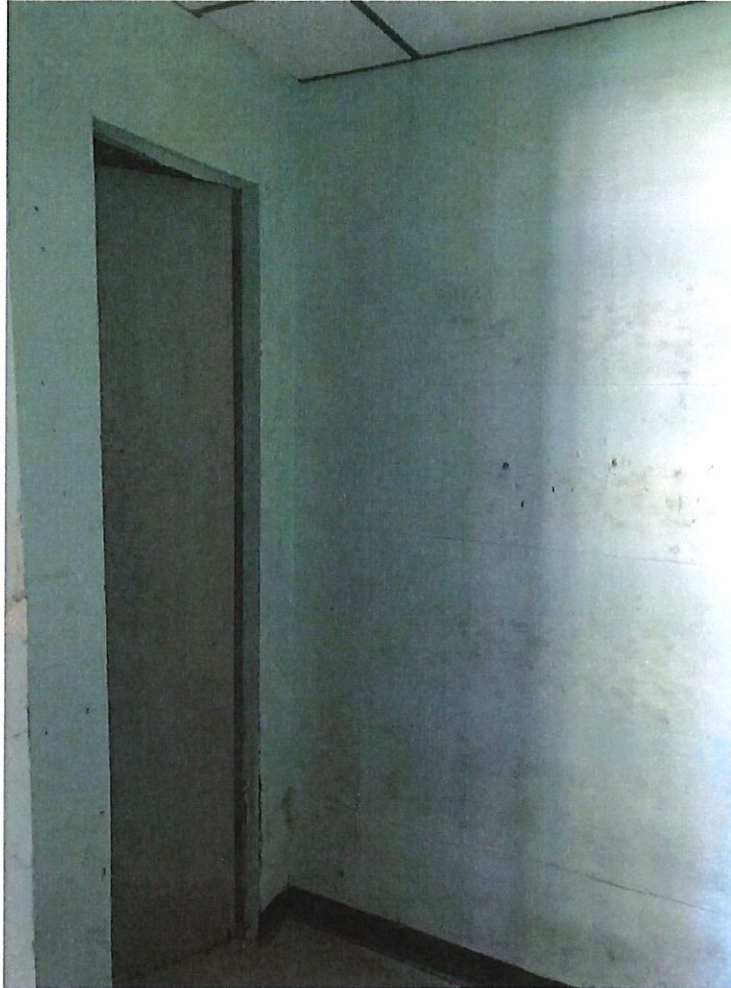
Photo Number 8 – Door X-Ray Room Clinical Dental

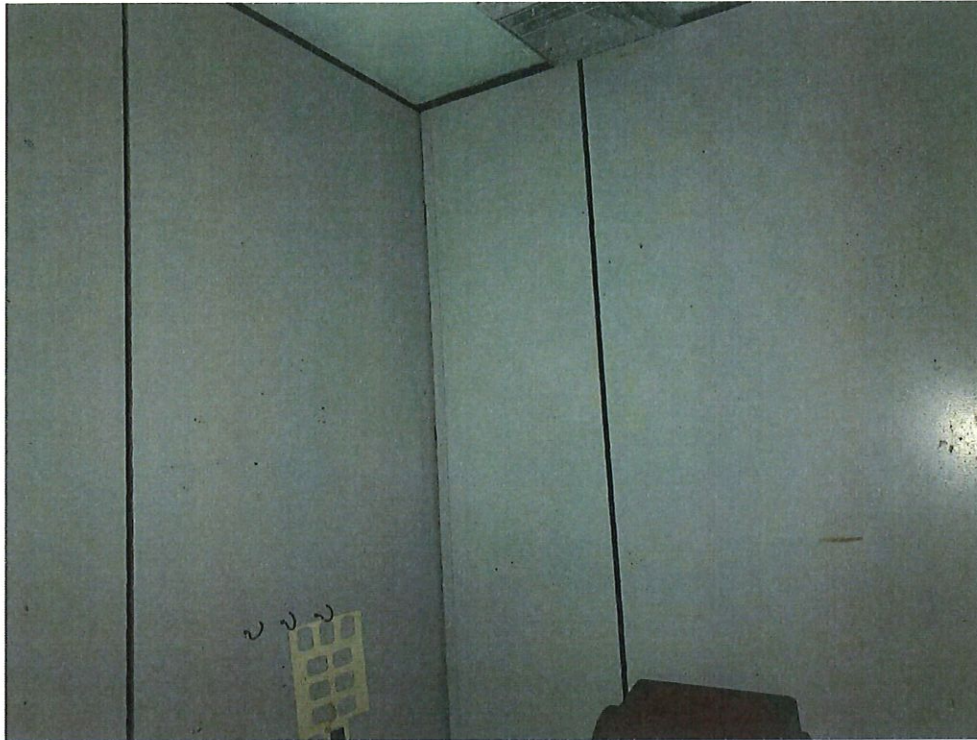
Photo Number 9 – Wall Interior “A” and “B” X-Ray Room Clinical Dental

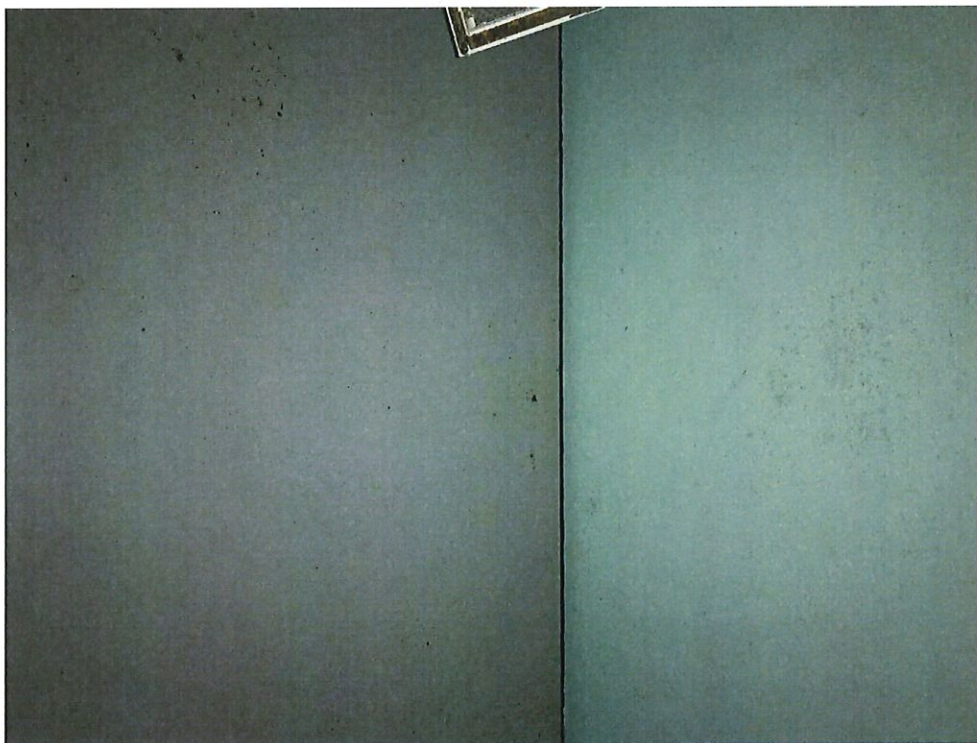
Photo Number 10 – Wall Interior “C” and “D” X-Ray Room Clinical Dental

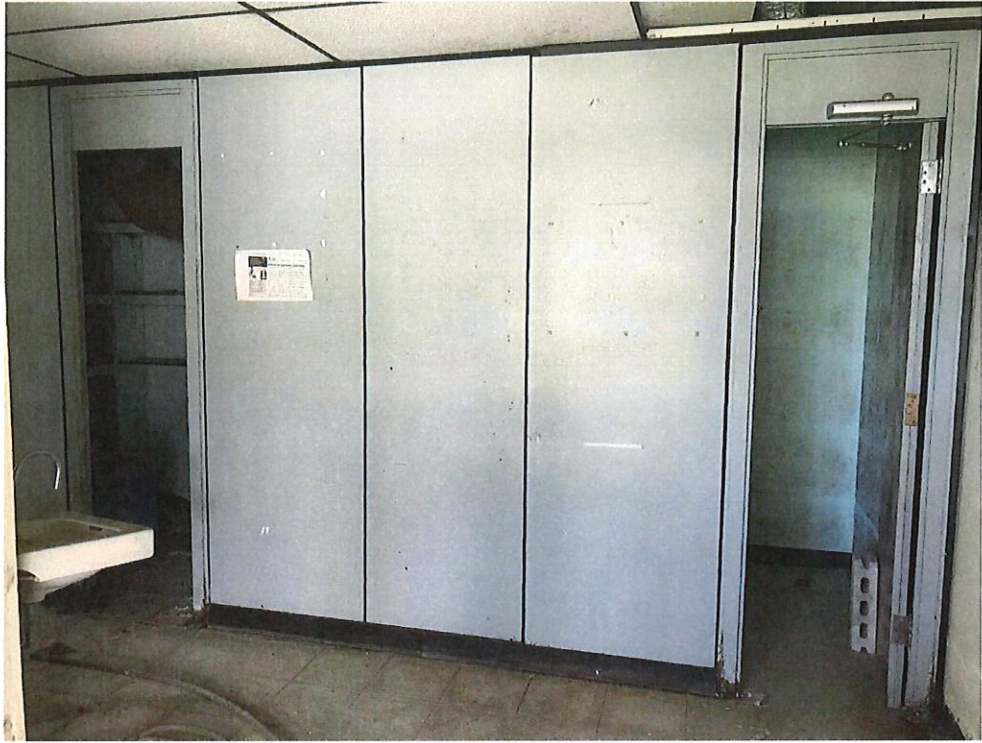
Photo Number 11 – Wall Interior “A” Clinical Dental

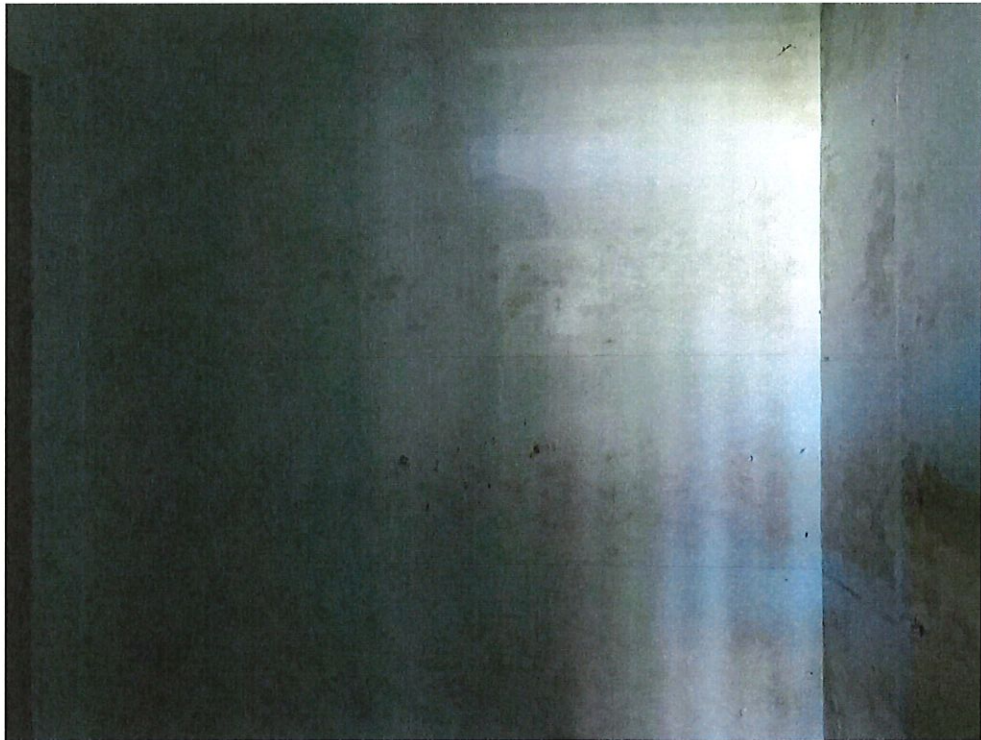
Photo Number 12 – Wall Interior “C” Dark Room at the X-Ray Room Area

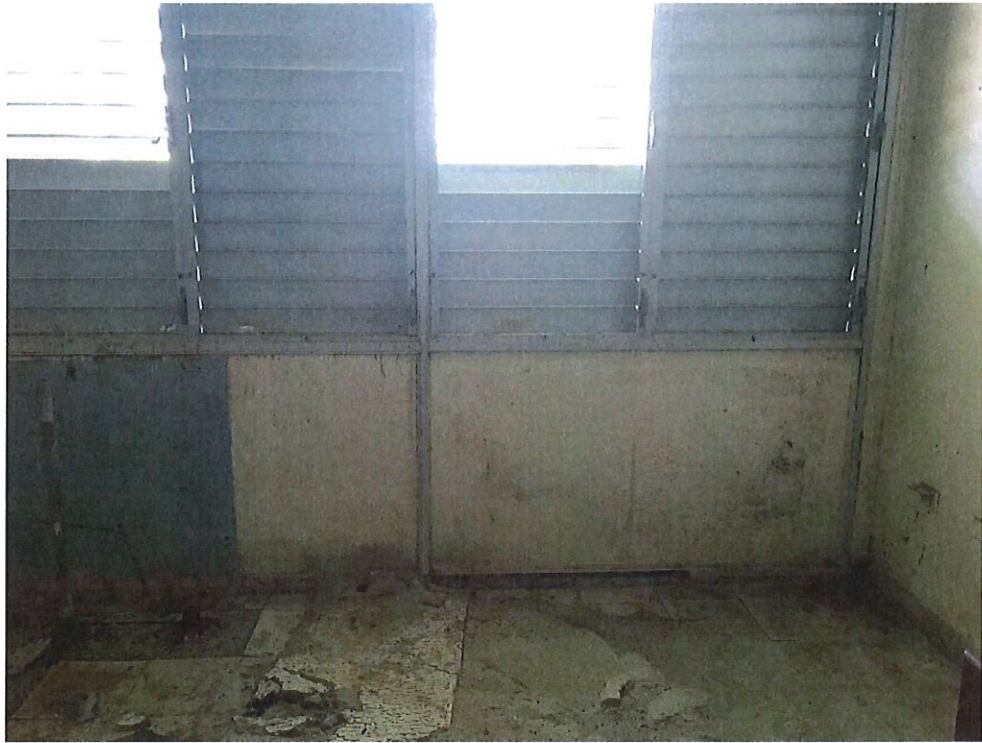
Photo Number 13 – Wall interior “D” Work Area

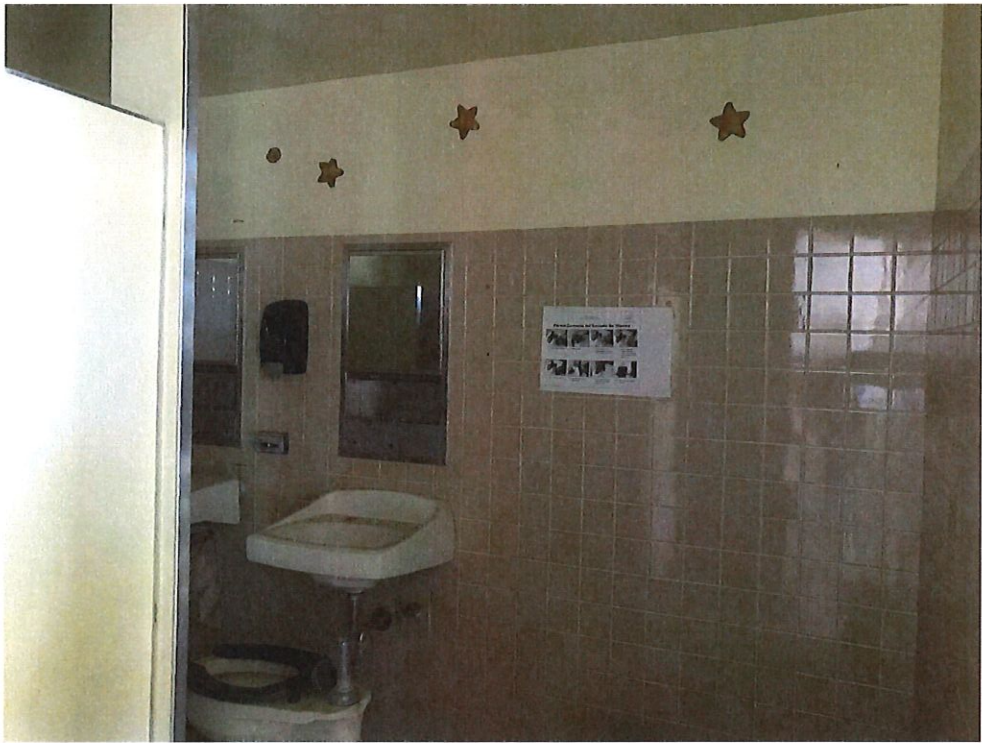
Photo Number 14 – Wall Interior Restrooms

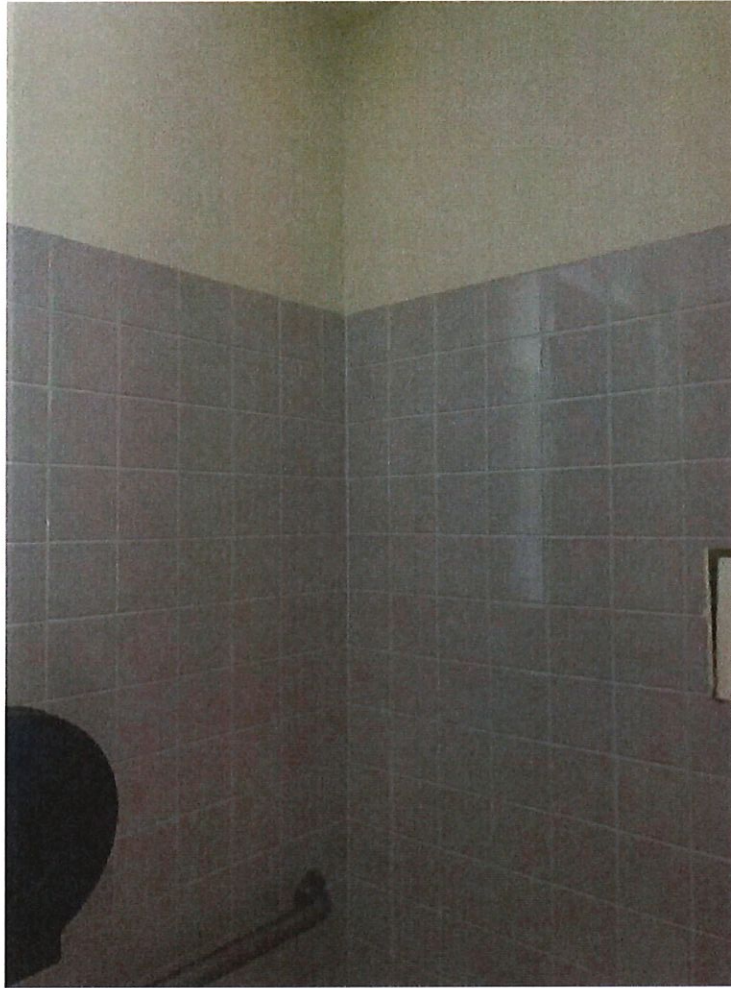
Photo Number 15 – Wall Interior Restrooms

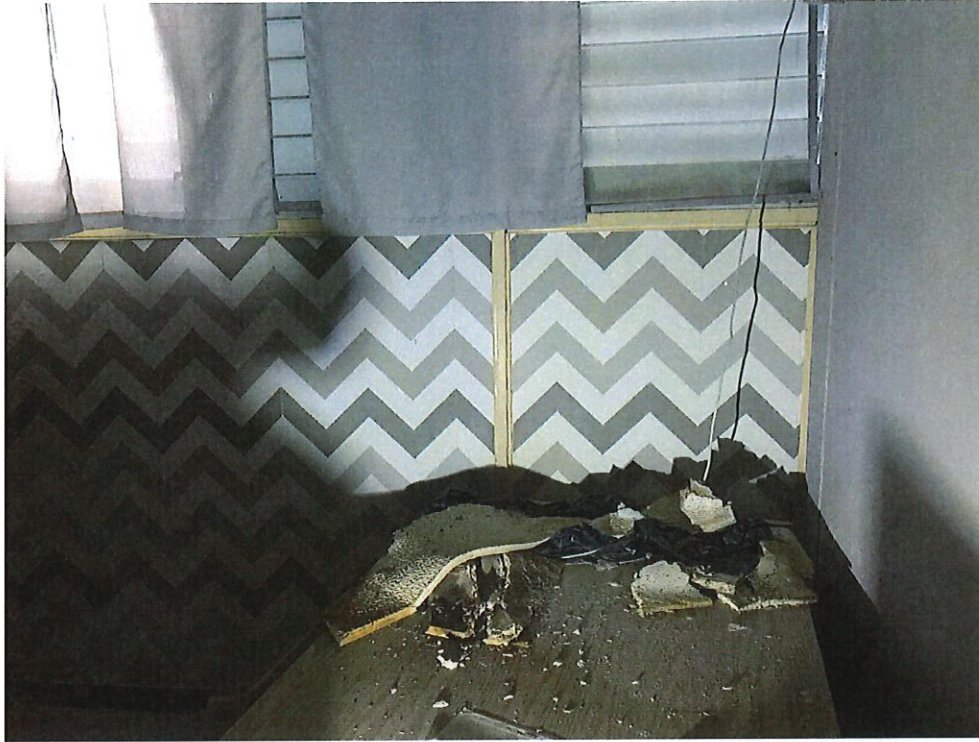
Photo Number 16 – Wall Interior “A” Exam & Treatment Room (83C)

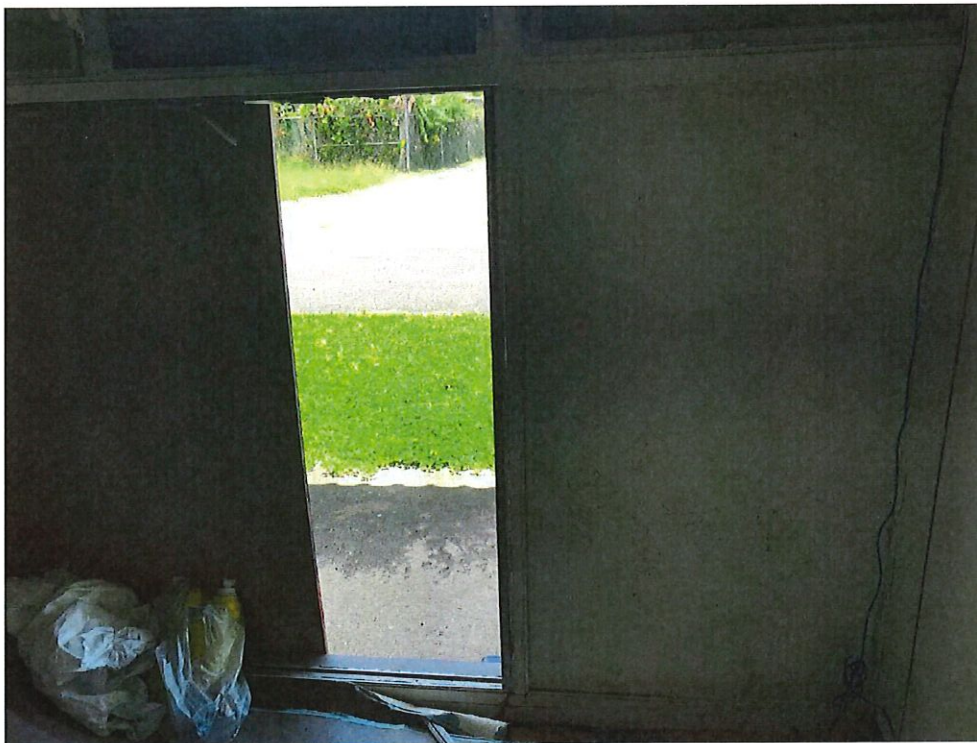
Photo Number 17 – Wall Interior “A” Exam & Treatment Room (71C)

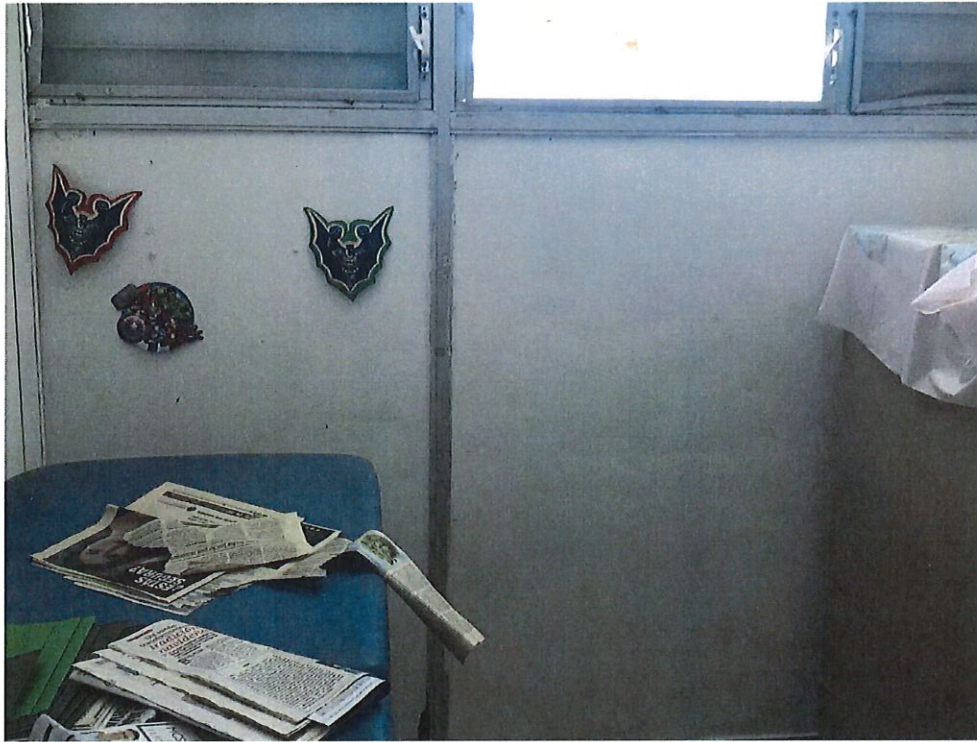
Photo Number 18 – Wall Interior "A" Exam & Treatment Room (70C)

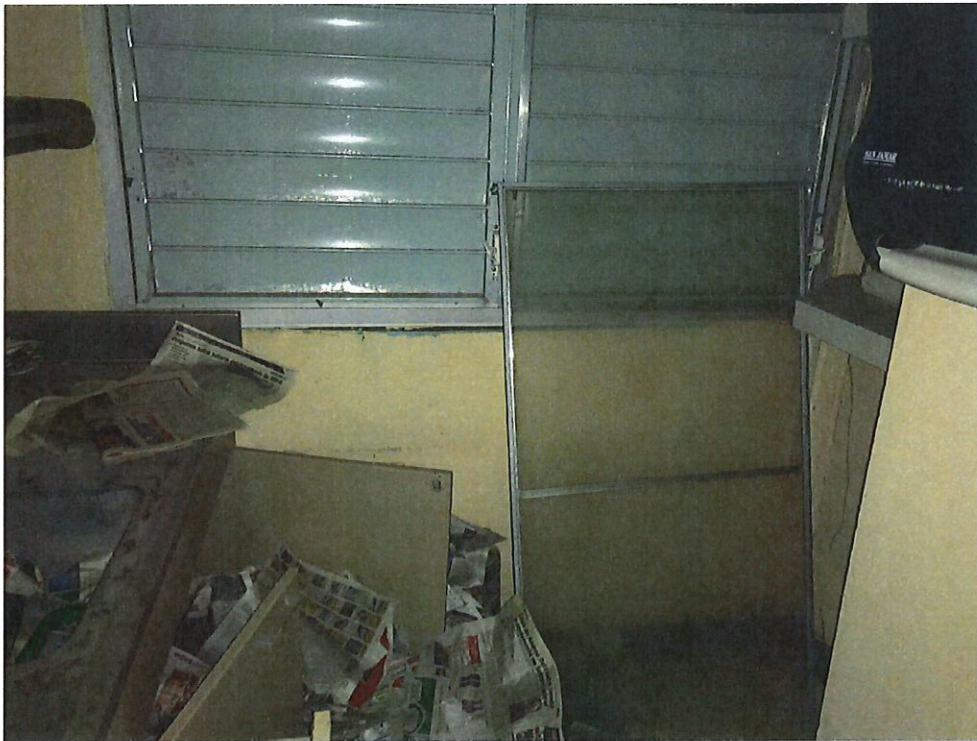
Photo Number 19 – Wall Interior "A" Clean Utility

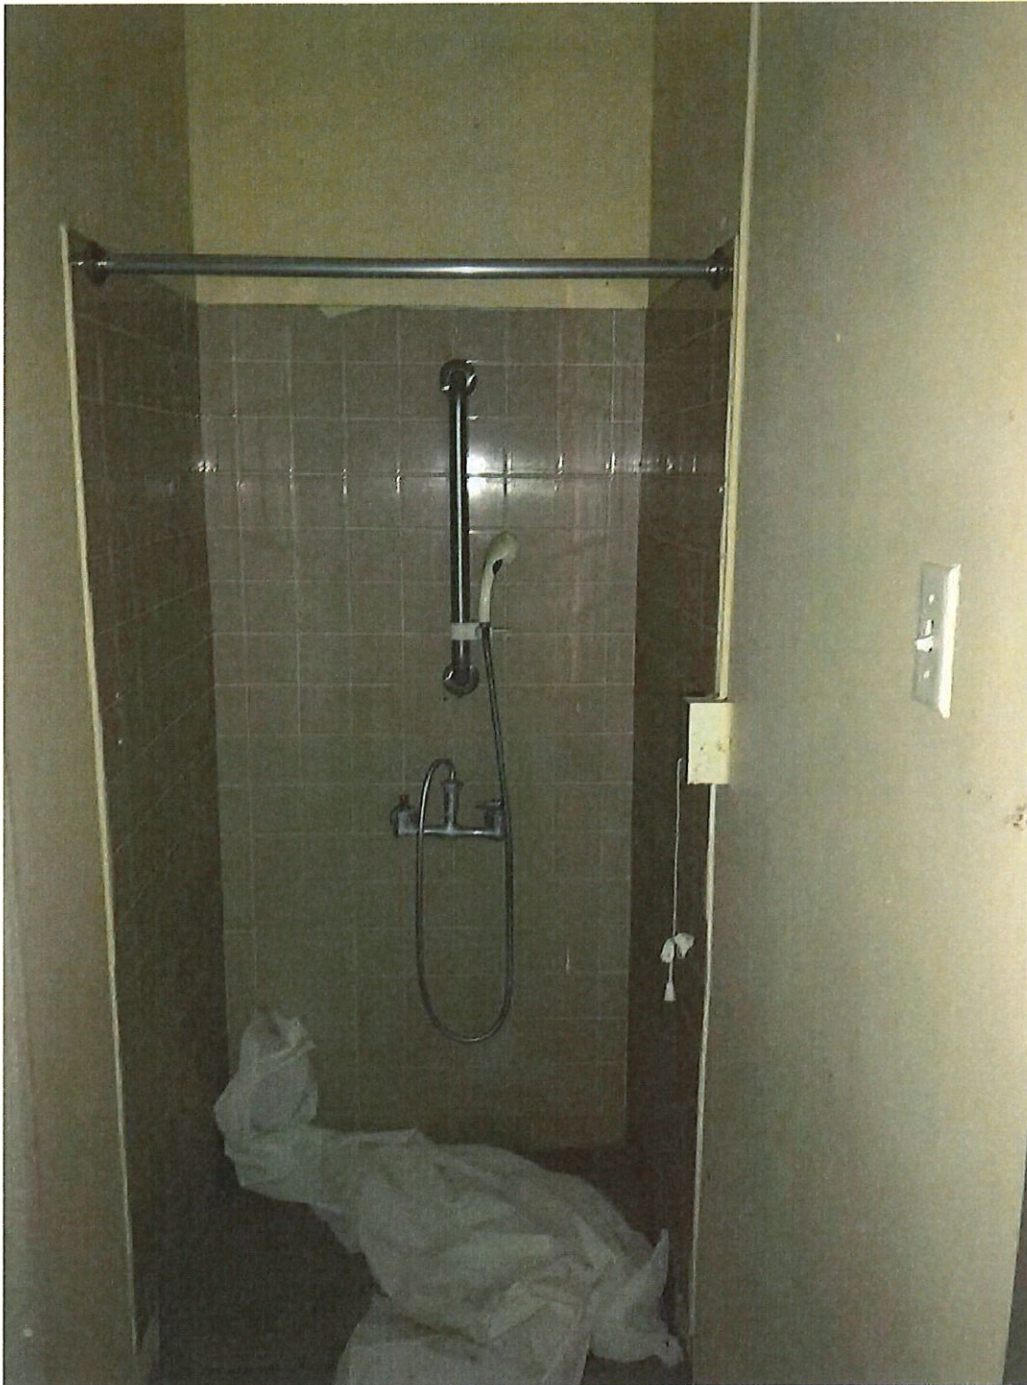
Photo Number 20 – Wall Interior Jan (Janitor) Room 58D

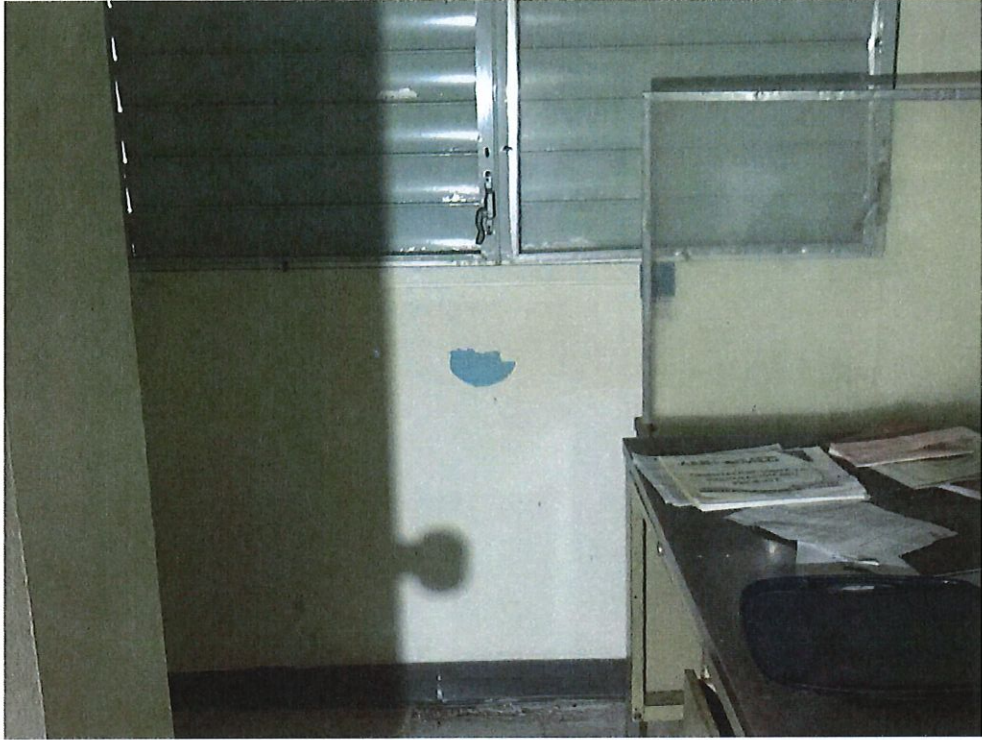
Photo Number 21 – Wall Interior “A” Soiled Utility

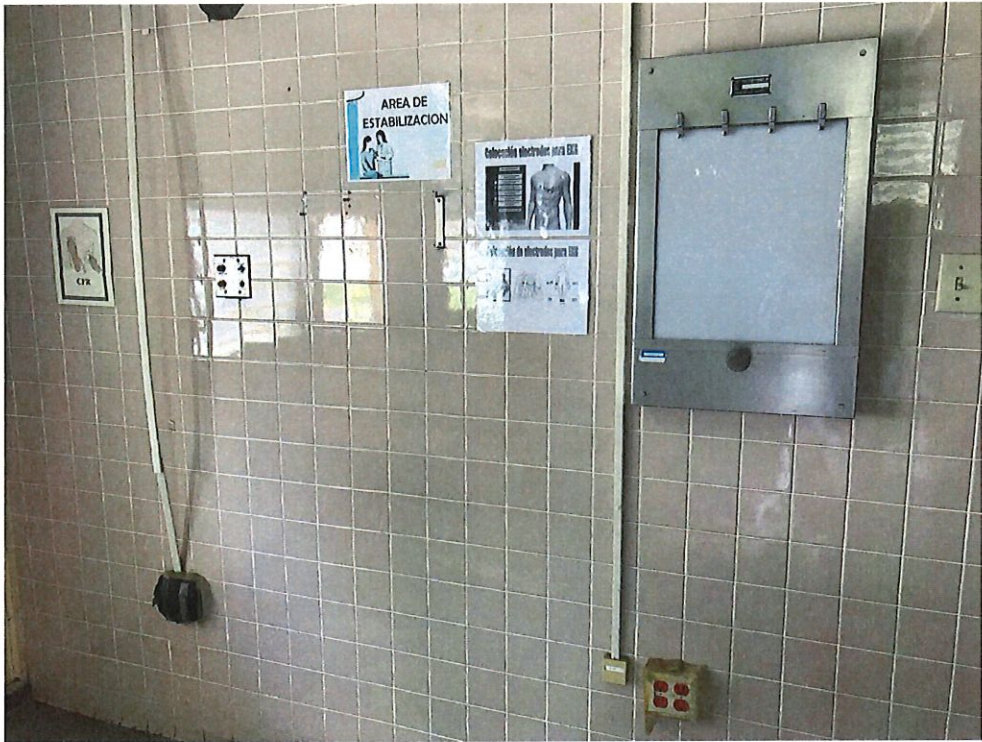
Photo Number 22 – Wall Interior Emergency Room

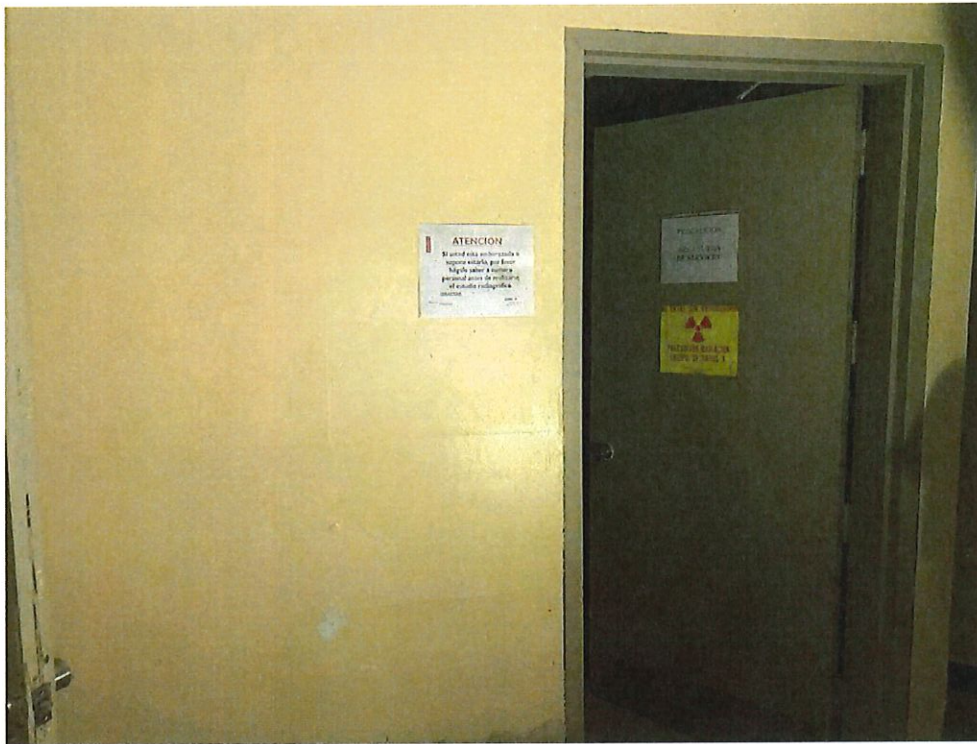
Photo Number 23 – Wall Interior “A” X-Ray Room

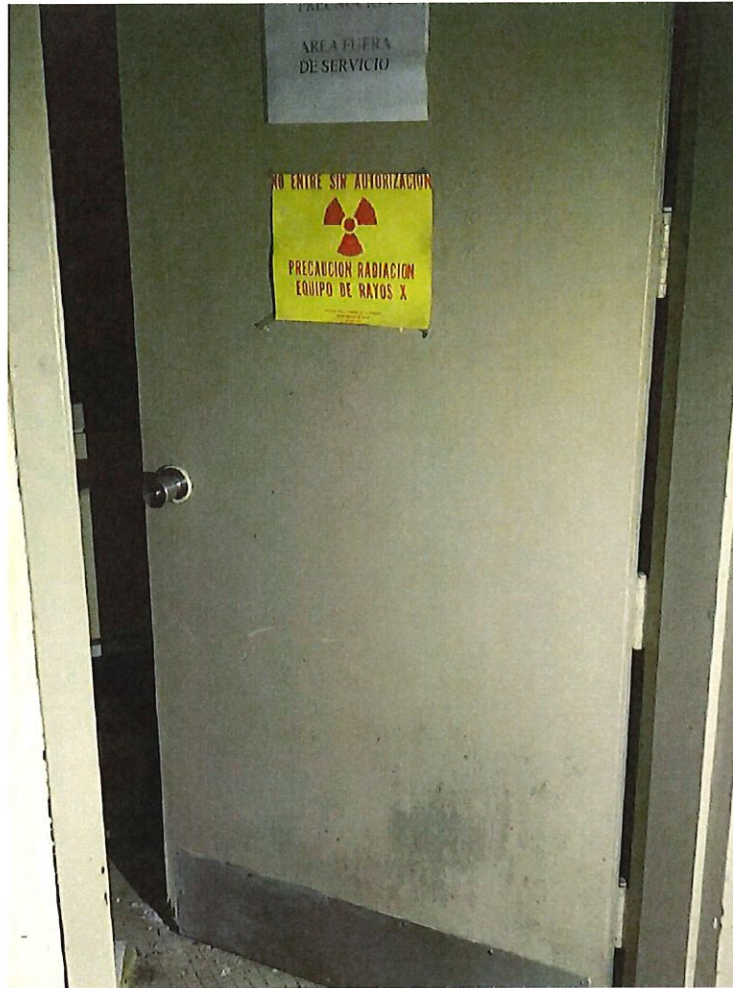
Photo Number 24 – Door Frame and Door Interior X-Ray Room
