**SUBASTA FORMAL 22J-11819
PARA EL SERVICIO DE DEMOLICIÓN DE ESTRUCTURA Y RECOGIDO DE
ESCOMBROS DEL CDT DE MAUNABO, ADSCRITO AL DEPARTAMENTO DE SALUD
DEL GOBIERNO DE PUERTO RICO**

ASUNTO: ESTUDIO DE ASBESTO Y PLOMO

ASBESTOS CONTAINING MATERIALS INSPECTION REPORT

CDT Maunabo

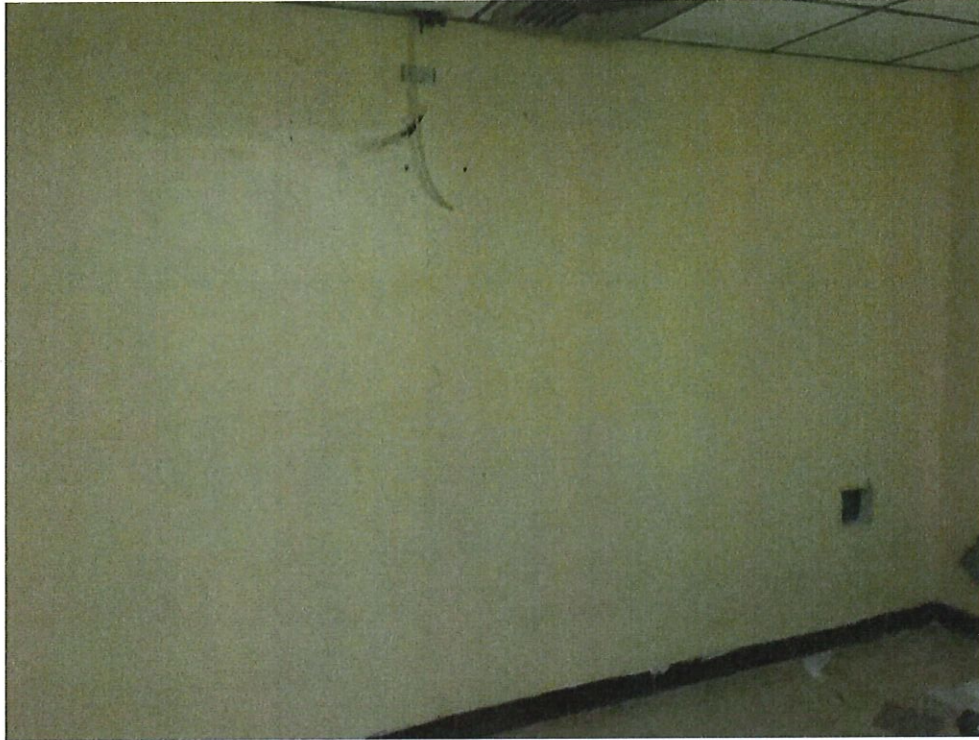
Photo Number 25 – Wall “B” Interior X-Ray Room

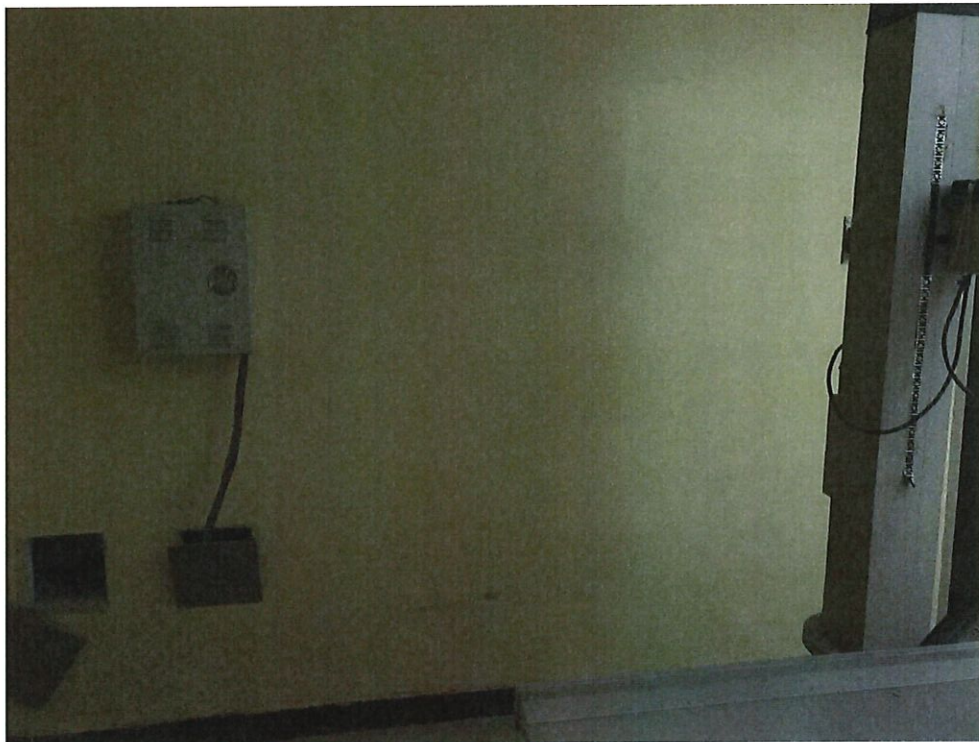
Photo Number 26 – Wall “D” Interior X-Ray Room

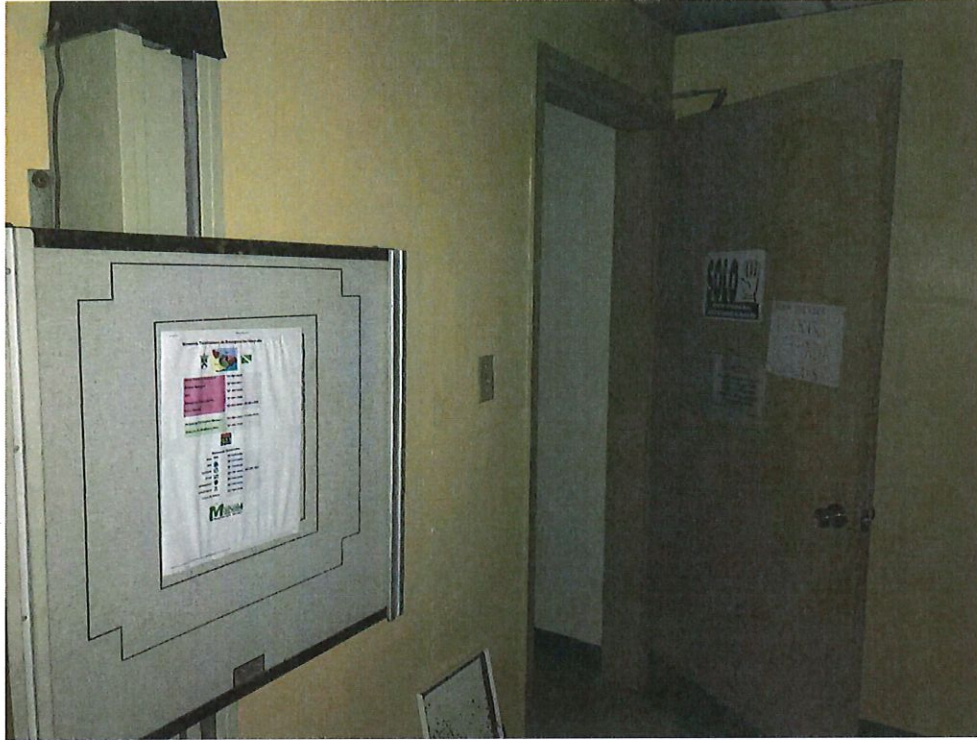
Photo Number 27 – Wall “C” Interior X-Ray Room

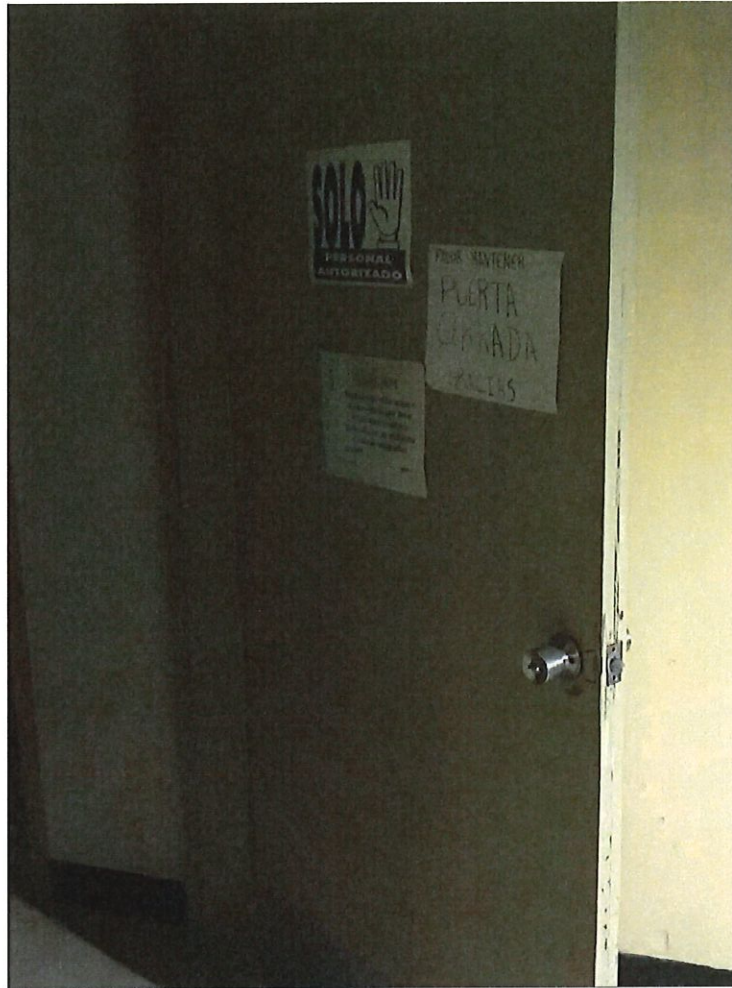
Photo Number 28 – Door Frame and Door Interior X-Ray Room

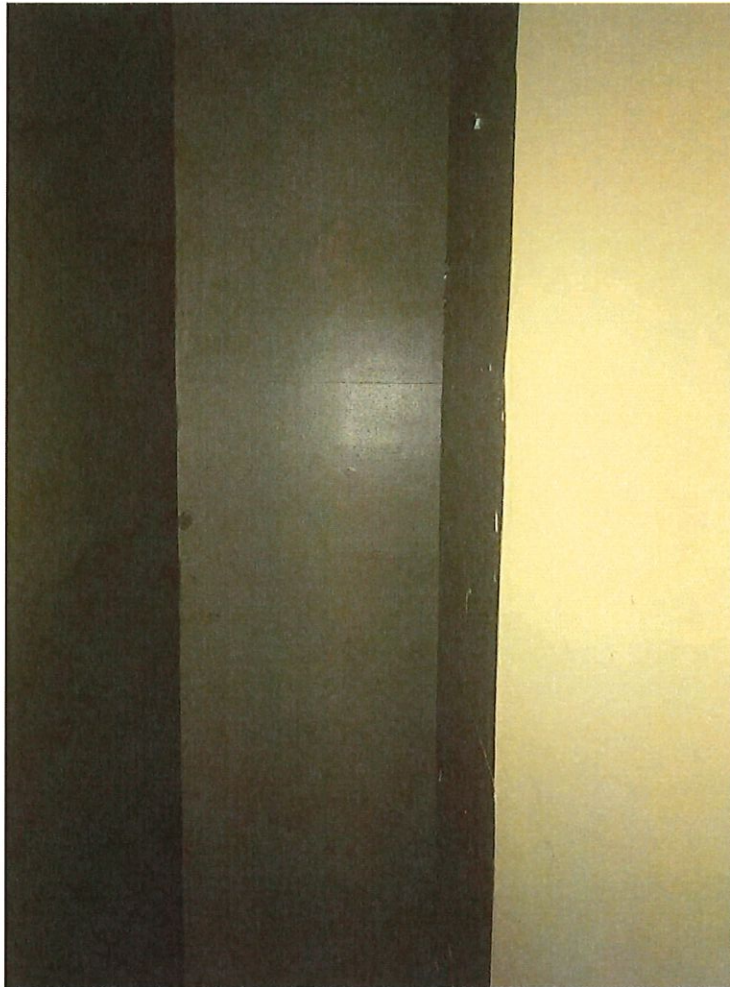
Photo Number 29 – Wall Interior Control X-Ray Room

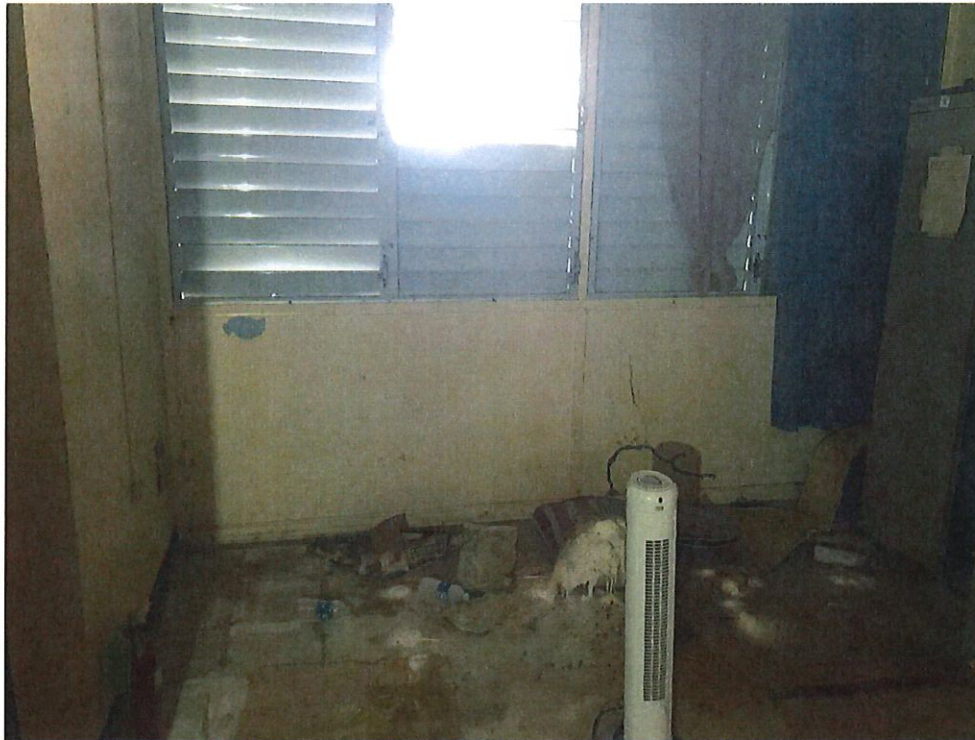
Photo Number 30 – Wall Interior "A" Soiled Linen

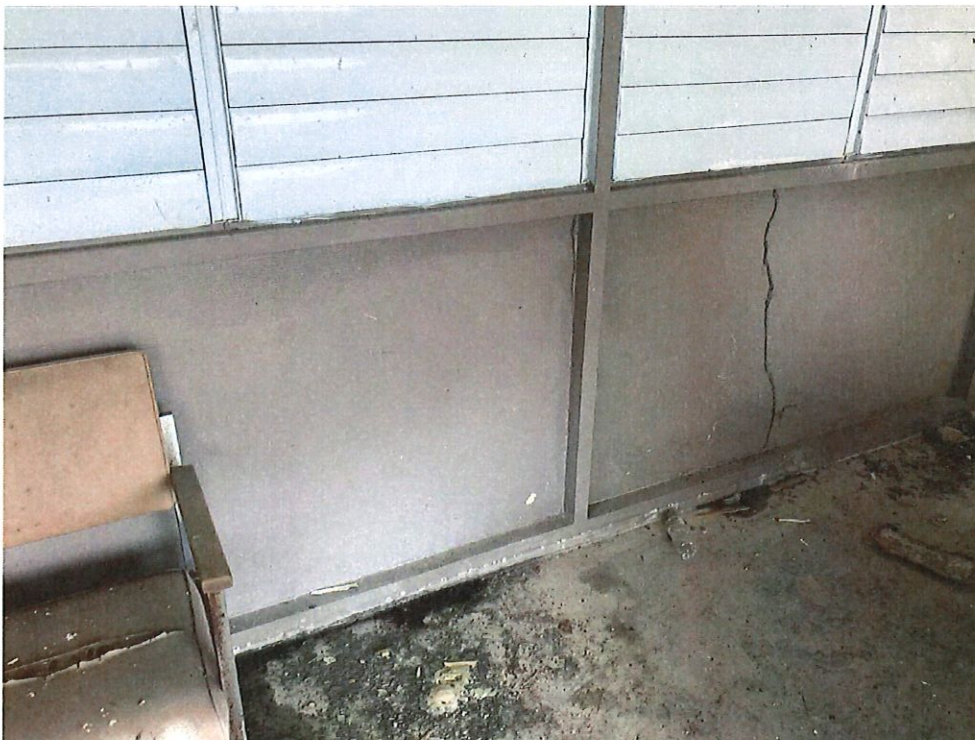
Photo Number 31 – Wall Interior "A" Loading Platform

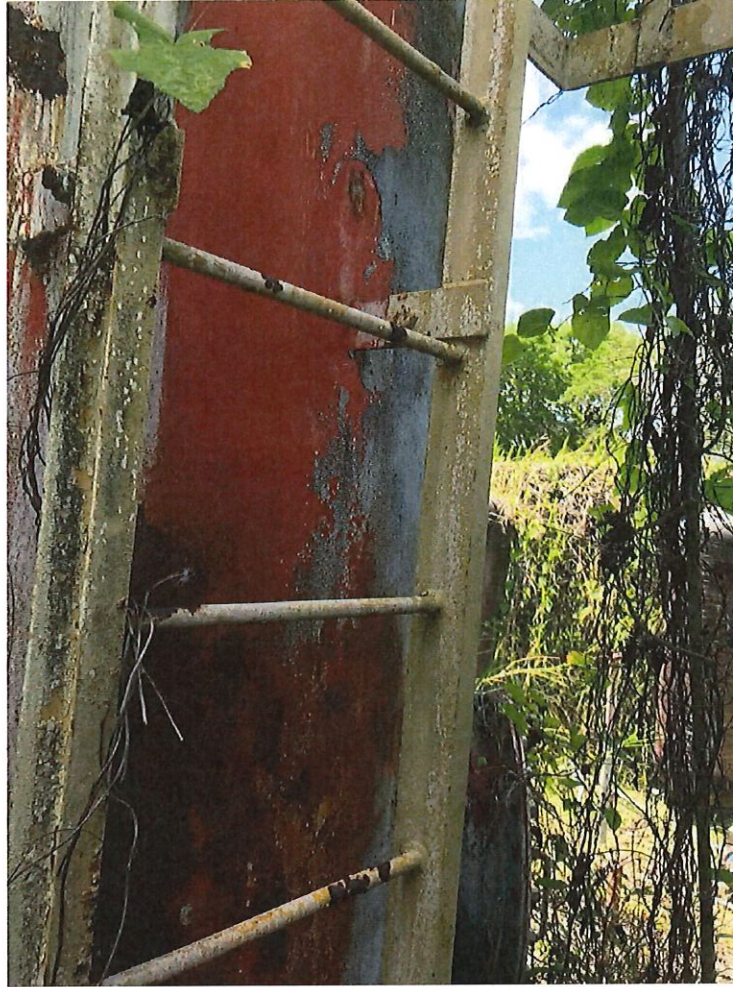
Photo Number 32 – Building Exterior Tank Stairs

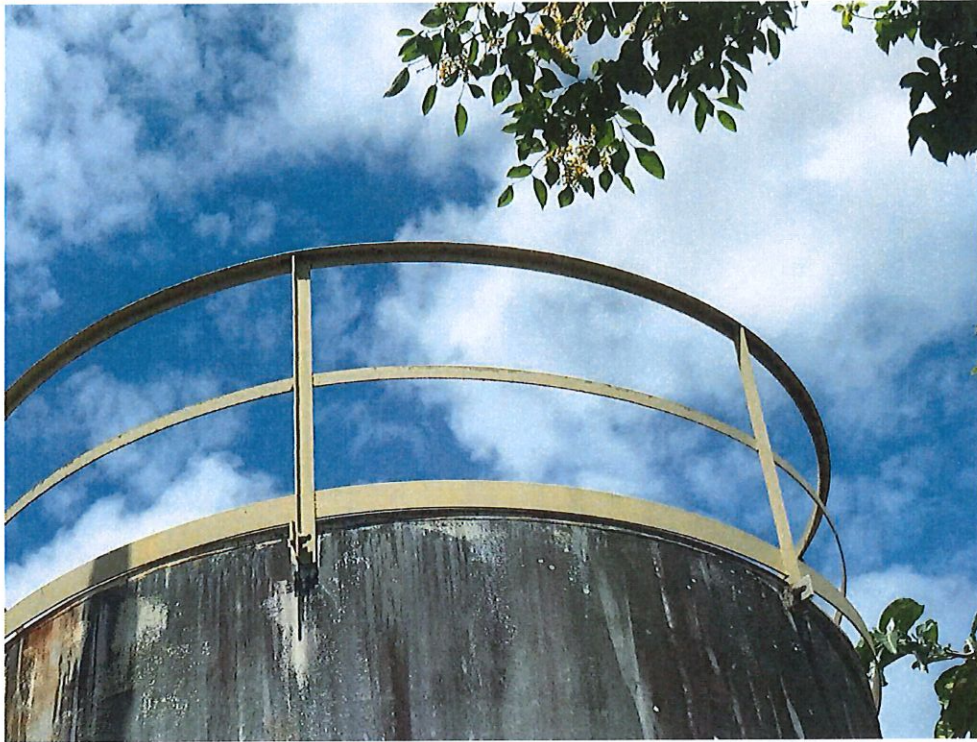
Photo Number 33 – Building Exterior Tank Handrail

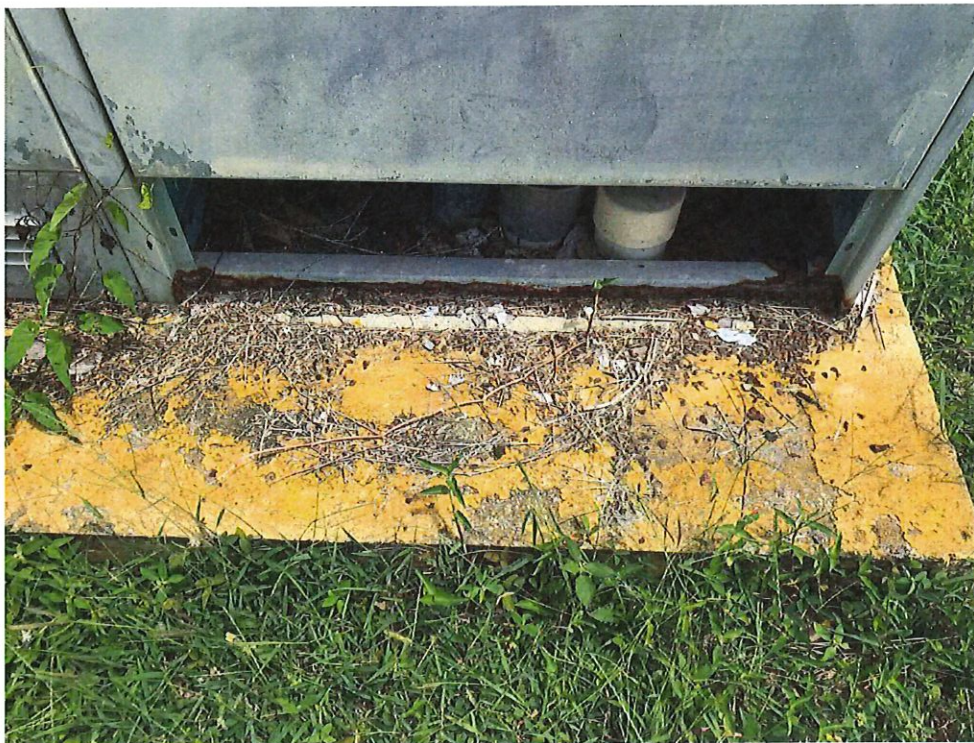
Photo Number 34 – Building Exterior Electric Transformer Slab

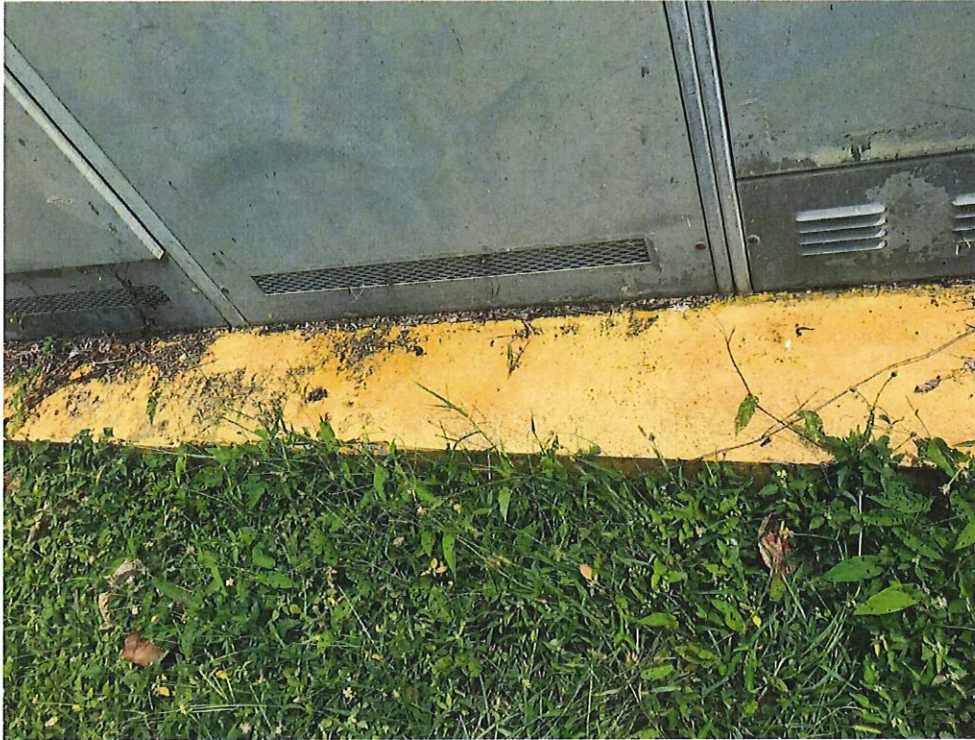
Photo Number 35 – Building Exterior Electric Transformer Slab

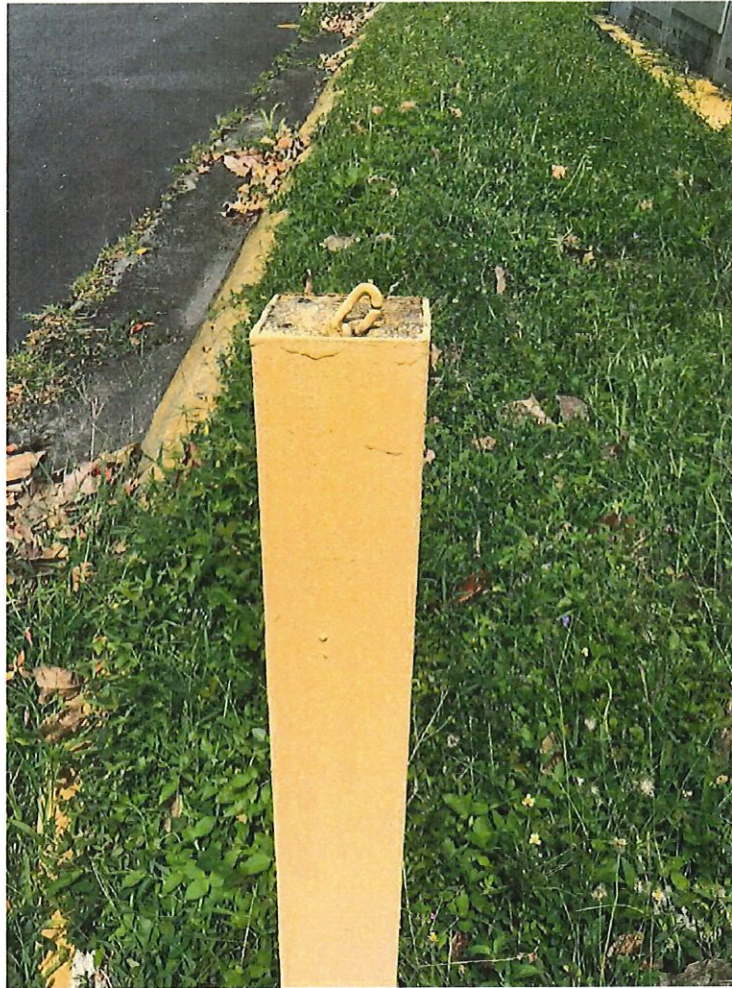
Photo Number 36 – Building Exterior Parking Bollard

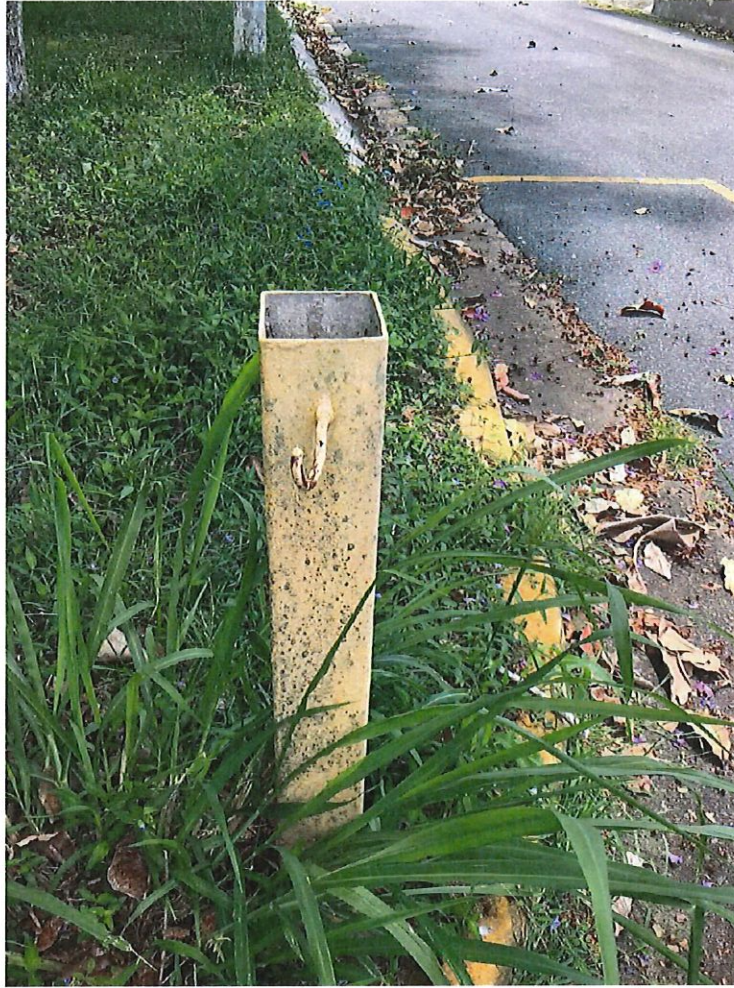
Photo Number 37 – Building Exterior Parking Bollard
