PROJECT: **ATRIUM REPAIR, REMEDIATION, AND/OR REHABILITATION 2021-002**

MARCH 19, 2021

355 AVENUE FRANKLIN DELANO ROOSEVELT,
SAN JUAN, P.R. 00918

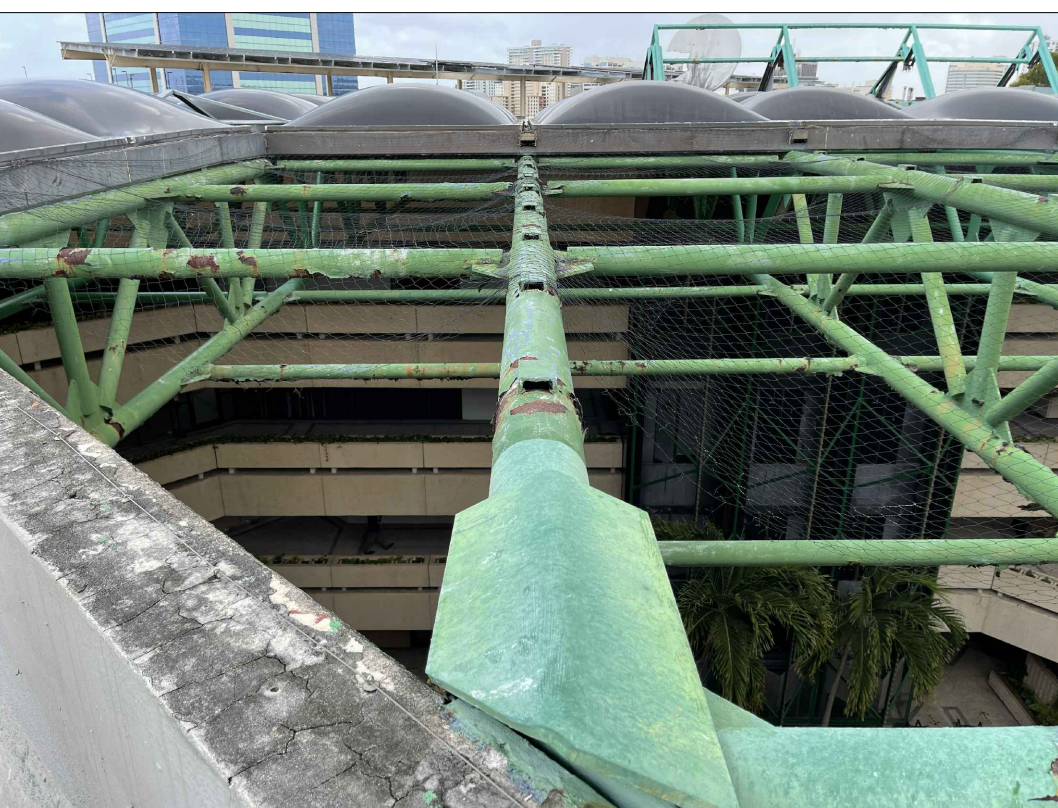
TYPICAL EXAMPLE OF FINDING ON TOP OF TRUSS.

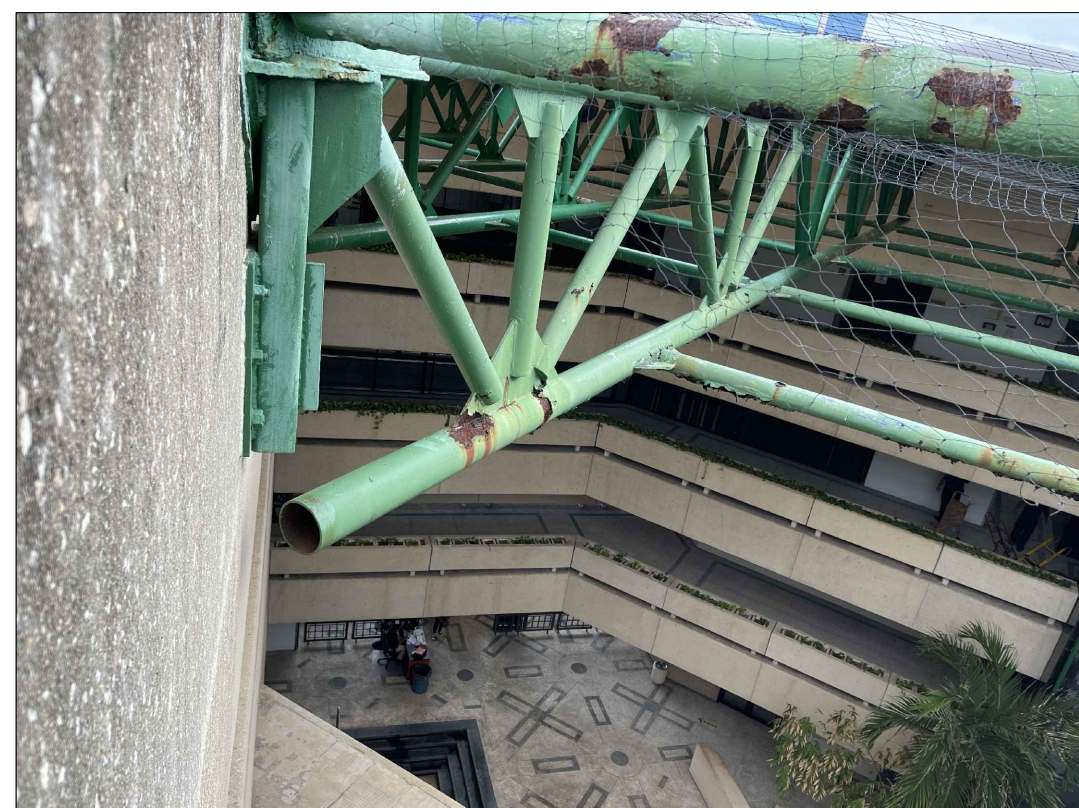
TYPICAL EXAMPLE OF FINDING ON BOTTOM OF TRUSS.

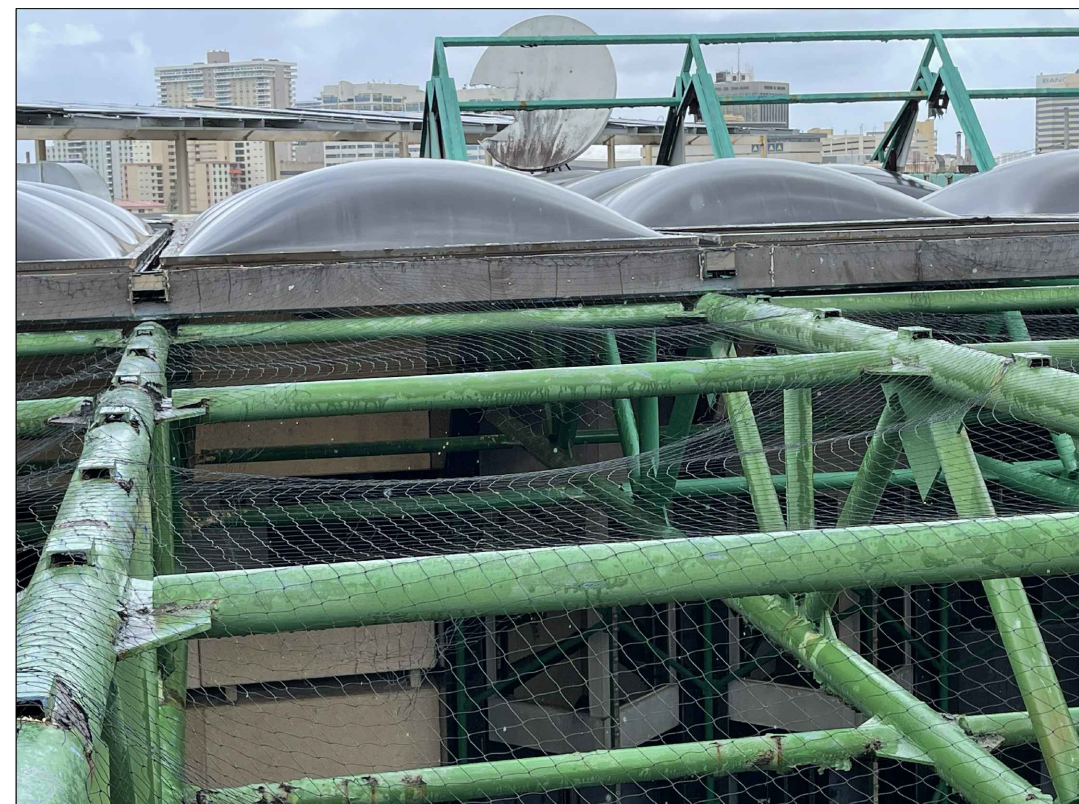
TYPICAL EXAMPLE OF FINDING ON TOP OF TRUSS.

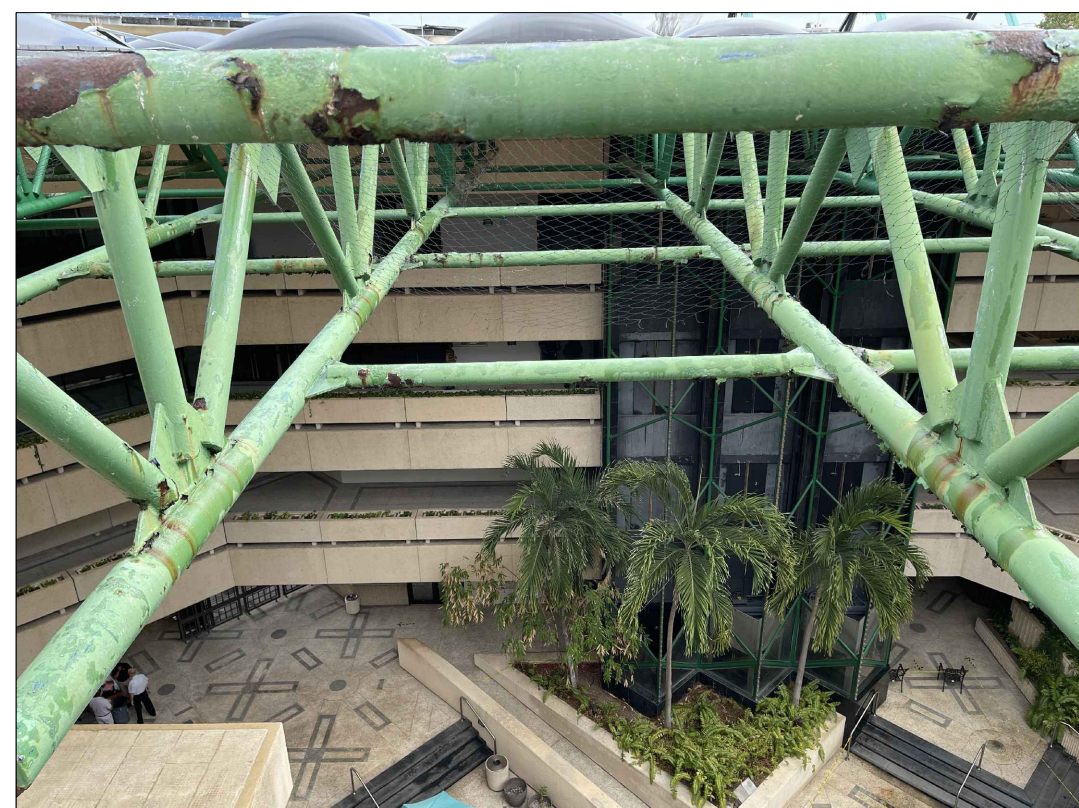
TYPICAL EXAMPLE OF FINDING ON BOTTOM OF TRUSS.

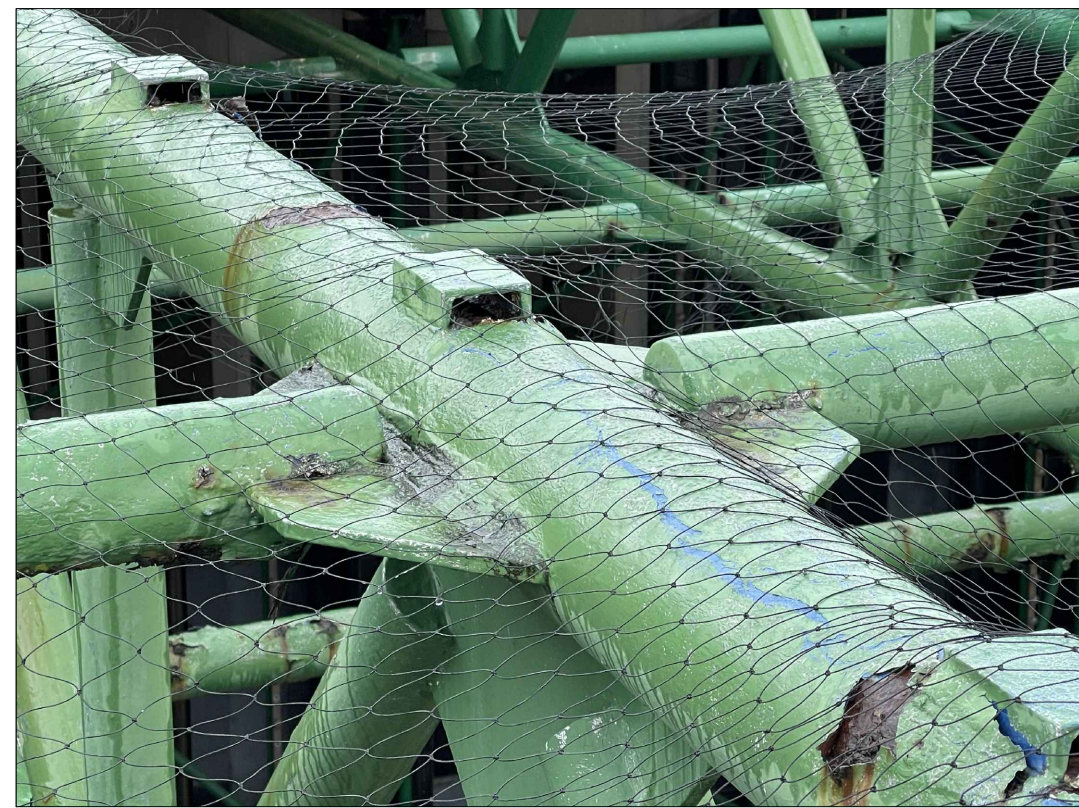
TYPICAL EXAMPLE OF FINDING
ON TOP OF CONNECTION.

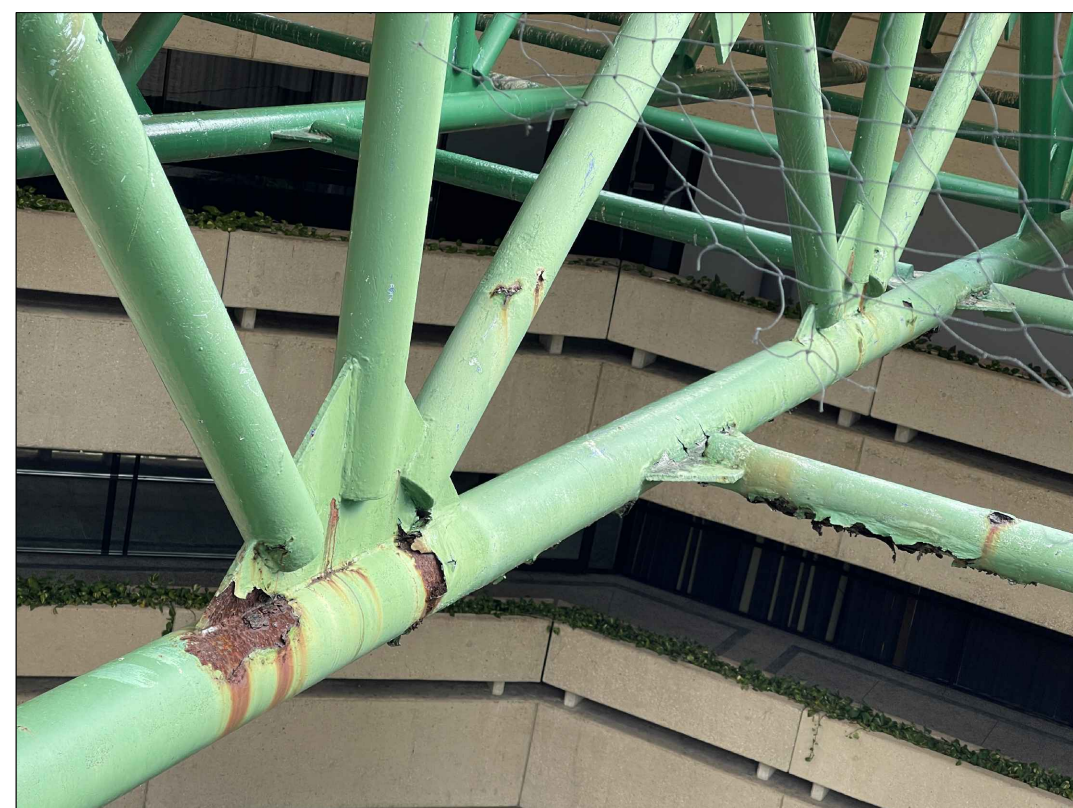
TYPICAL EXAMPLE OF FINDING
ON JOIST WEB MEMBERS.
