RECORD OF ENVIRONMENTAL CONSIDERATION (REC)

Project PA-02-PR-4339-PW-08361

Title: 86681 - MDTP147 - Arecibo Region - DTOP Buildings

Applicant: DTOP		Damage Inventory # 220569		Category E	
Work Order # 31008		FIPS # 000-UK2GJ-00		Date: 8-22-19	
Site Inspector: Raiza Rivera		GPS		Damage Facility: Lago Dos Bocas Buildings	
Damage Description Ballroom: Ballroom Building exterior paint		Photo# 1		Damage Description Ballroom: wood casement windows with jalousie

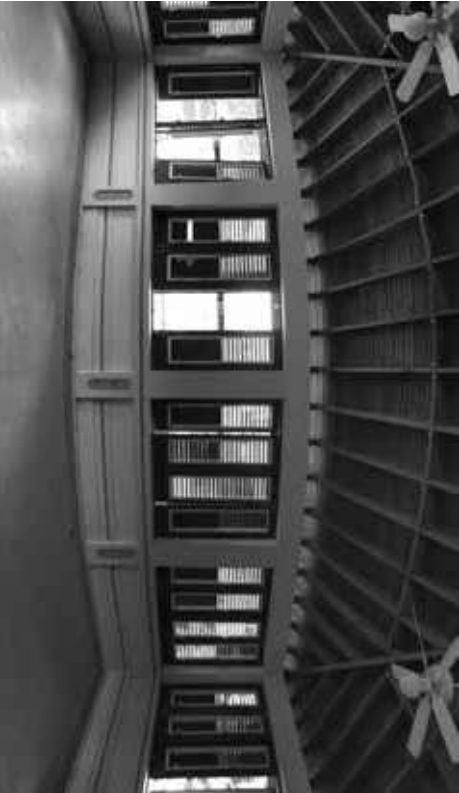
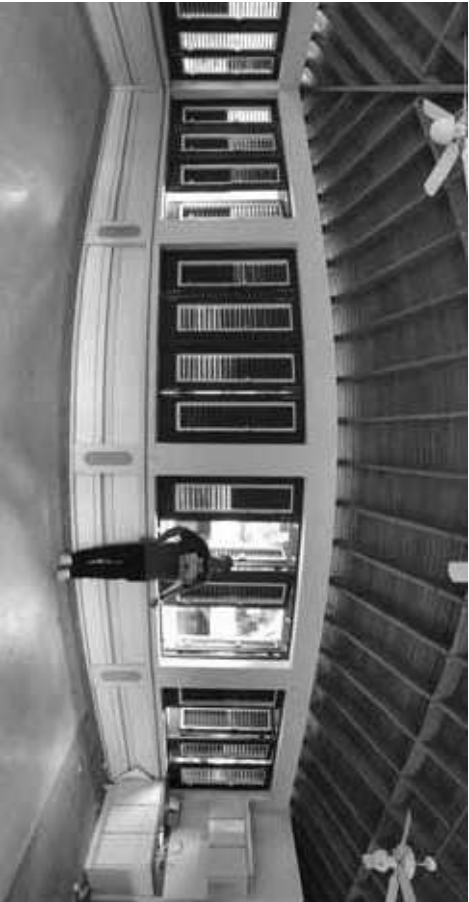
Photo# 4

Damage Description Ballroom: wood casement windows with jalousie		Photo# 3		Damage Description Ballroom: wood casement windows with jalousie

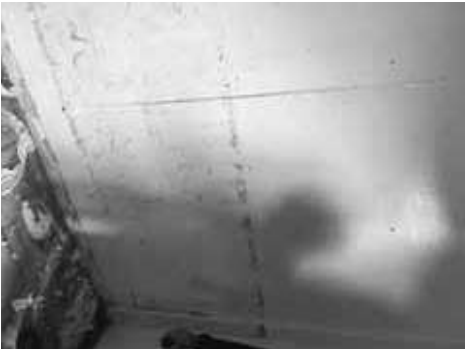
</div> <div> Damage Description Ballroom: 72 SF of gypsum wall division </div> <div> Photo# 2

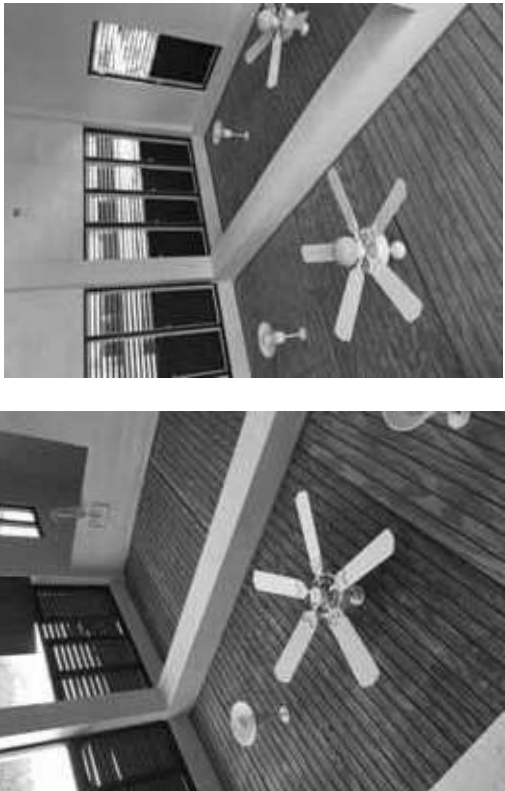
</div>		
Damage Description Ballroom: 2,025 SF of wood ceiling panels		<div> Photo# 3

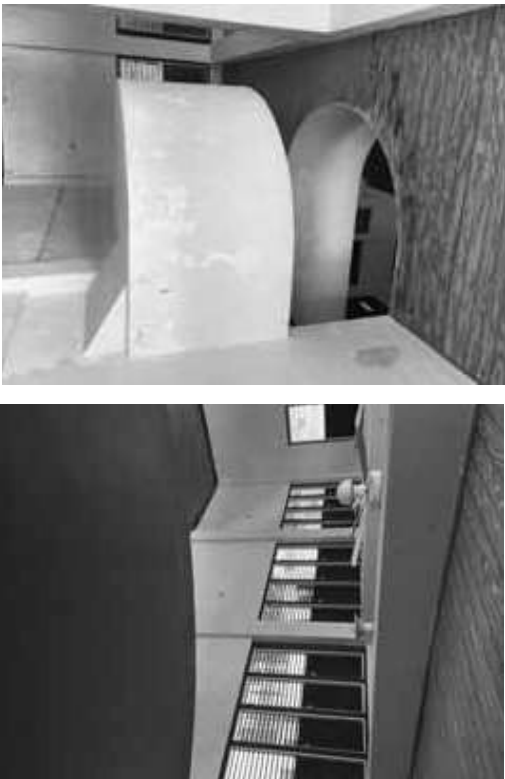
</div> <div> Damage Description Ballroom: 2,328 SF of interior paint </div> <div> Photo# 4

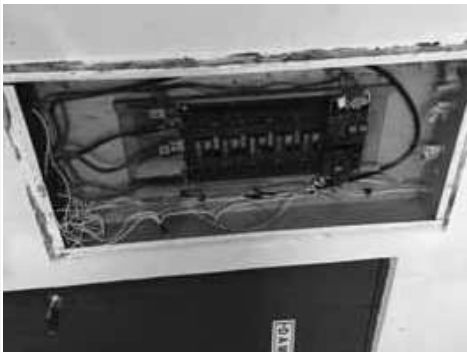
Applicant: DTOP			Damage Inventory # 220569			Category E					
Work Order # 31008			FIPS # 000-UK2GJ-00			Date: 8-22-19 GPS					
Site Inspector: Raiza Rivera			Damage Facility: Lago Dos Bocas Buildings								
Damage Description			Photo# 1			Damage Description			Photo# 2		
Ballroom: electrical panel door

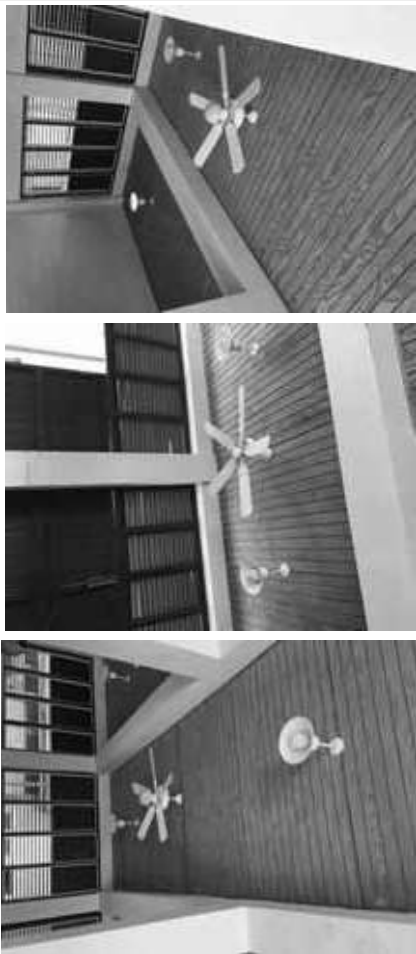
Ballroom: single light, with classic rod pendant light fixture and ceiling fans

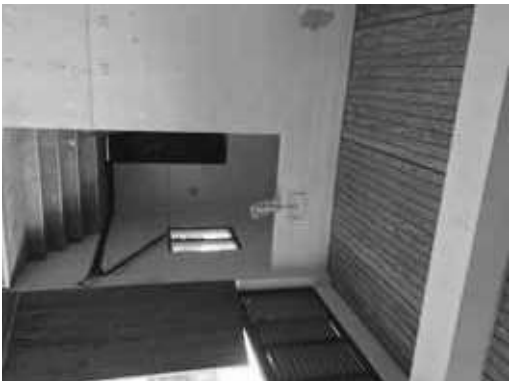
Damage Description			Photo# 3			Damage Description			Photo# 4		
Ballroom: refractory exit sign single face with battery backup case

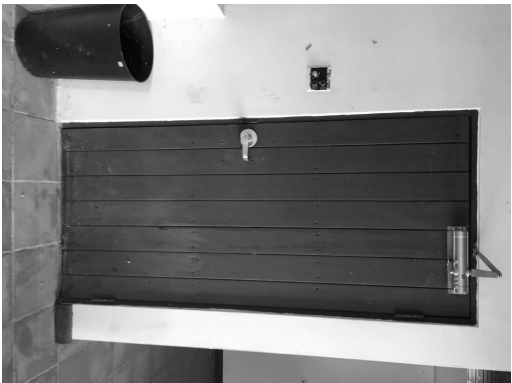
Ballroom: Porch-Lift, rated load 750lbs vertical platform lift

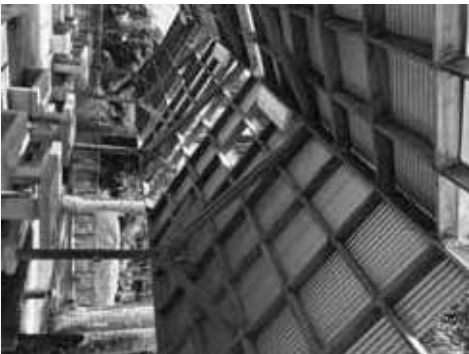
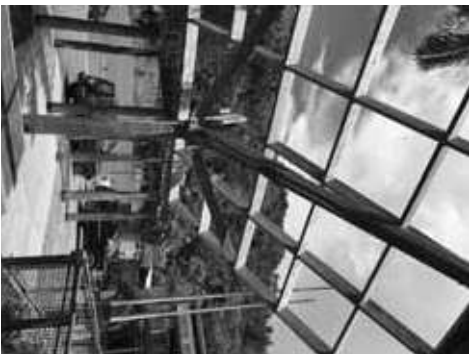
Applicant: DTOP			Damage Inventory # 220569			Category E					
Work Order # 31008			FIPS # 000-UK2GJ-00			Date: 8-22-19			GPS		
Site Inspector: Raiza Rivera						Damage Facility: Lago Dos Bocas Buildings					
Damage Description			Photo# 1			Damage Description			Photo# 2		
Gazebo 1: corrugated metal roof panels						Gazebo 1: corrugated metal roof panels

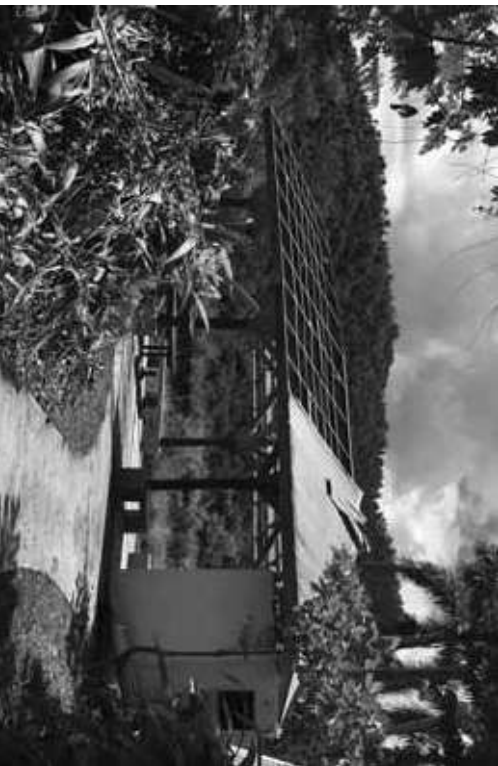
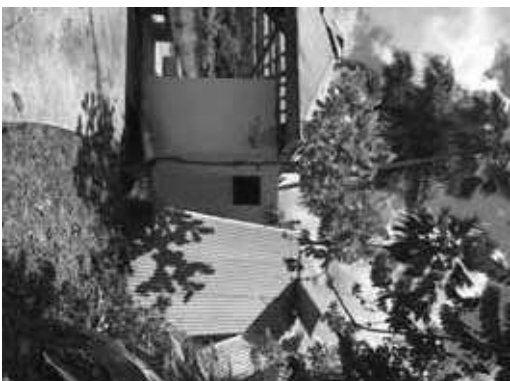
Damage Description			Photo# 3			Damage Description			Photo# 4		
Gazebo 2: corrugated metal roof panels						Gazebo 2: corrugated metal roof panels

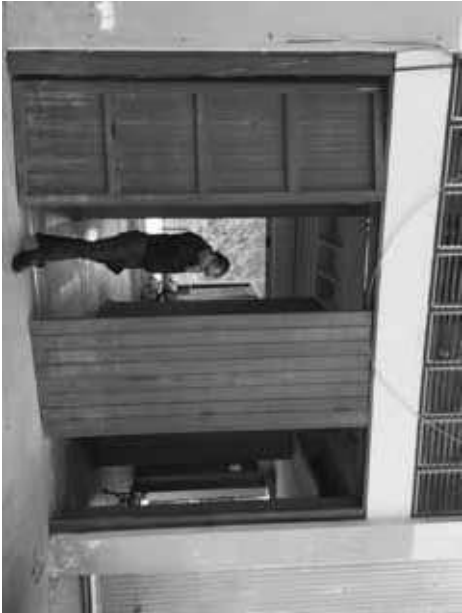
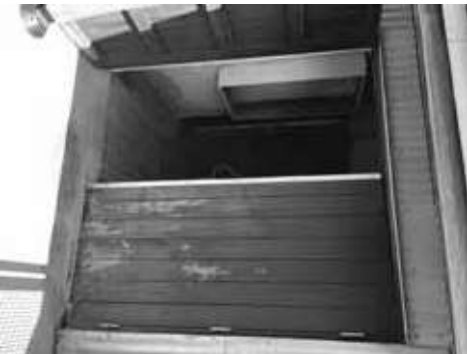
Applicant: DTOP		Damage Inventory # 220569		Category E	
Work Order # 31008		FIPS # 000-UK2GJ-00		Date: 8-22-19	
Site Inspector: Raiza Rivera		GPS 18.332163,-66.670258		Damage Facility: Lago Dos Bocas Buildings	
Damage Description: Offices Building: 4 each of entrance wood doors,		Photo# 5		Damage Description Offices Building: double wood door, 6 FT wide x 7 FT high

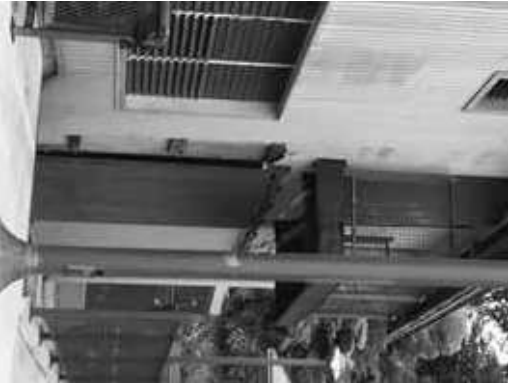
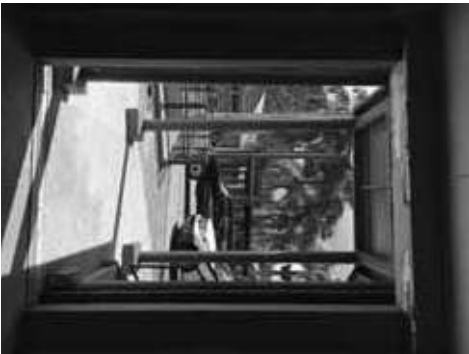
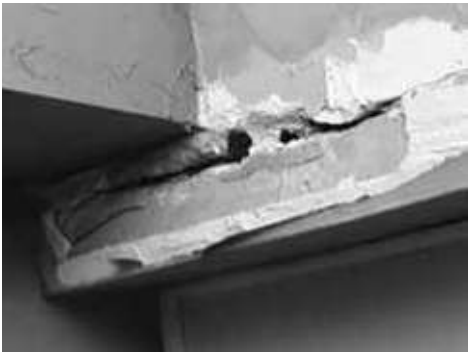
Damage Description Offices Building: Wall corrugate metal siding. 3 FT wide x 8 FT high		Photo# 7		Damage Description Offices Building: door threshold plaster

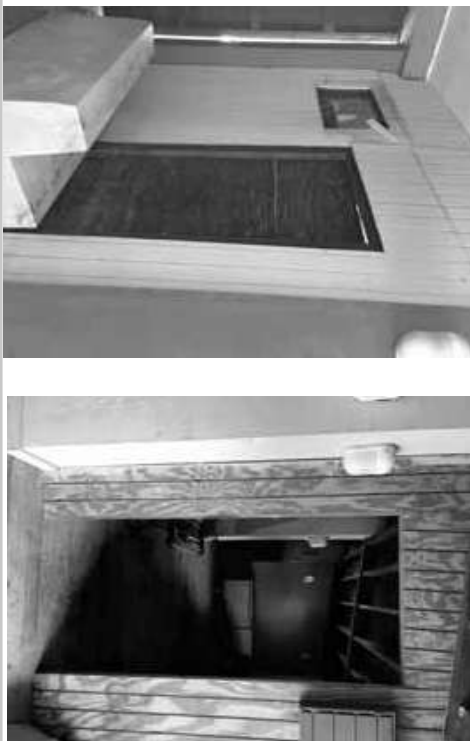
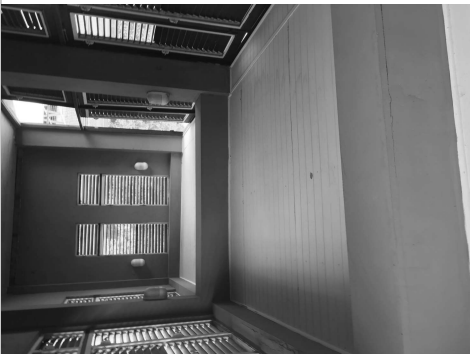
Applicant: DTOP		Damage Inventory # 220569		Category E	
Work Order # 31008		FIPS # 000-UK2GJ-00		Date: 8-22-19	
Site Inspector: Raiza Rivera		GPS		Damage Facility: Lago Dos Bocas Buildings	
Damage Description		Photo# 9		Damage Description	
Office Building: 2 each of wood door, 3 FT wide x 7 FT high				Offices Building: wood panel division at 1st Floor

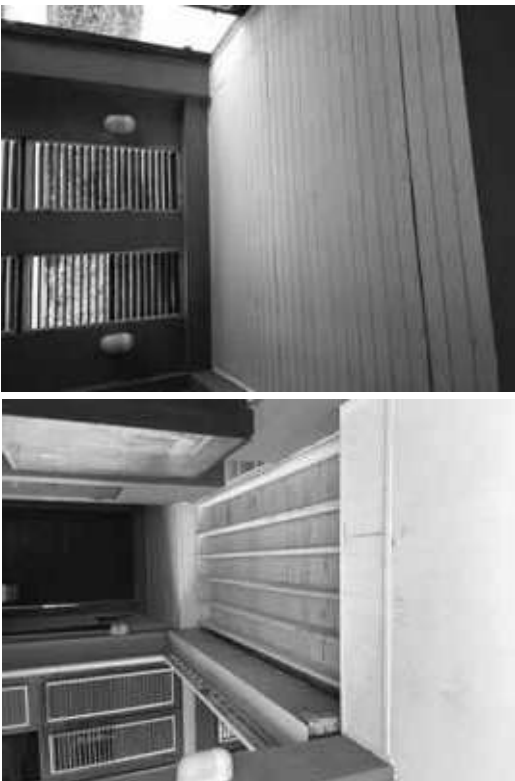
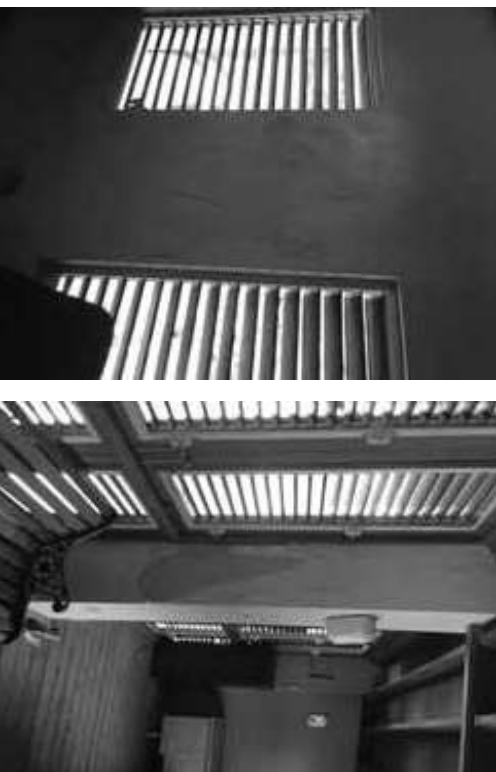
Damage Description		Photo# 11		Damage Description	
Offices Building: Entire wood ceiling panels at 1st Floor				Offices Building: 2,850 SF of interior paint

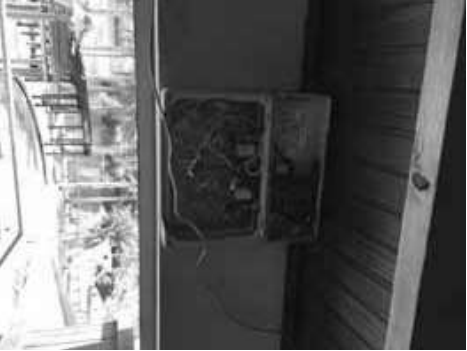
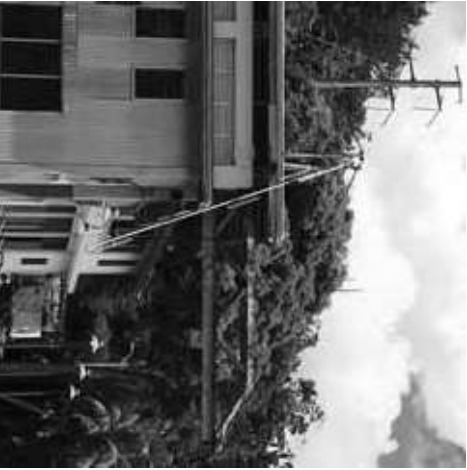
Applicant: DTOP		Damage Inventory # 220569		Category E	
Work Order # 31008		FIPS # 000-UK2GJ-00		Date: 8-22-19 GPS	
Site Inspector: Raiza Rivera		Damage Facility: Lago Dos Bocas Buildings			
Damage Description Offices Building: refractory exit sign single face with battery backup case		Photo# 21		Damage Description Offices Building: communication radio antenna

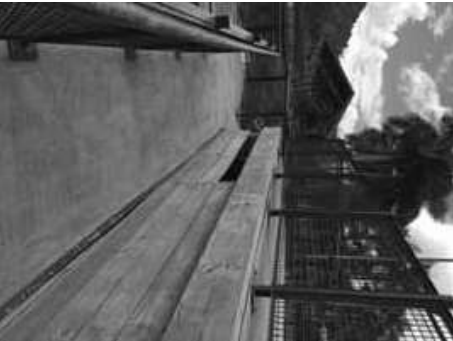
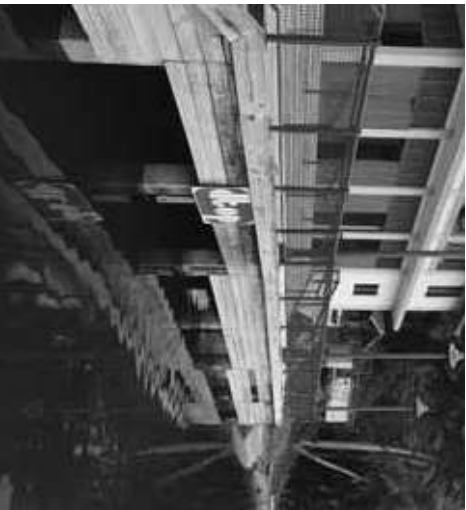
Applicant: DTOP		Damage Inventory # 220569		Category E	
Work Order # 31008		FIPS # 000-UK2GJ-00		Date: 8-22-19 GPS	
Site Inspector: Raiza Rivera		Damage Facility: Lago Dos Bocas Buildings			
Damage Description Pier Area: cladding wooden slat		Photo# 1		Damage Description Pier Area: ladding wooden slat

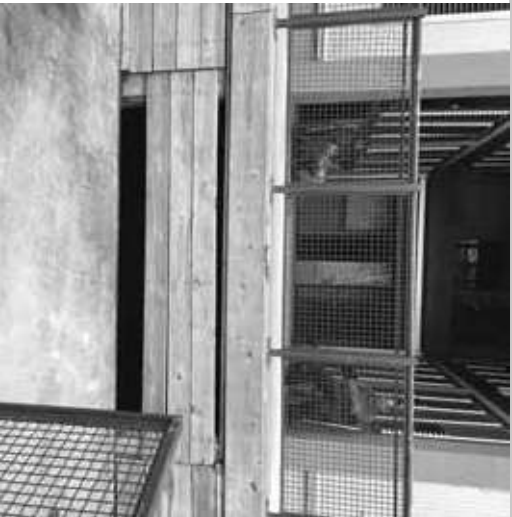
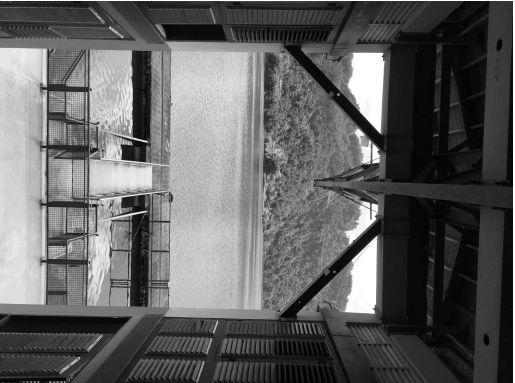
Damage Description Offices Building: ladding wooden slat		Photo# 1		Damage Description Offices Building: wood joint in floating pier

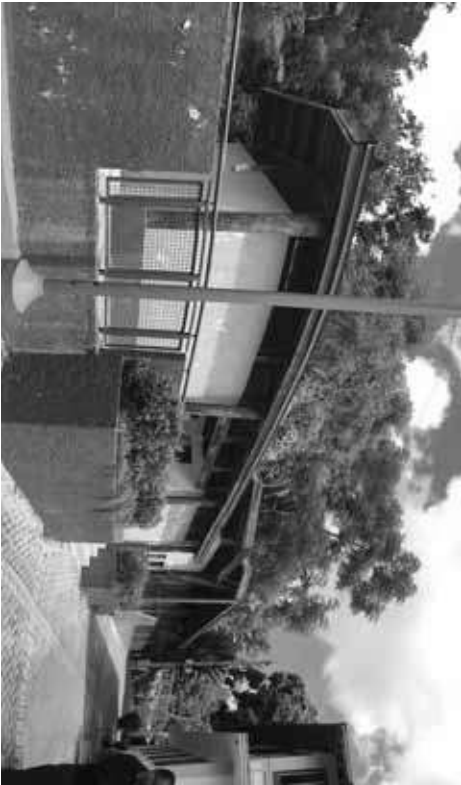
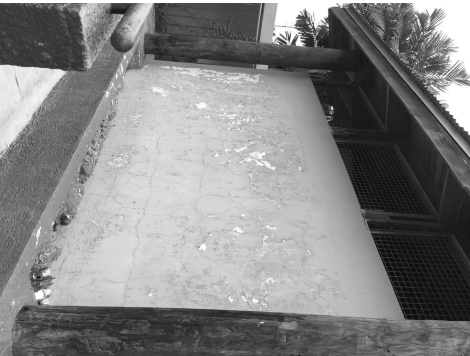
Applicant: DTOP			Damage Inventory # 220569			Category E		
Work Order # 31008			FIPS # 000-UK2GJ-00			Date: 8-22-19		
Site Inspector: Raiza Rivera			GPS			Damage Facility: Lago Dos Bocas Buildings		
Damage Description Restrooms and Kitchen: 1,300 SF of exterior paint			Photo# 4			Damage Description Restrooms and Kitchen: 1,300 SF of exterior paint

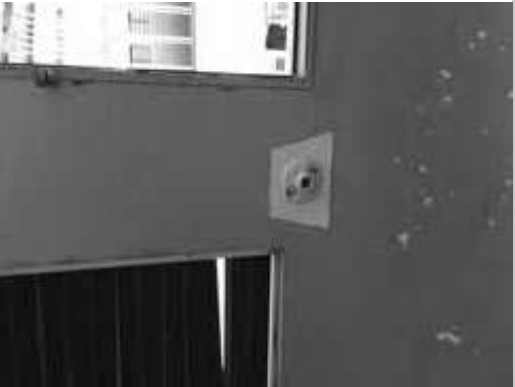
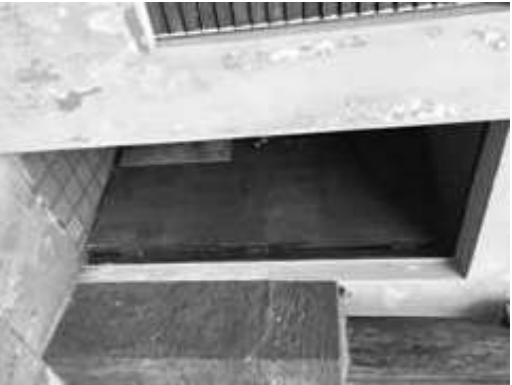
Damage Description Restrooms and Kitchen: wood jalousie windows, 2 FT wide x 4 FT high			Photo# 6			Damage Description Restrooms and Kitchen: damaged wood door, 3 FT wide x 7 FT high

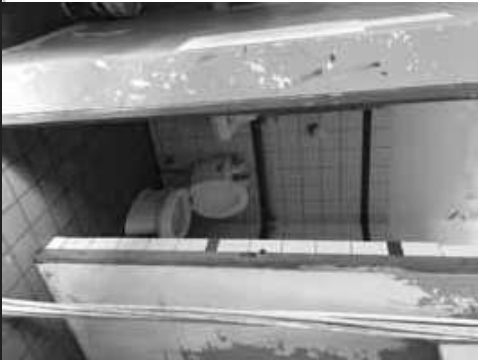
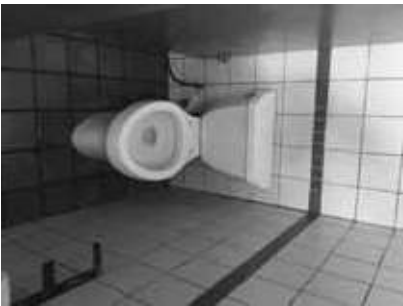
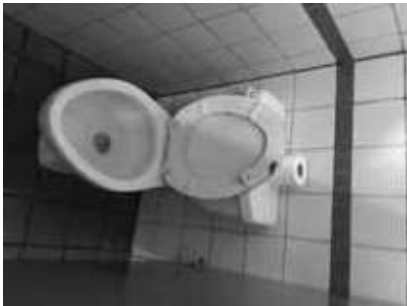
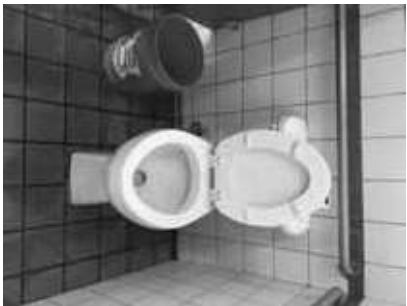
Applicant: DTOP			Damage Inventory # 220569			Category E		
Work Order # 31008			FIPS # 000-UK2GJ-00			Date: 8-22-19		
Site Inspector: Raiza Rivera			GPS			Damage Facility: Lago Dos Bocas Buildings		
Damage Description Restrooms and Kitchen: missing wood door, 2.5 FT wide x 7 FT high			Photo# 8			Damage Description Restrooms and Kitchen: Woman Bathroom Toilets complete toilet tank repair kit

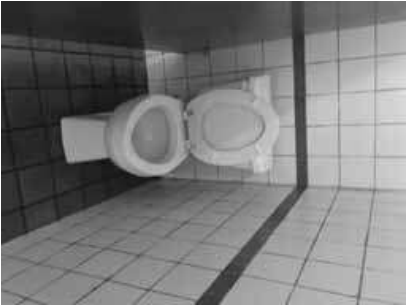
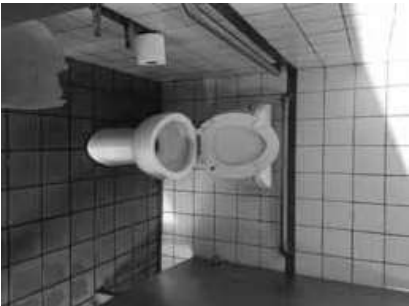
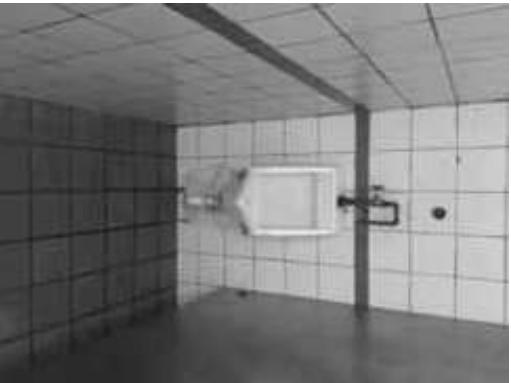
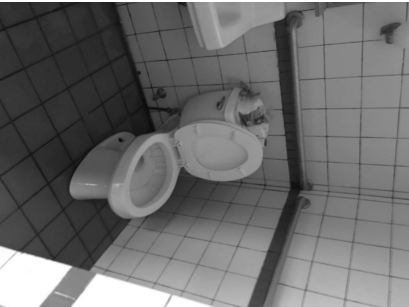
Damage Description Restrooms and Kitchen: Kitchne and Men Bathroom Toilets			Photo# 10			Damage Description Restrooms and Kitchen: urinal flush valve

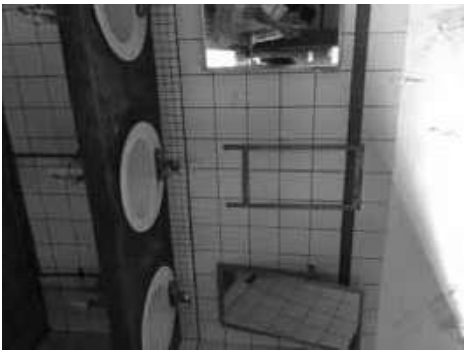
Applicant: DTOP			Damage Inventory # 220569			Category E		
Work Order # 31008			FIPS # 000-UK2GJ-00			Date: 8-22-19		
Site Inspector: Raiza Rivera			GPS			Damage Facility: Lago Dos Bocas Buildings		
Damage Description Restrooms and Kitchen: rectangular wall mirror, 24 IN wide x 36 IN high			Photo# 12			Damage Description Restrooms and Kitchen: stainless steel handicap bathroom partition in corner

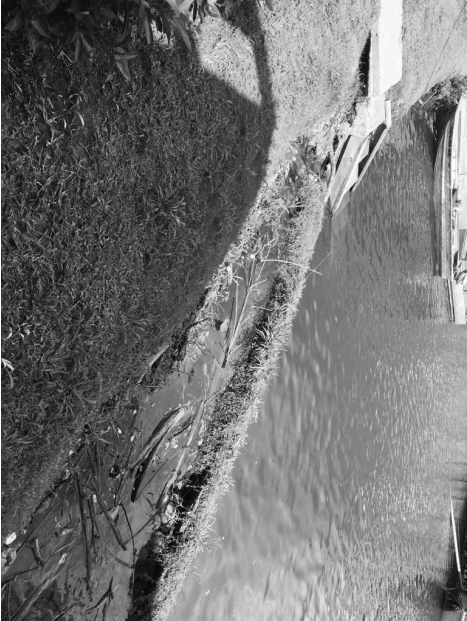
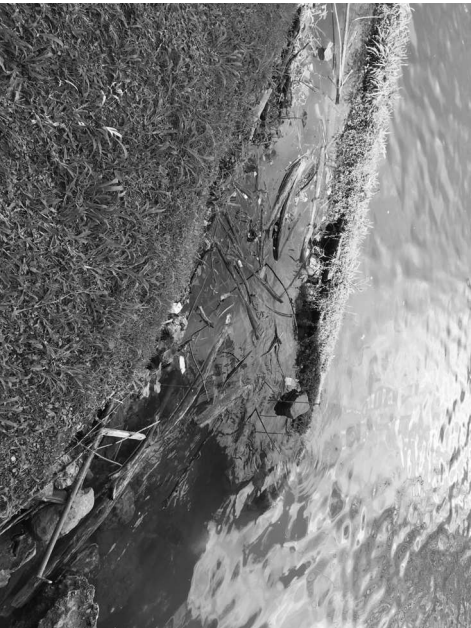
Applicant: DTOP		Damage Inventory # 220569		Category E	
Work Order # 31008		FIPS # 000-UK2GJ-00		Date: 8-22-19 GPS	
Site Inspector: Raiza Rivera		Damage Facility: Lago Dos Bocas Buildings			
Damage Description		Photo# 1		Damage Description	
Shoreline: 1,908 CF of Gabion revetment				Shoreline: Gabion revetment

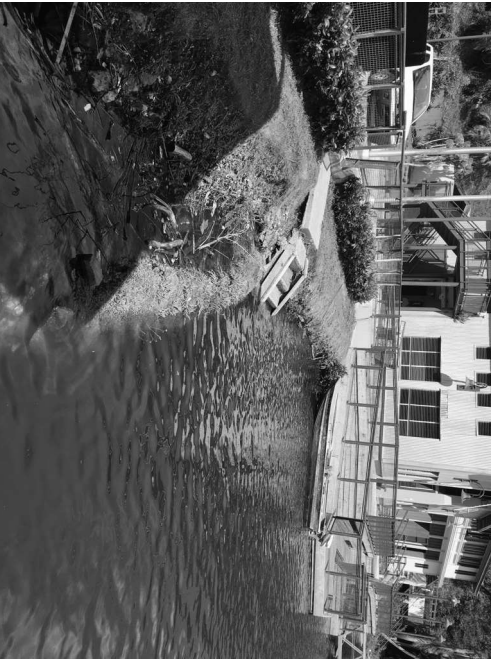
Damage Description		Photo# 3			
Shoreline: Gabion revetment

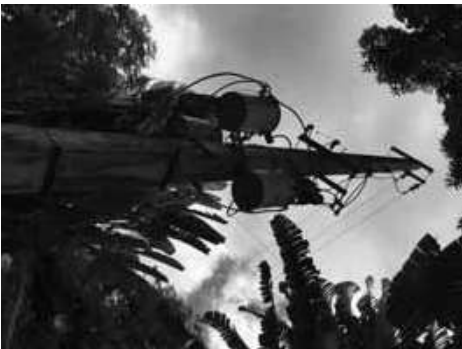
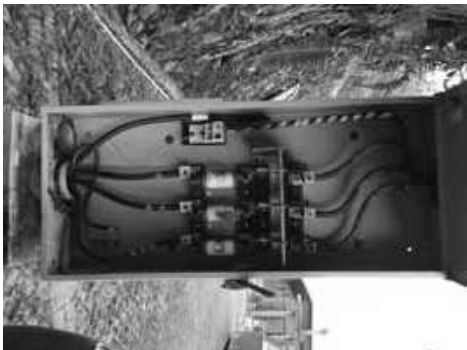
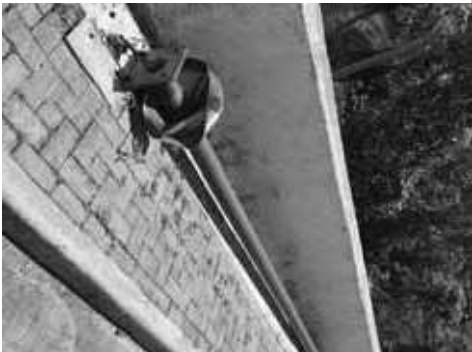
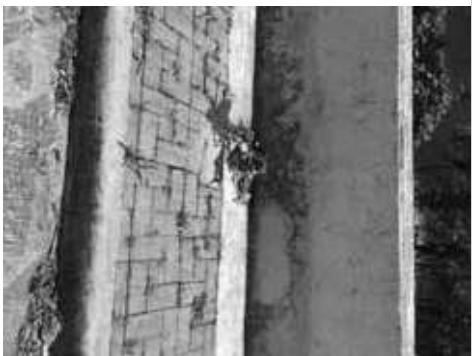
Applicant: DTOP		Damage Inventory # 220569		Category E			
Work Order # 31008		FIPS # 000-UK2GJ-00		Date: 8-22-19 GPS			
Site Inspector: Raiza Rivera		Damage Facility: Lago Dos Bocas Buildings					
Damage Description		Photo# 1		Damage Description		Photo# 2	
Site: 3-phase main disconnect switch				Site: outdoor lighting fixture cast aluminum post

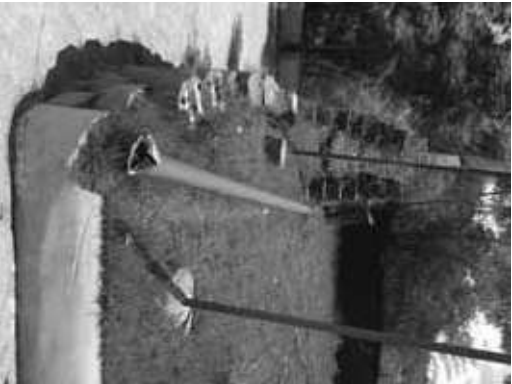
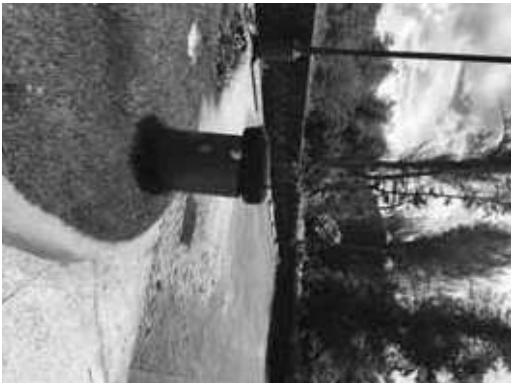
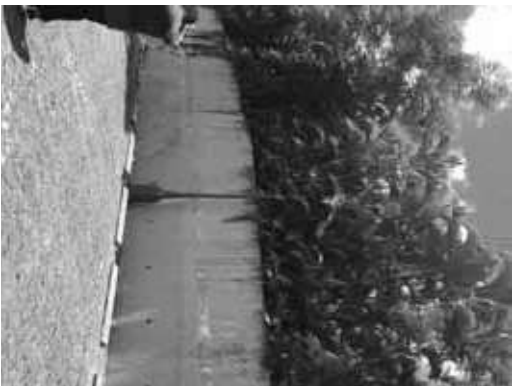
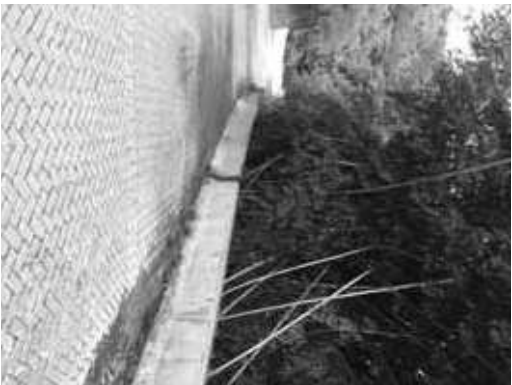
Damage Description		Photo# 3		Damage Description		Photo# 4	
Site: outdoor lighting fixture cast aluminum post				Site: outdoor lighting fixture cast aluminum post

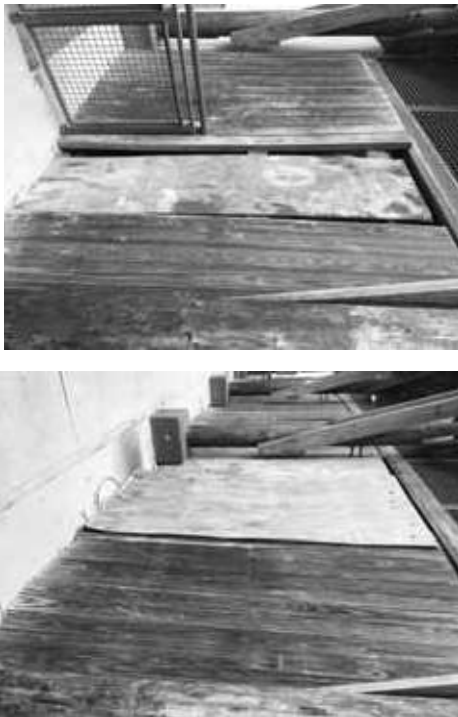
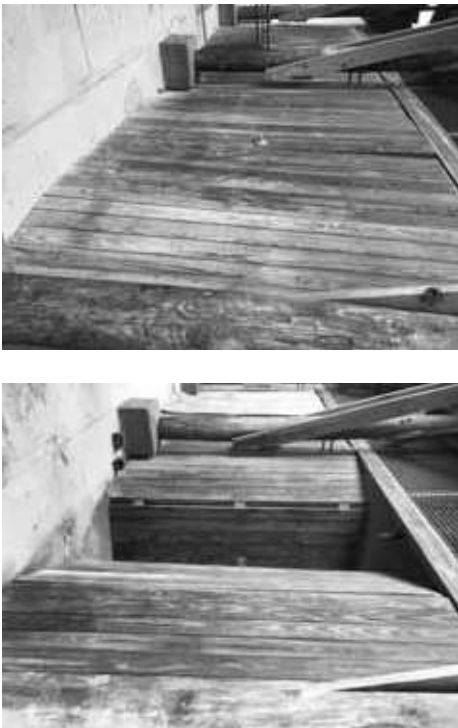
Applicant: DTOP			Damage Inventory # 220569			Category E					
Work Order # 31008			FIPS # 000-UK2GJ-00			Date: 8-22-19 GPS					
Site Inspector: Raiza Rivera			Damage Facility: Lago Dos Bocas Buildings								
Damage Description Warehouse: wood folding door			Photo# 1			Damage Description Warehouse: wood folding door			Photo# 2

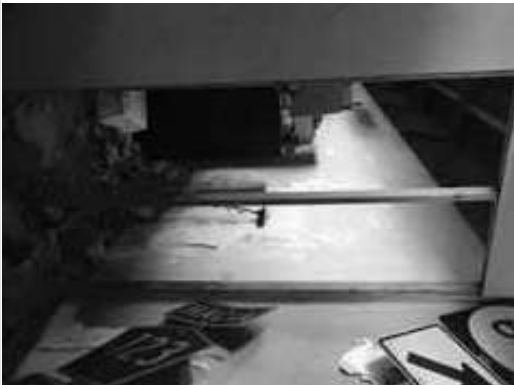
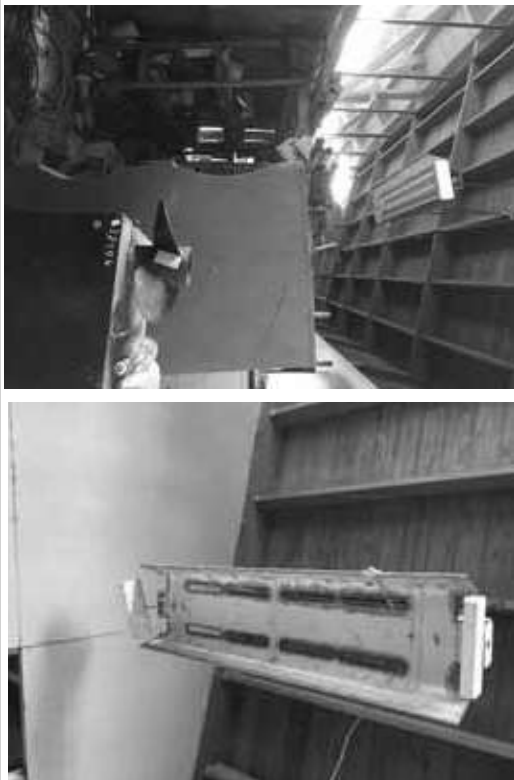
Damage Description Warehouse: wood panel division			Photo# 3			Damage Description Warehouse: 3 tubs florescent light fixture,			Photo# 4

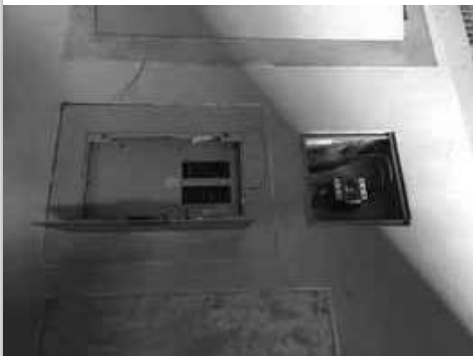
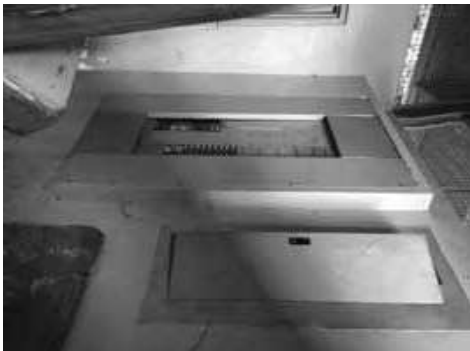
Applicant: DTOP		Damage Inventory # 220569		Category E			
Work Order # 31008		FIPS # 000-UK2GJ-00		Date: 8-22-19 GPS			
Site Inspector: Raiza Rivera		Damage Facility: Lago Dos Bocas Buildings					
Damage Description		Photo# 5		Damage Description		Photo# 6	
Warehouse: electrical panel,				Warehouse: main distribution panel,

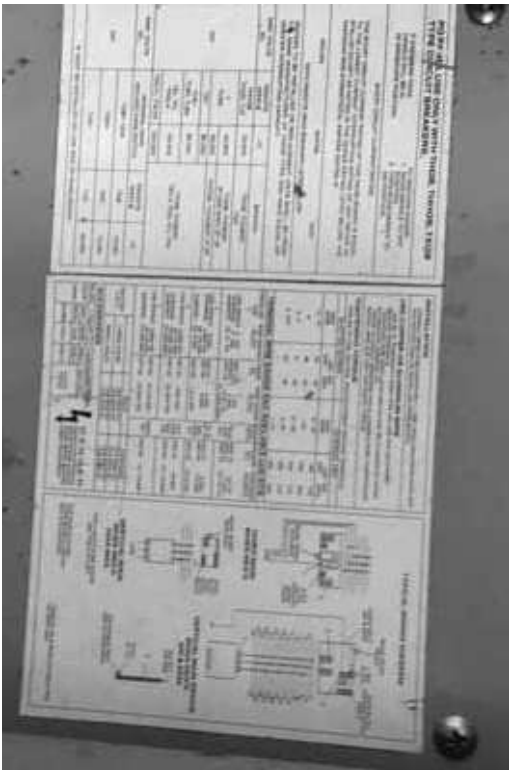
Damage Description		Photo# 7					
Warehouse: main distribution panel,

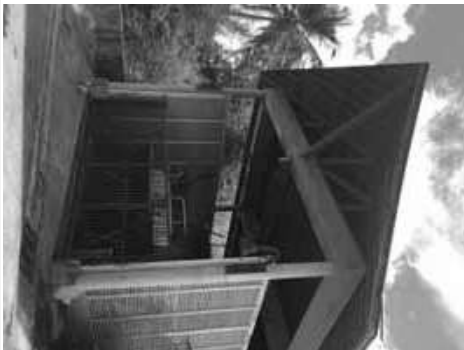
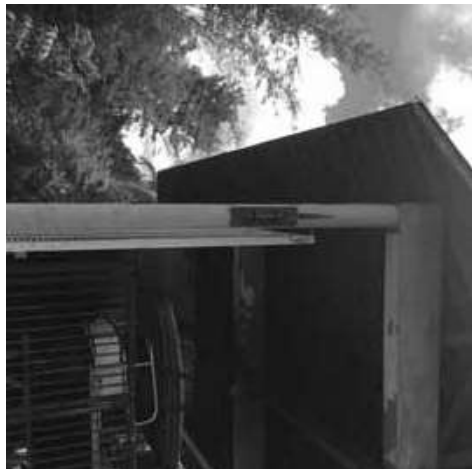
Applicant: DTOP			Damage Inventory # 220569			Category E					
Work Order # 31008			FIPS # 000-UK2GJ-00			Date: 8-22-19			GPS		
Site Inspector: Raiza Rivera						Damage Facility: Lago Dos Bocas Buildings					
Damage Description			Photo# 1			Damage Description			Photo# 2		
Workshop:barn wall mounted light fixtures						Workshop:barn wall mounted light fixtures
