Department of Homeland Security Federal Emergency Management Agency

Project #	123407	PW #	9549	Project Type	Standard
Project Category	G - Parks, Recreational Facilities, and Other Items			Applicant	Department of Natural & Environmental Resources (000-UW1XD-00)
Project Title	Balneario de Punta Salinas			Event	4339DR-PR (4339DR)
Project Size	Large			Declaration Date	9/20/2017
Activity Completion Date	9/20/2024			Incident Start Date	9/17/2017
Process Step	Obligated			Incident End Date	11/15/2017

Damage #355538; Balneario de Punta Salinas Lifeguard Towers

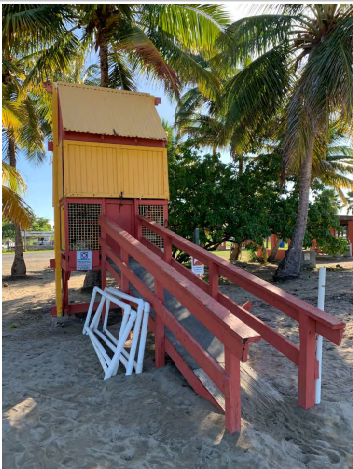
Damage Description:	Photo# 1
Lifeguard Tower #1: Front view with ramp. Ramp and handle are loose due to the flood and heavy wind.

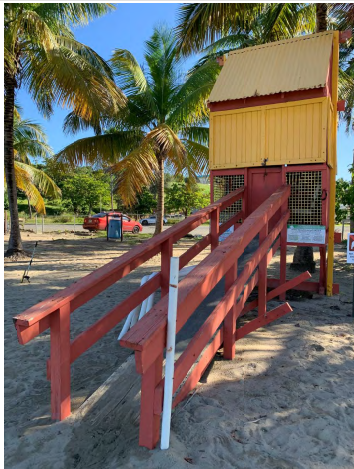
Damage Description	Photo# 2
Lifeguard Tower #1: Front view with ramp. Surf board rack is loose due to the flood and heavy wind.

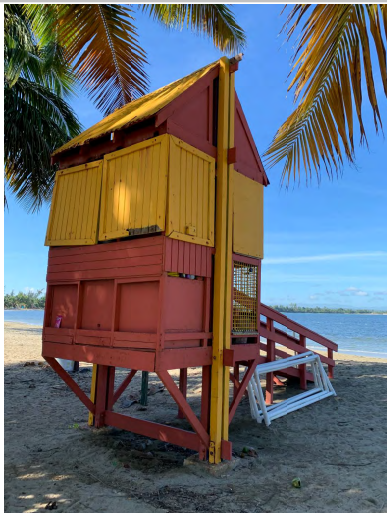
Damage Description	Photo# 4
Lifeguard Tower #1: Side and back view. Windows got loose from the heavy winds. Also, some of the plywood got detached and flew away.

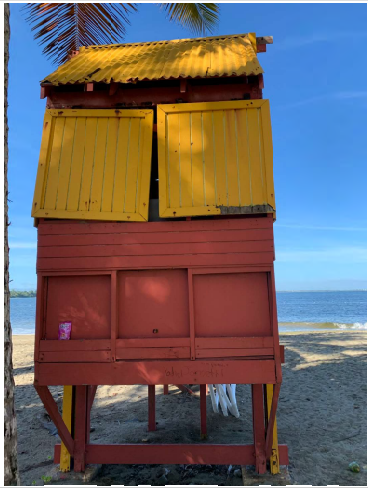
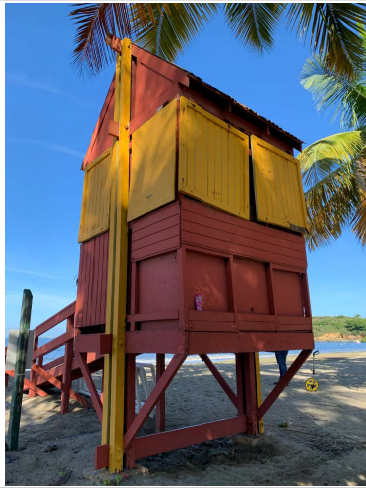
Applicant: Department of Natural & Environmental Resources		Damage Inventory # 355538		Category E	
Work Order# 62759		FIPS # 000-UW1XD-00		Date: 10-19-2020	
Site Inspector: Raymond Gutierrez, Christian Garcia		GPS		Damage Facility: Balneario de Puntas Salinas Lifeguard Towers	
		Photo# 5		Damage Description	
Lifeguard Tower #1: Back view. Windows got loose from the heavy winds. Also, some of the plywood got detached and flew away.				Lifeguard Tower #1: Side and back view. Windows got loose from the heavy winds. Also, some of the plywood got detached and flew away.

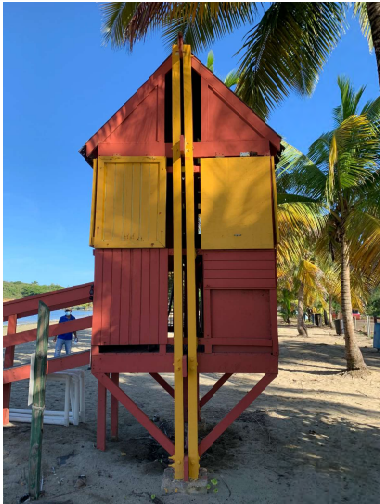
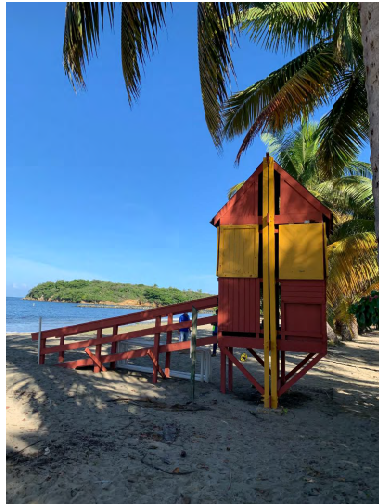
Damage Description:		Photo# 7		Damage Description	
Lifeguard Tower #1: Side view. Windows got loose from the heavy winds. Also, some of the plywood got detached and flew away.				Lifeguard Tower #1: Side view with ramp.

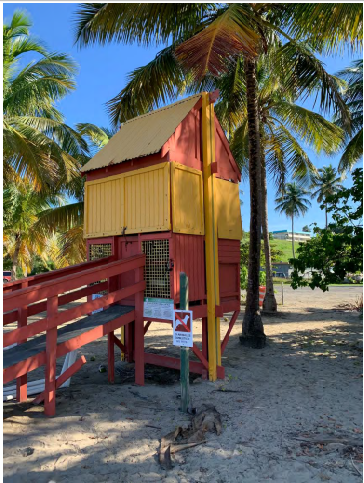
Applicant: Department of Natural & Environmental Resources		Damage Inventory # 355538		Category E	
Work Order # 62759		FIPS # 000-UW1XD-00		Date: 10-19-2020 GPS	
Site Inspector: Raymond Gutierrez, Christian Garcia		Damage Facility: Balneario de Puntas Salinas Lifeguard Towers			
		Photo# 9		Damage Description	
Lifeguard Tower #1: Side view with ramp.				Lifeguard Tower #1: Down view. It got loose due to the high winds.

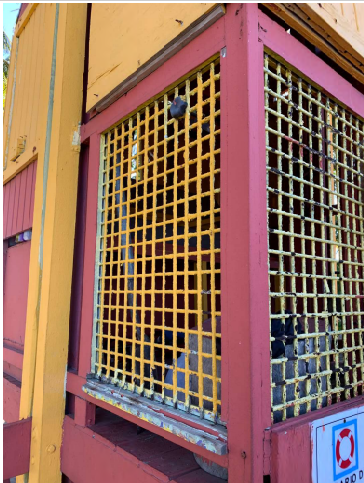
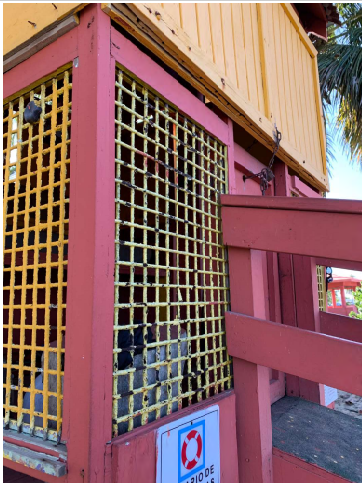
Damage Description:		Photo# 11		Damage Description	
Lifeguard Tower #1: Front side view. Metal grid got loose and lost part of the frames due to the high winds.				Lifeguard Tower #1: Front side view. Metal grid got loose and lost part of the frames due to the high winds.

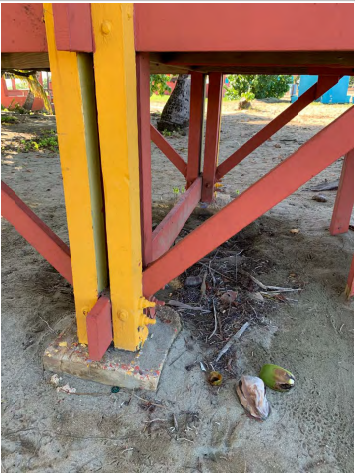
Applicant: Department of Natural & Environmental Resources		Damage Inventory # 355538		Category E	
Work Order # 62759		FIPS # 000-UW1XD-00		Date: 10-19-2020 GPS	
Site Inspector: Raymond Gutierrez, Christian Garcia		Damage Facility: Balneario de Puntas Salinas Lifeguard Towers			
Damage Description:		Photo#		13	
Lifeguard Tower #1: Columns and bolts were affected and loose due to the high wind provoked during the event.

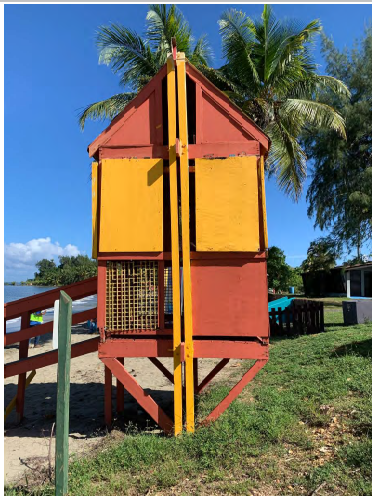
Damage Description:		Photo#			
Lifeguard Tower #2: Side windows and plywoods with frame got loose due to high wind.

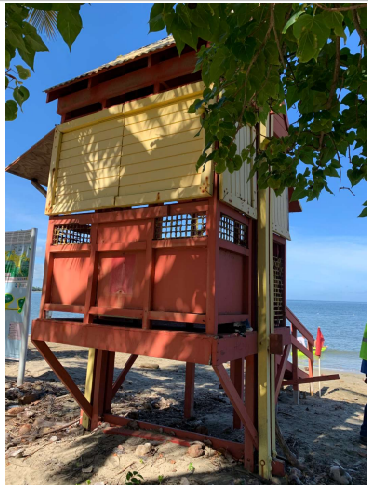
Applicant: Department of Natural & Environmental Resources		Damage Inventory # 355538		Category E	
Work Order# 62759		FIPS # 000-UW1XD-00		Date: 10-19-2020	
Site Inspector: Raymond Gutierrez, Christian Garcia		GPS			
		Damage Facility: Balneario de Puntas Salinas Lifeguard Towers			
Damage Description:		Photo#		9	
Lifeguard Tower #3: Back windows and plywoods with frame got loose due to high wind.

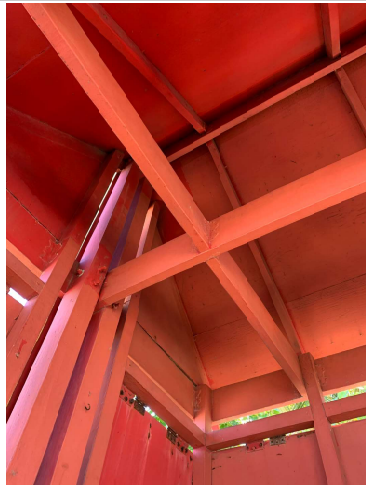
Damage Description		Photo#		10	
Lifeguard Tower #3: Roof beam frame got loose due to high winds.

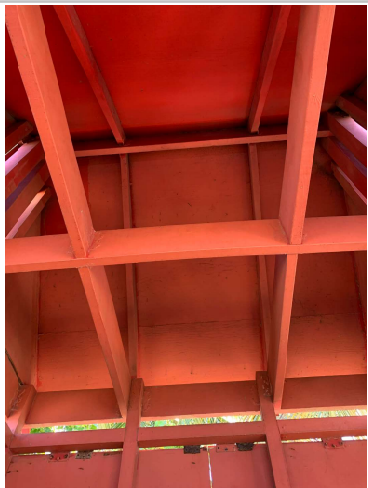
Damage Description:		Photo#		11	
Lifeguard Tower #3: Roof beam frame got loose due to high winds.

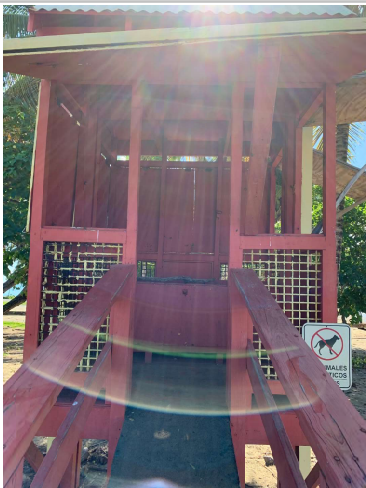
Damage Description		Photo#		12	
Lifeguard Tower #3: Front door, windows and plywoods with frame got loose due to high wind.

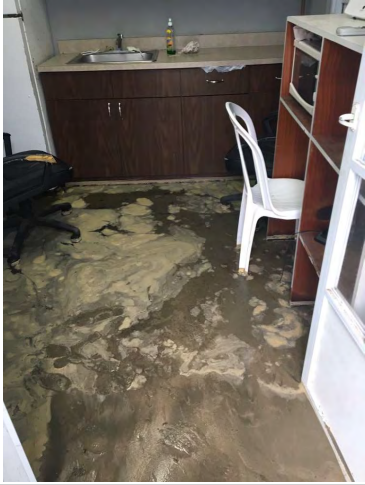
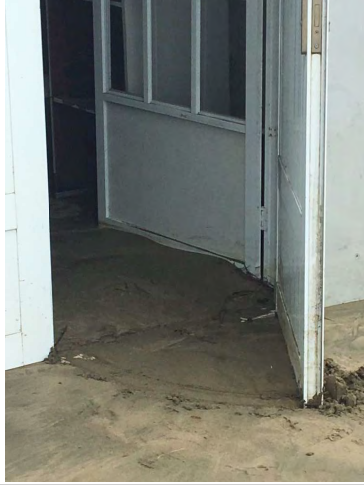
Applicant: Department of Natural & Environmental Resources		Damage Inventory # 355538		Category E	
Work Order# 62759		FIPS # 000-UW1XD-00		Date: 9-2017 GPS	
Site Inspector:		Damage Facility:			
		Photo# 5		Damage Description	
Kitchen room of the lifeguard was flooded damaging the refrigerator and the kitchen furniture.				Lifeguard office room was flooded damaging all office desk and bookshelf.

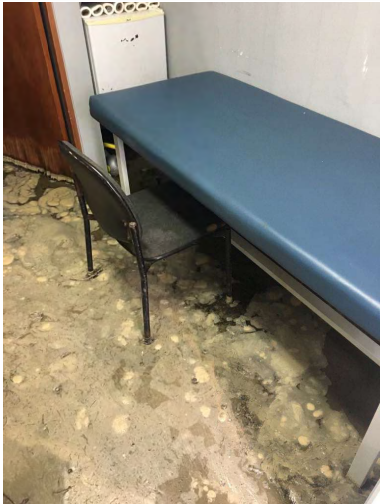
Damage Description:		Photo# 7		Damage Description	
Lifeguard room was flooded damaging wood bathroom door.

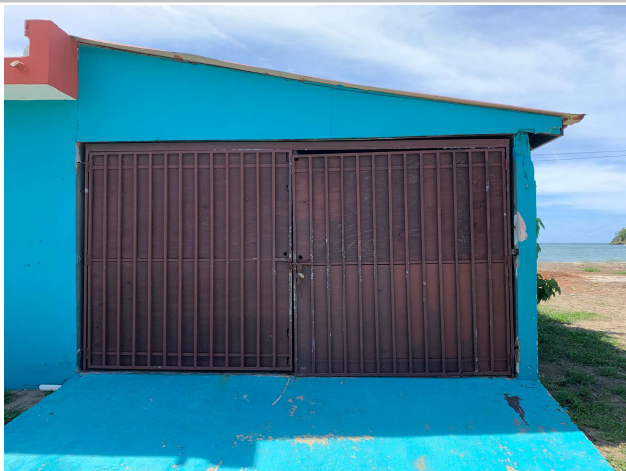
Damage Description: **Photo#** 1
 Storage Room garage metal gate was flew out due to the high wind. Applicant did provisional repairs to the gates but is a hazard if they fall off.

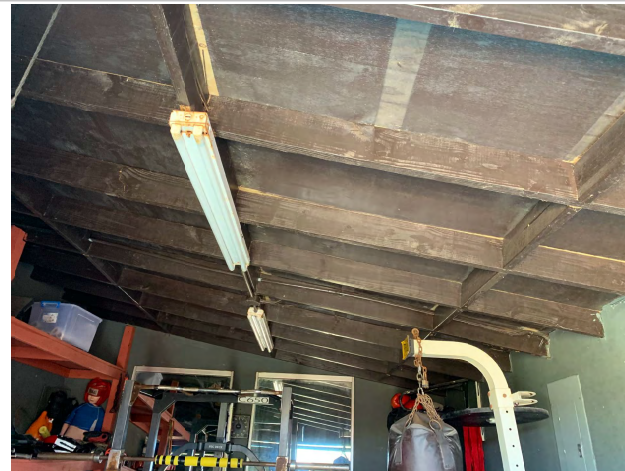
Damage Description **Photo#** 2
 Storage room garage roof plywood, beams and galvalum metal roof were flew out due to the high winds. Applicant use recycle material to protect equipment

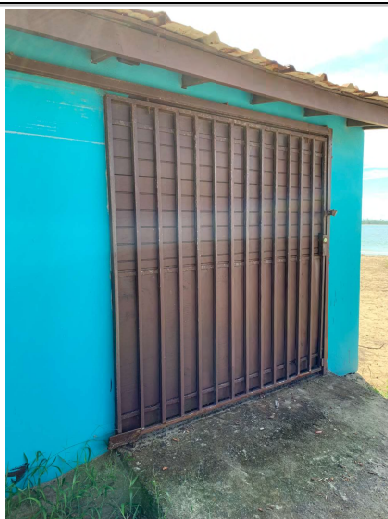
Damage Description: **Photo#** 3
 Vehicle storage room metal gate was detached from the base due to high winds. Applicant did provisionals repairs to avoid vandalism.

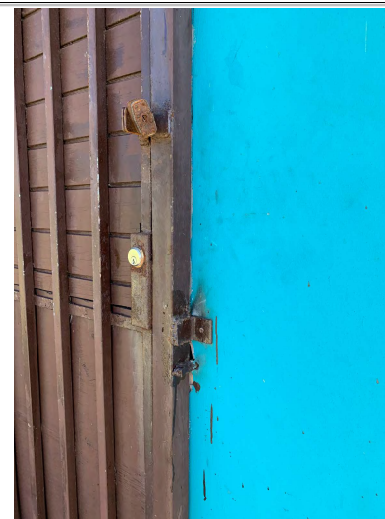
Damage Description **Photo#** 4
 Vehicle storage lock was affected when the gate flew off.

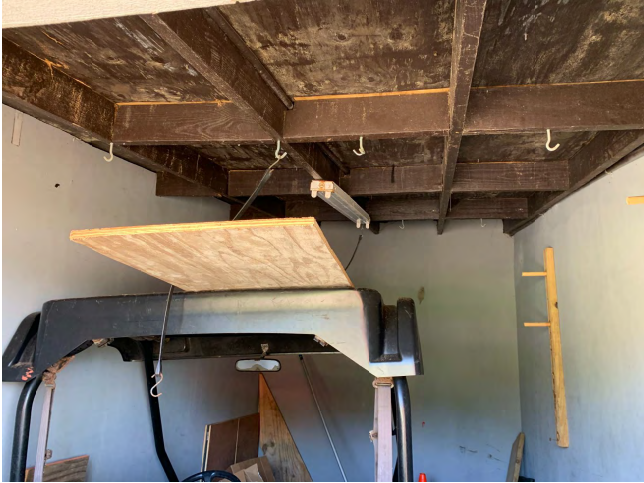
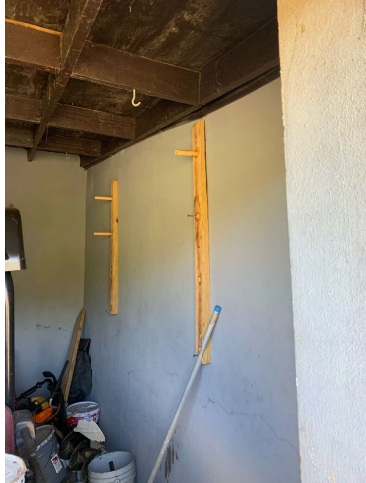
Applicant: Department of Natural & Environmental Resources		Damage Inventory # 355538		Category E	
Work Order# 62759		FIPS # 000-UW1XD-00		Date: 10-19-2020	
Site Inspector: Raymond Gutierrez, Christian Garcia		GPS			
		Damage Facility: Balneario de Puntas Salinas Lifeguard Towers			
		Photo# 17		Damage Description	
Galvalum, plywood and wood beams from the roof flew off with the high winds. Applicant used recycle material to protect equipment.

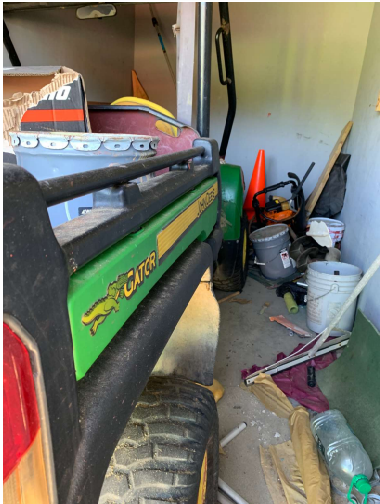
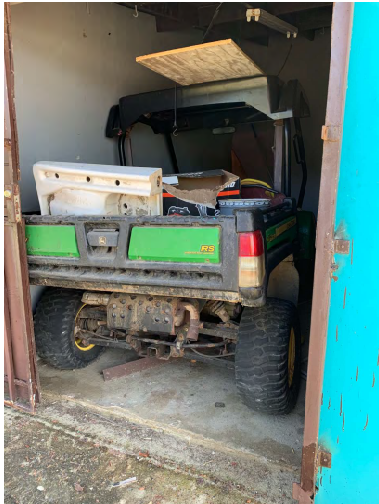
Damage Description:		Photo# 19		Damage Description	
Vehicle used in the facility was damage due to high flood in the storage room.		Vehicle used in the facility was damage due to high flood in the storage room.

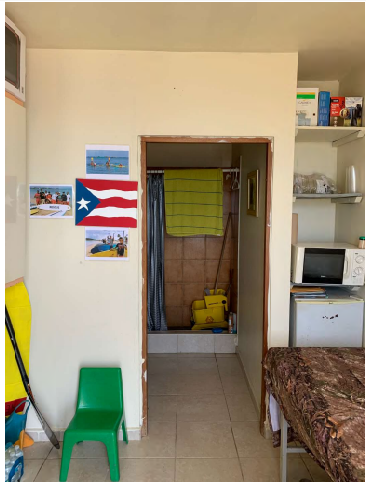
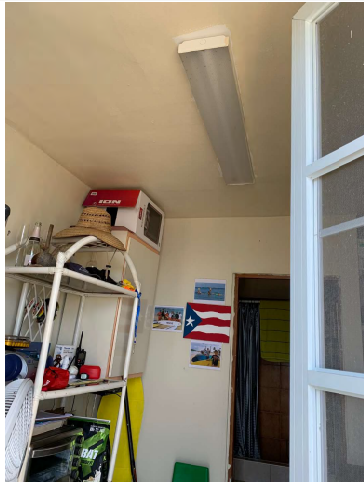
Applicant: Department of Natural & Environmental Resources		Damage Inventory # 355538		Category E	
Work Order # 62759		FIPS # 000-UW1XD-00		Date: 10-19-2020	
Site Inspector: Raymond Gutierrez, Christian Garcia		GPS		Damage Facility: Balneario de Puntas Salinas Lifeguard Towers	
Photo# 21		Damage Description		Photo# 22	
Lifeguard room got flooded during the event and damage the bathroom door and walls paint.		Ceiling paint was affected due to leaks due to the high winds an rains that affect the roof coating elastomeric material.

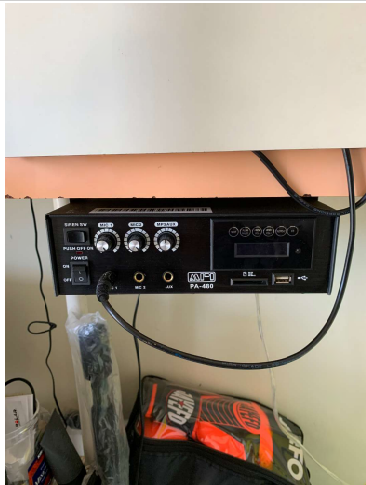
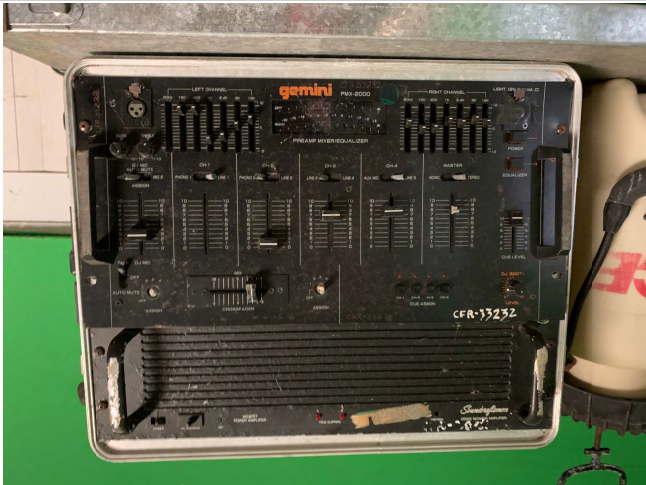
Damage Description:		Photo# 23		Damage Description	
Provisional equipment use by the lifeguard because their equipment got damage due the high volume of water during the flood.				Original equipment use by the lifeguard that got damage during the flood in the lifeguard room.

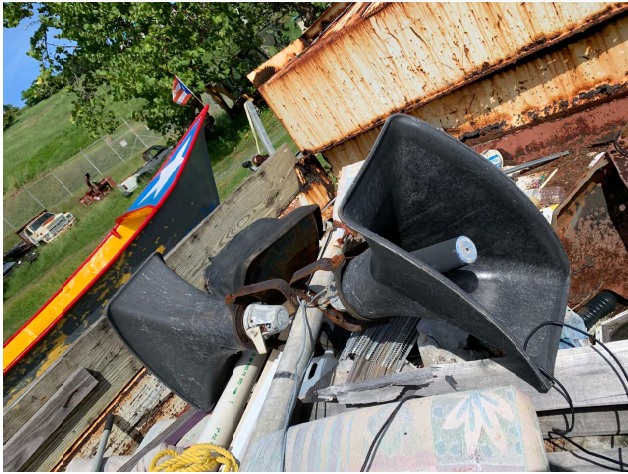
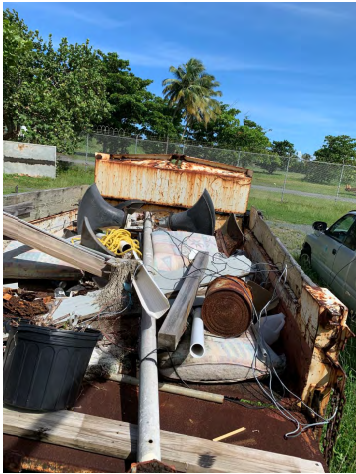
Applicant: Department of Natural & Environmental Resources		Damage Inventory # 355538		Category E	
Work Order # 62759		FIPS # 000-UW1XD-00		Date: 10-19-2020	
Site Inspector: Raymond Gutierrez, Christian Garcia		GPS		Damage Facility: Balneario de Puntas Salinas Lifeguard Towers	
Damage Description:		Photo# 25		Damage Description	
Roof speaker that got detached, break and flew off the base during the event of Maria. Applicant is using a provisional equipment.				Photo# 26	
				Roof speaker that got detached, break and flew off the base during the event of Maria. Applicant is using a provisional equipment.

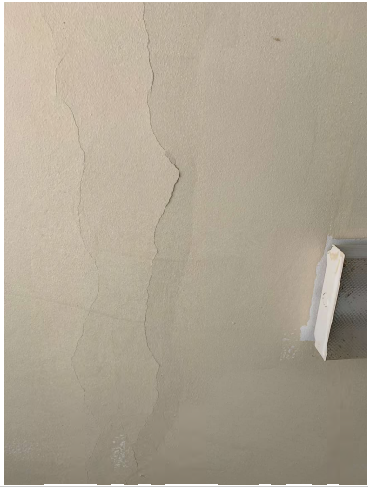
Applicant: Department of Natural & Environmental Resources		Damage Inventory # 355538		Category E	
Work Order # 62759 FIPS # 000-UW1XD-00		Date: 10-19-2020		GPS	
Site Inspector: Raymond Gutierrez, Christian Garcia		Damage Facility: Balneario de Puntas Salinas Lifeguard Towers			
Damage Description:		Photo#		17	
Kitchen roof ceiling got affected (crack) due to leak from the roof. Roof coating got damage due to high volume of water and winds.

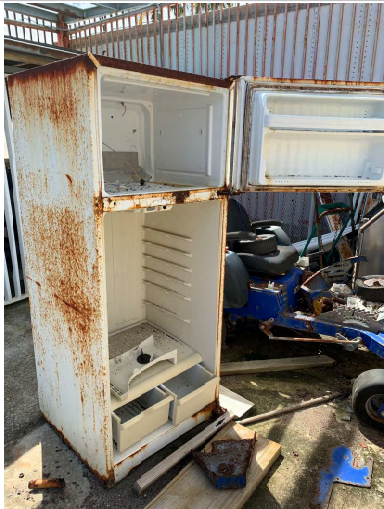
Damage Description:		Photo#		19	
Refrigerator got damage during the flood in the kitchen room.

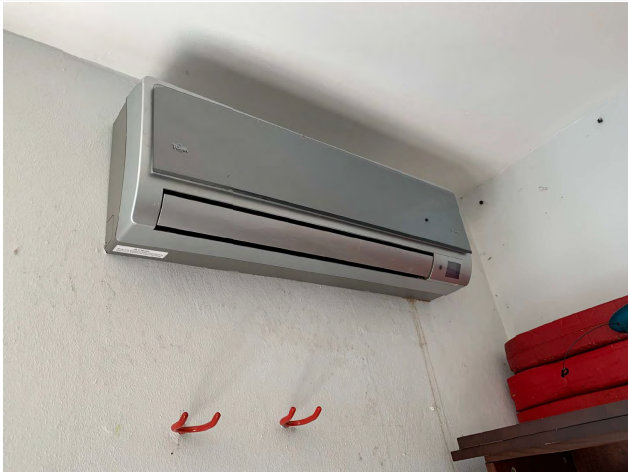
Applicant: Department of Natural & Environmental Resources		Damage Inventory # 355538		Category E	
Work Order # 62759		FIPS # 000-UW1XD-00		Date: 10-19-2020 GPS	
Site Inspector: Raymond Gutierrez, Christian Garcia		Damage Facility: Balneario de Puntas Salinas Lifeguard Towers			
Damage Description:		Photo#		25	
Lifeguard office a/c unit got damage during the event due to the high winds. Condensor got flooded and blades were detached.

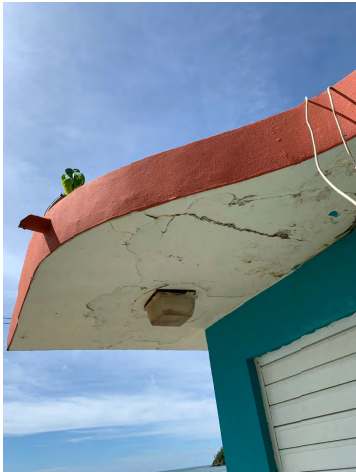
Damage Description:		Photo#		26	
Outside light fixture got damages due to high winds with waters.

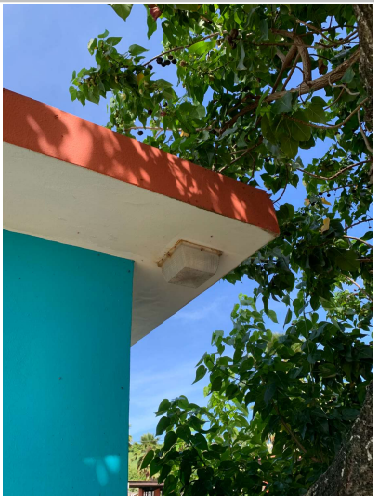
Damage Description:		Photo#		27	
Outside light fixture got damages due to high winds with waters.

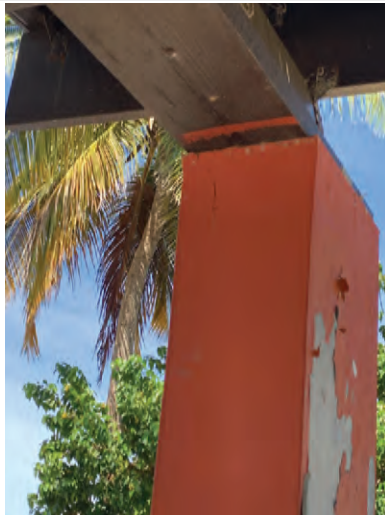
Damage Description	Photo# 4
Booth #1: Reinforced concrete columns, 8 FT long x 1.25 FT high x 0.67 FT thick, Severely cracked due to fallen tree

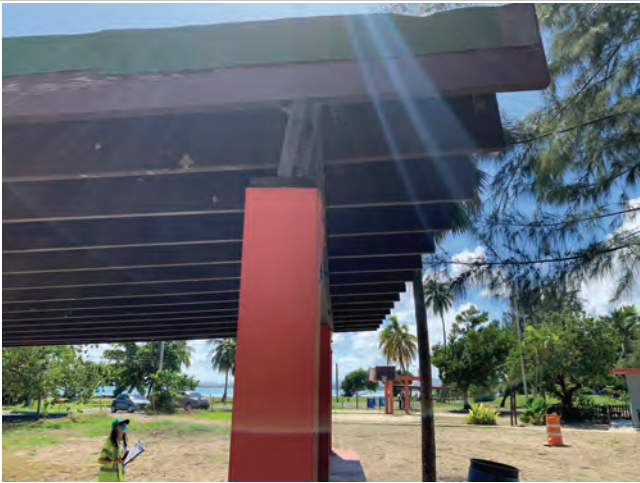
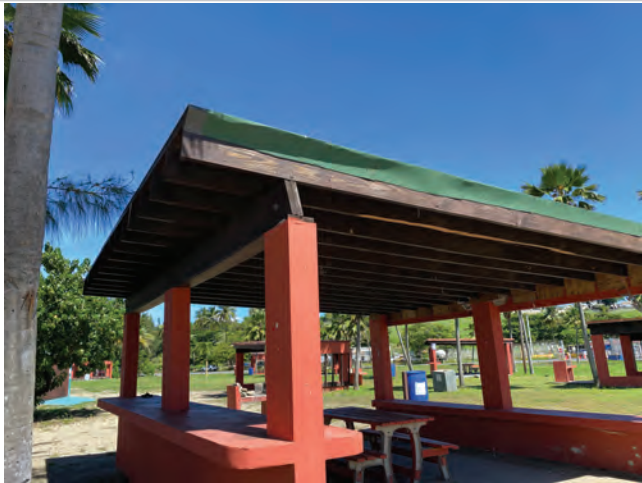
Applicant: Department of Natural & Environmental Resources		Damage Inventory # 355539		Category E	
Work Order # 62759		FIPS # 000-UW1XD-00		Date: 10/19/2020	
				GPS 18.472857, -66.185544	
Site Inspector: Isabelle Martinez Rivera		Damage Facility: Balneario de Punta Salinas Booths			
		Photo# 9		Damage Description	
				Photo# 10	
Booth #1: Treated wooden roof Fallen tree tilted the 2 in x10 in wood beam and broke some wood elements		Booth #1: Treated wooden roof Fallen tree tilted the 2 in x10 in wood beam and broke some wood elements

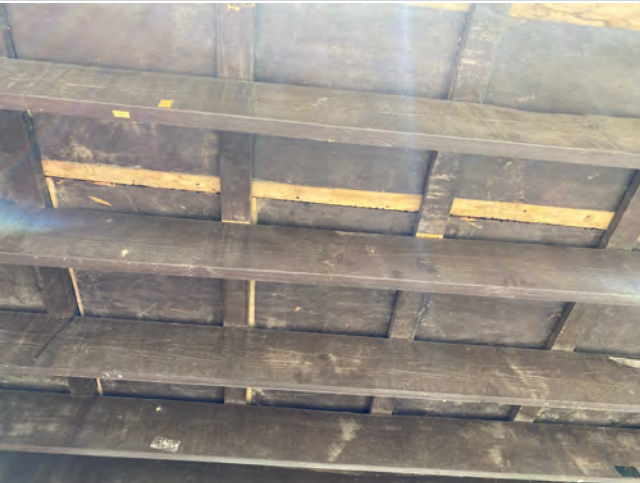
Damage Description:		Photo# 11		Damage Description	
				Photo# 12	
Booth #1: Treated wooden roof Fallen tree tilted the 2 in x10 in wood beam and broke some wood elements		Booth #1: Treated wooden roof Fallen tree tilted the 2 in x10 in wood beam and broke some wood elements

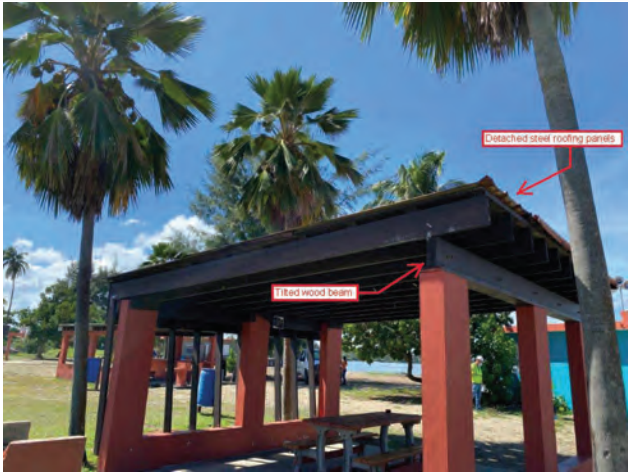
Applicant: Department of Natural & Environmental Resources		Damage Inventory # 355539		Category E	
Work Order # 62759		FIPS # 000-UW1XD-00		Date: 10/19/2020	
				GPS 18.473067, -66.185543	
Site Inspector: Isabelle Martinez Rivera		Damage Facility: Balneario de Punta Salinas Booths			
Damage Description:		Photo#		13	
Booth #3: 24 gauge pre-painted steel roofing panel, 20 FT long x 16.5 FT wide, Partially detached and displaced due to high winds

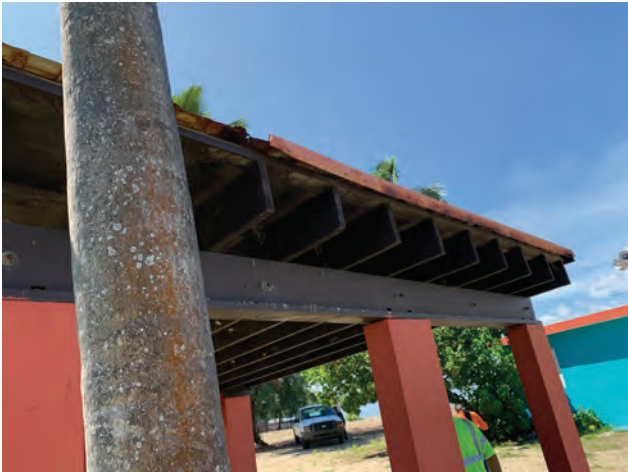
Damage Description:		Photo#		14	
Booth #3: 24 gauge pre-painted steel roofing panel, 20 FT long x 16.5 FT wide, Partially detached and displaced due to high winds

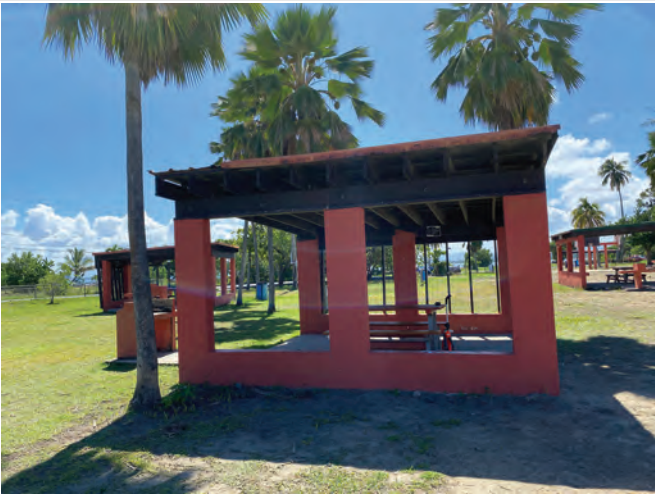
Damage Description:		Photo#		15	
Booth #3: 24 gauge pre-painted steel roofing panel, 20 FT long x 16.5 FT wide, Partially detached and displaced due to high winds

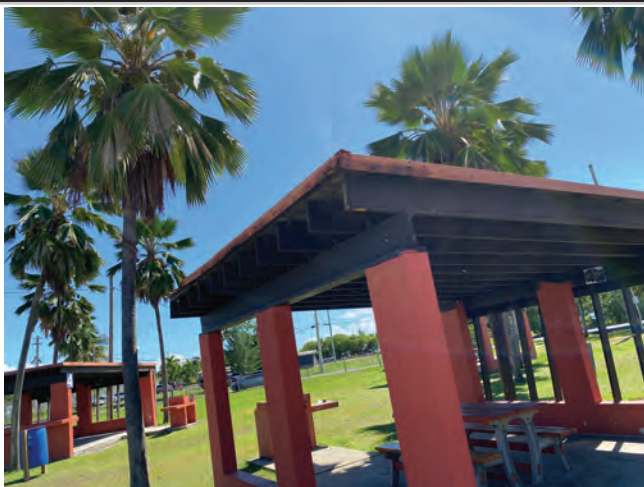
Damage Description:	Photo# 17
Booth #3: 330 SF of Treated wooden roof consist, High winds tilted the 2 in x10 in wood beam causing the roof to be unstable

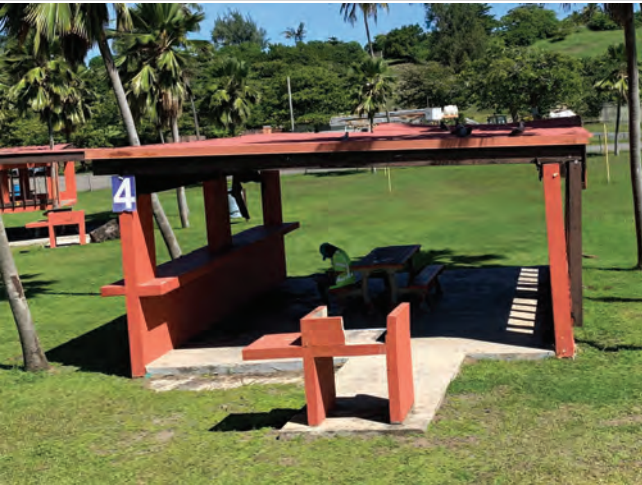
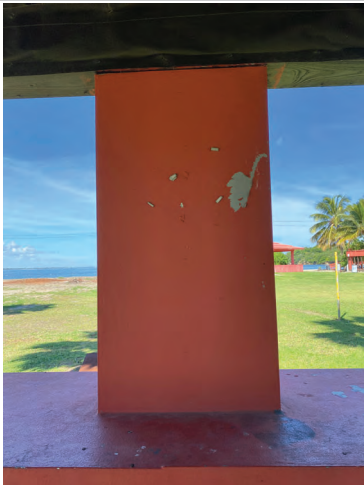
Damage Description:		Photo# 23		Damage Description	
Booth #4: 24 gauge pre-painted steel roofing panel , 21 FT long x 23 FT wide, Partially detached and displaced due to high winds				Booth #4: 600 SF of Paint, Surface area, Damaged due to heavy rains and high winds

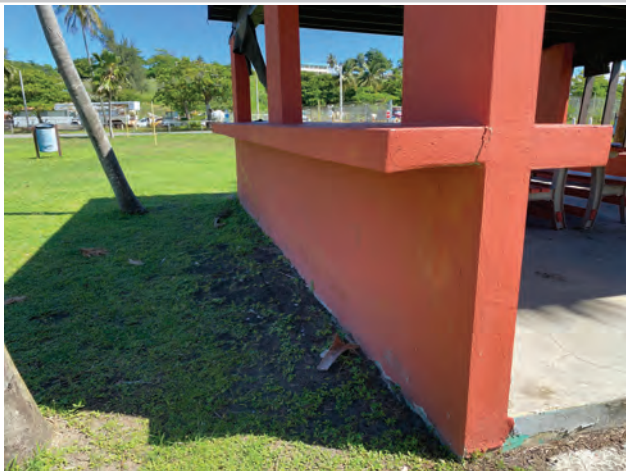
Damage Description:	Photo# 29
Booth #4: Reinforced concrete table top on wall, 22 FT long x 31 IN wide x 5 IN thick, Cracked due to flying debris

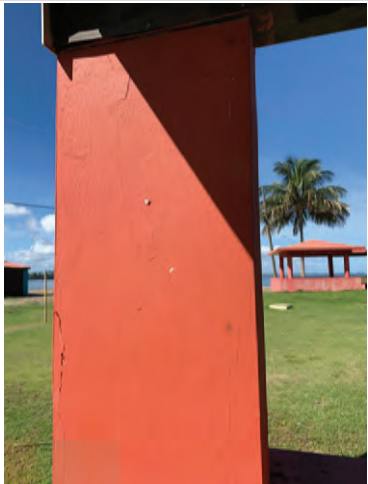
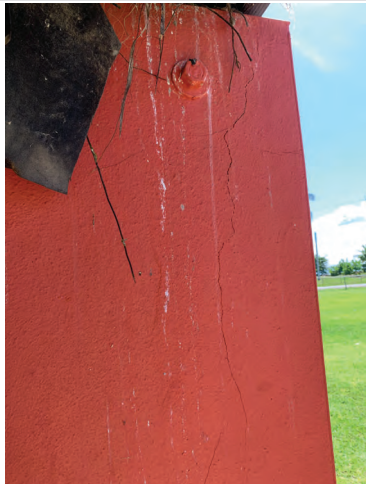
Applicant: Department of Natural & Environmental Resources		Damage Inventory # 355539		Category E	
Work Order# 62759		FIPS # 000-UW1XD-00		Date: 10/19/2020	
				GPS 18.473368, -66.185366	
Site Inspector: Isabelle Martinez Rivera		Damage Facility: Balneario de Punta Salinas Booths			
		Photo# 33		Photo# 34	
Booth #5: 2 each of Reinforced concrete columns, 2 FT long x 8 FT high x 8 FT thick, Cracked due to flying debris		Booth #5: 2 each of Reinforced concrete columns, 2 FT long x 8 FT high x 8 FT thick, Cracked due to flying debris

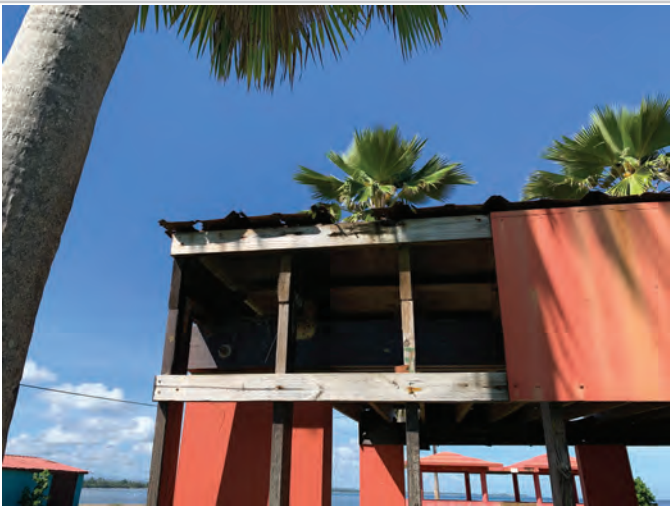
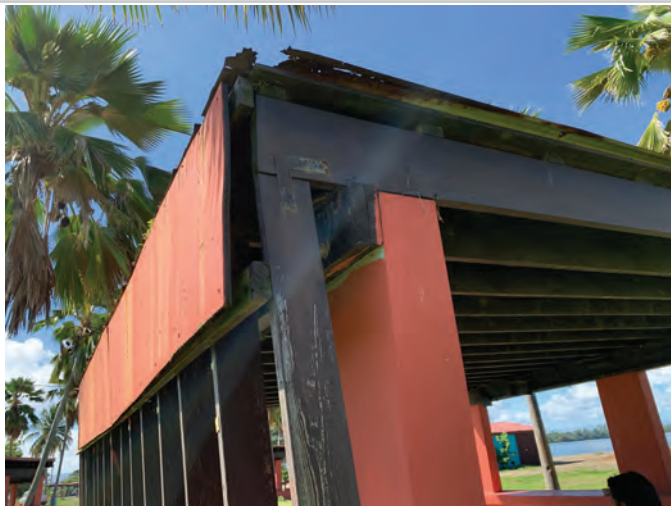
Damage Description:		Photo# 35		Photo# 36	
Booth #5: 24 gauge pre-painted steel roofing panel , 25 FT long x 21 FT wide, Partially detached and displaced due to high winds		Booth #5: 24 gauge pre-painted steel roofing panel , 25 FT long x 21 FT wide, Partially detached and displaced due to high winds & damaged wood panels

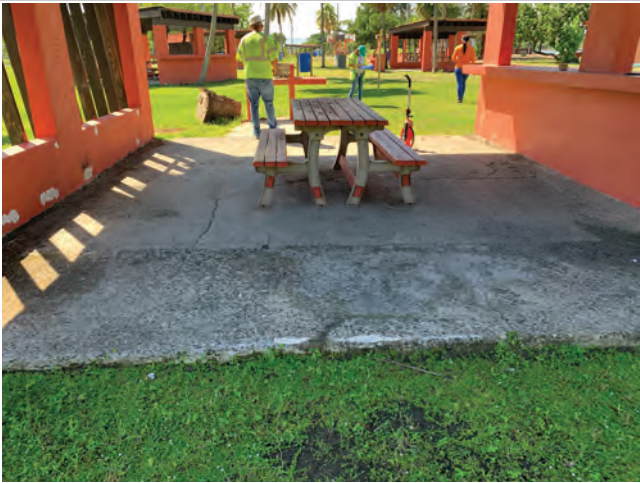
Applicant: Department of Natural & Environmental Resources		Damage Inventory # 355539		Category E	
Work Order # 62759		FIPS # 000-UW1XD-00		Date: 10/19/2020	
				GPS 18.473368, -66.185366	
Site Inspector: Isabelle Martinez Rivera		Damage Facility: Balneario de Punta Salinas Booths			
		Photo# 37		Photo# 38	
Booth # 5: 600 SF of Paint, Surface area, Damaged due to heavy rains and high winds		Booth #5: 44 SF of Treated wood 2 ft. x 8 ft. panels, 22 FT long x 2 FT wide, Detached and missing due to high winds

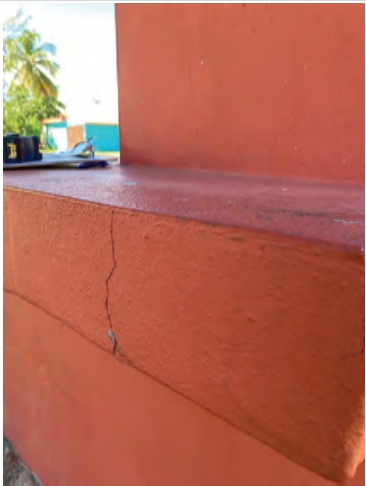
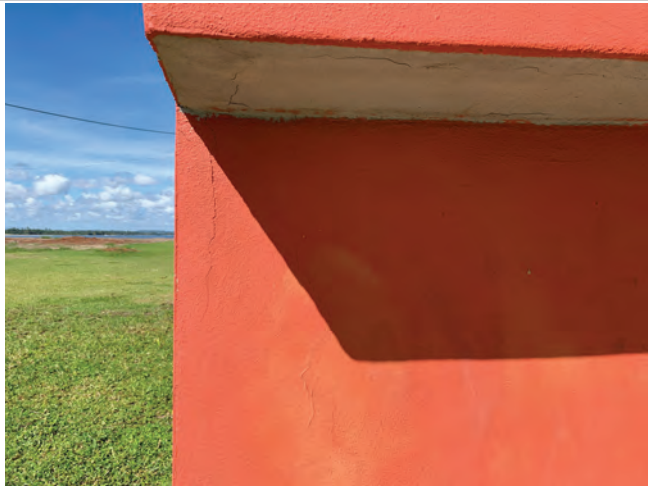
Damage Description:		Photo# 39		Photo# 40	
Booth #5: 1 each of Reinforced concrete table top on wall, 22 FT long x 31 IN wide x 5 IN thick, Cracked due to flying debris		Booth #5: 1 each of Reinforced concrete table top on wall, 22 FT long x 31 IN wide x 5 IN thick, Cracked due to flying debris

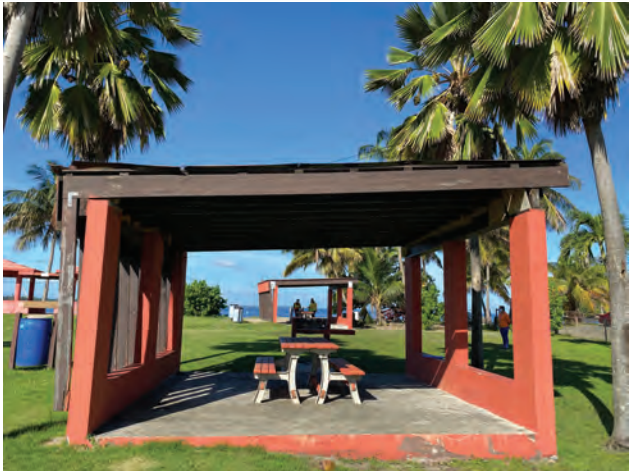
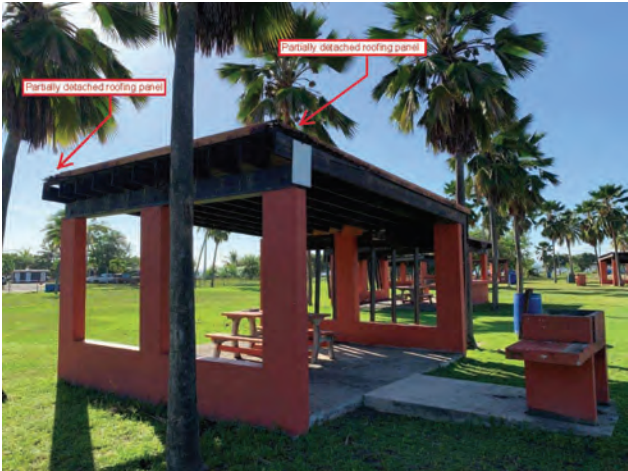
Damage Description:	Photo# 41	Damage Description	Photo# 42
Booth #6: 300 SF of Paint , Surface area, Damaged due to heavy rains and high winds		Booth #6: 330 SF of 24 gauge pre-painted steel roofing panel , 20 FT long x 16.5 FT wide, Partially detached and displaced due to high winds

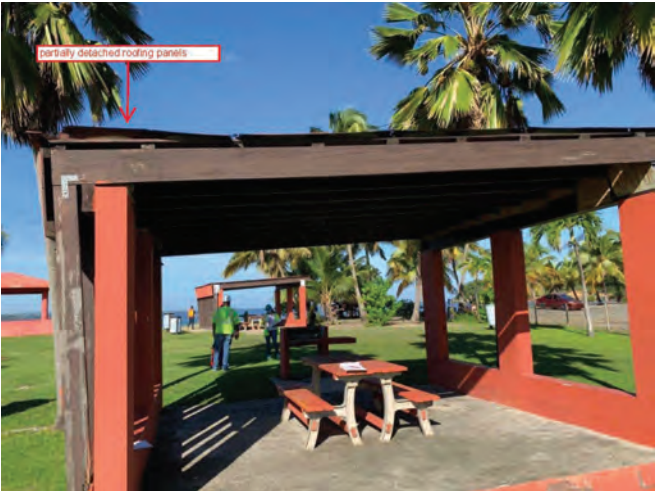
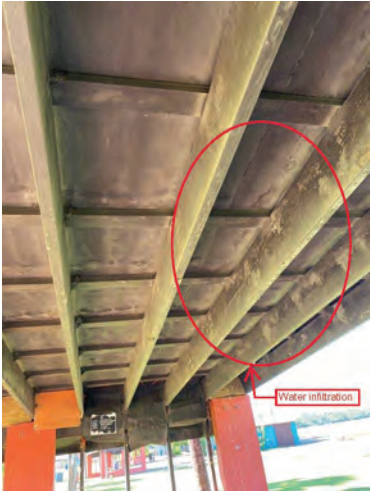
Damage Description:	Photo# 43	Damage Description	Photo# 44
Booth #6: 330 SF of 24 gauge pre-painted steel roofing panel , 20 FT long x 16.5 FT wide, Partially detached and displaced due to high winds		Booth #6: 330 SF of Treated wood sheeting, Water infiltrating due to partially detached metal roofing panels

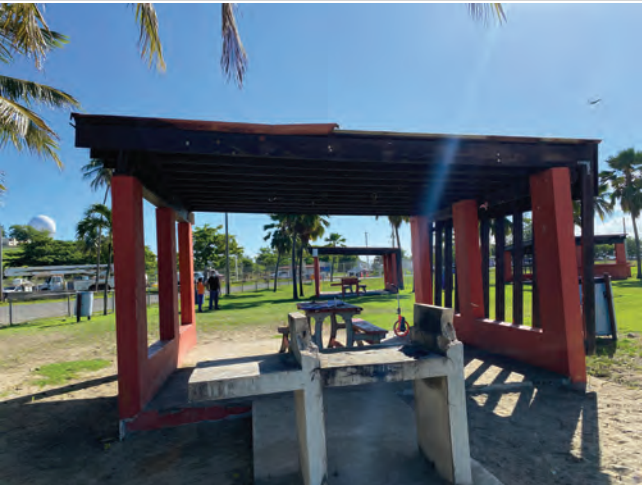
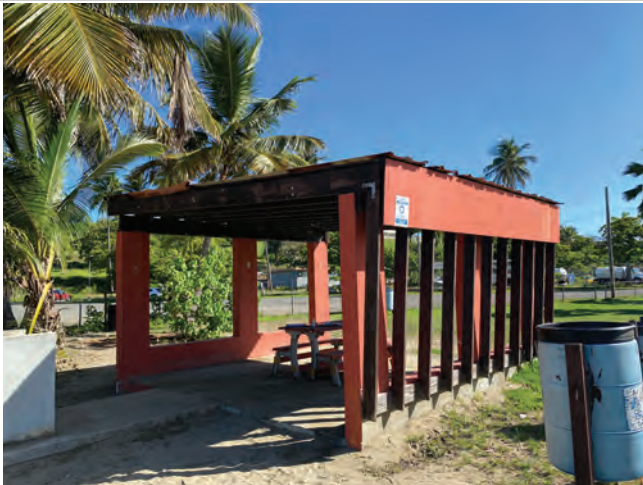
Damage Description:		Photo# 50		Damage Description	
Booth #7: 330 SF of 24 gauge pre-painted steel roofing panel , 20 FT long x 16.5 FT wide, Partially detached and displaced due to high winds				Booth #7: 330 SF of 24 gauge pre-painted steel roofing panel , 20 FT long x 16.5 FT wide, Partially detached and displaced due to high winds

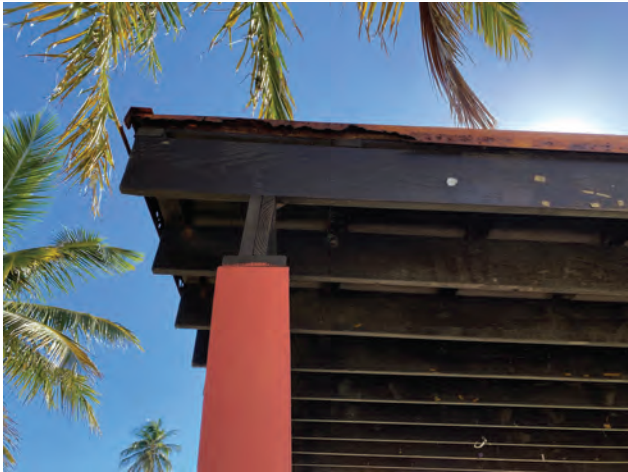
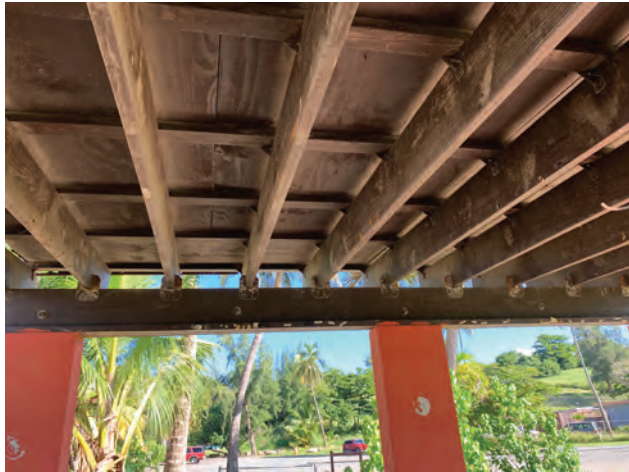
Applicant: Department of Natural & Environmental Resources		Damage Inventory # 355539		Category E	
Work Order # 62759		FIPS # 000-UW1XD-00		Date: 10/19/2020	
				GPS 18.473482, -66.185768	
Site Inspector: Isabelle Martinez Rivera		Damage Facility: Balneario de Punta Salinas Booths			
Damage Description:		Photo# 52		Damage Description	
Booth #7: Treated wooden roof, High winds tilted the 2"x10" wood beam causing the roof to be unstable				Booth #7: Treated wooden roof, High winds tilted the 2"x10" wood beam causing the roof to be unstable

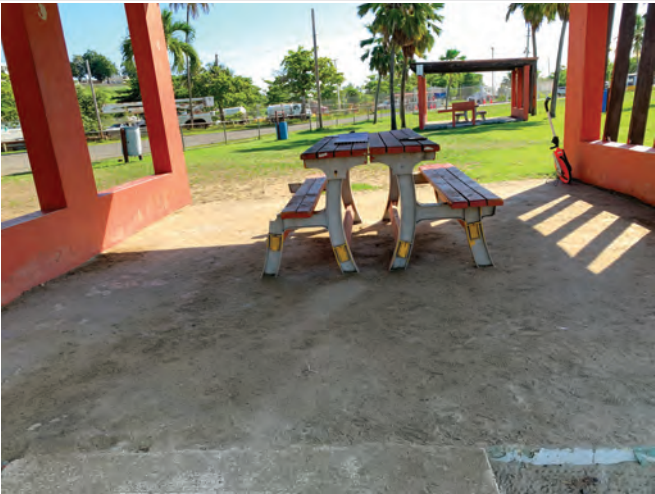
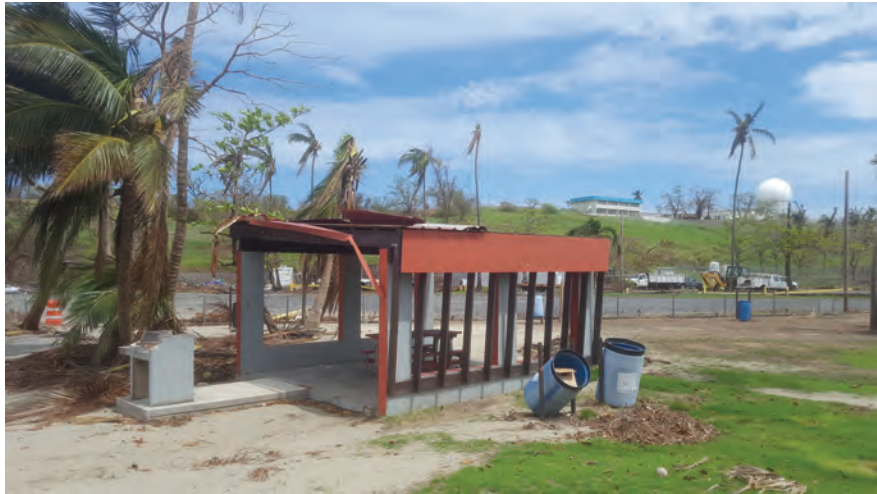
Damage Description:		Photo# 54		Damage Description	
Booth #7: 1 each of Picnic table 6 ft. long x 5 ft wide, Damaged due to high winds and flying debris				Booth #7: After Hurricane Maria

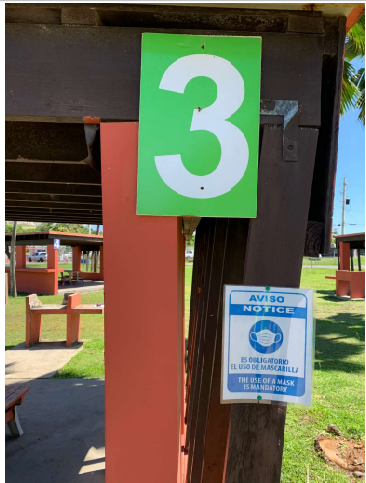
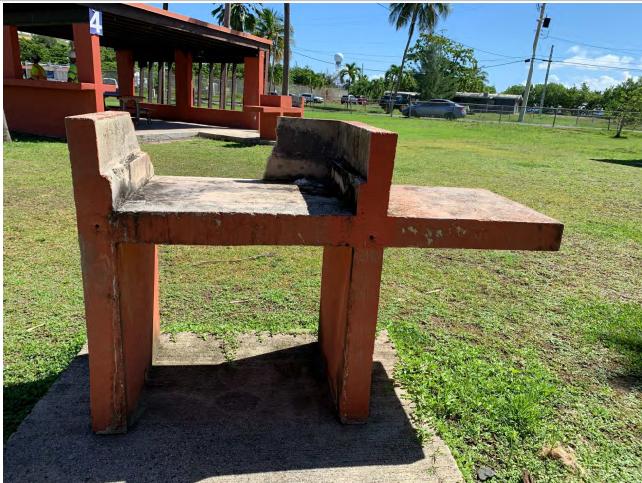
Applicant: Department of Natural & Environmental Resources		Damage Inventory # 355541		Category G	
Work Order # 62759		FIPS # 000-UW1XD-00		Date: 10-19-2020 GPS	
Site Inspector:		Damage Facility: Balneario de Punta Salinas BBQ's			
BBQ #3		Photo# 9		Damage Description Photo# 10

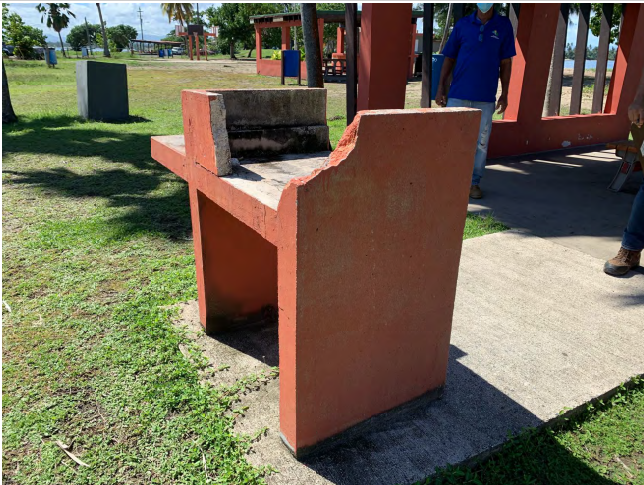
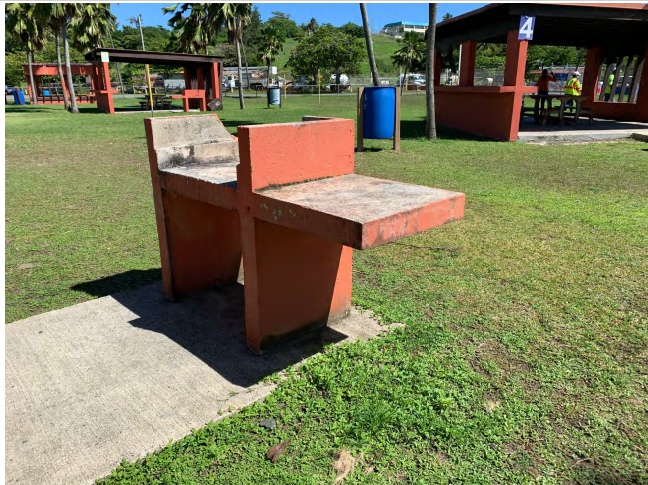
Damage Description: Photo# 11		Damage Description Photo# 12			
BBQ #3 completed destroyed due to the high velocity wind and flooding		BBQ #3 completed destroyed due to the high velocity wind and flooding

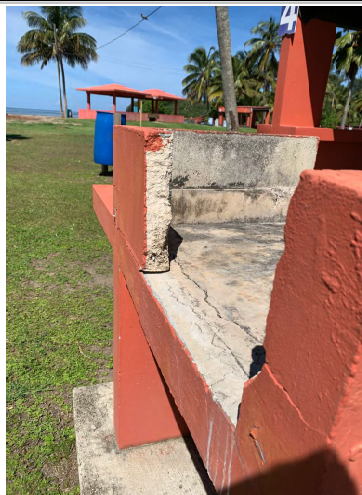
Damage Description		Photo#		16	
BBQ #4 completely destroyed due to the high velocity wind and flooding

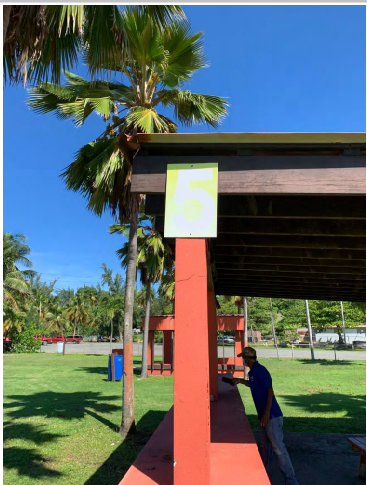
Damage Description BBQ #5 completed destroyed due to the high velocity wind and flooding	Photo# 18

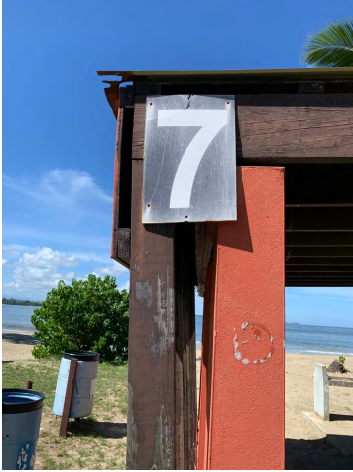
Applicant: Department of Natural & Environmental Resources		Damage Inventory # 355541		Category G	
Work Order # 62759		FIPS # 000-UW1XD-00		Date: 10-19-2020 GPS	
Site Inspector:		Damage Facility: Balneario de Punta Salinas BBQ's			
Damage Description:		Photo#		13	
BBQ #7

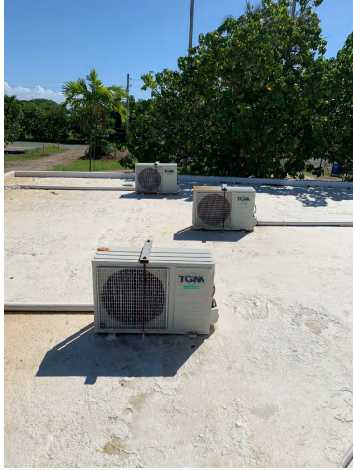
Damage Description:	Photo#
Outdoor condensing unit TJM got damage due to high wind.

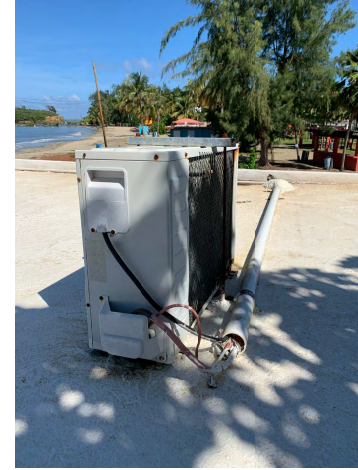
Damage Description	Photo#
Outdoor condensing unit #1.	18.47257, -66.18569

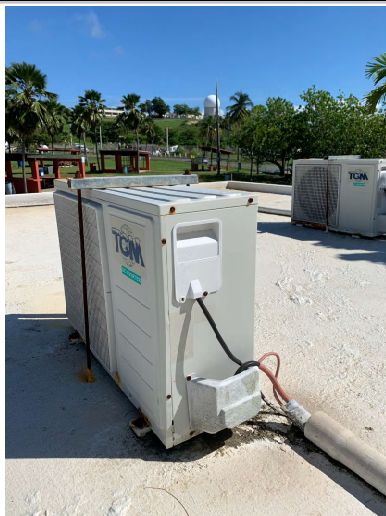
Damage Description:	Photo#
Outdoor condensing unit #2.

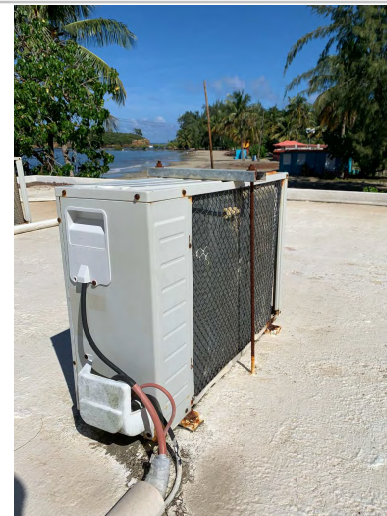
Damage Description	Photo#
Outdoor condensing unit #3.

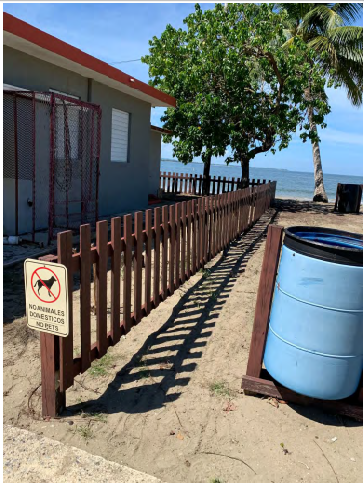
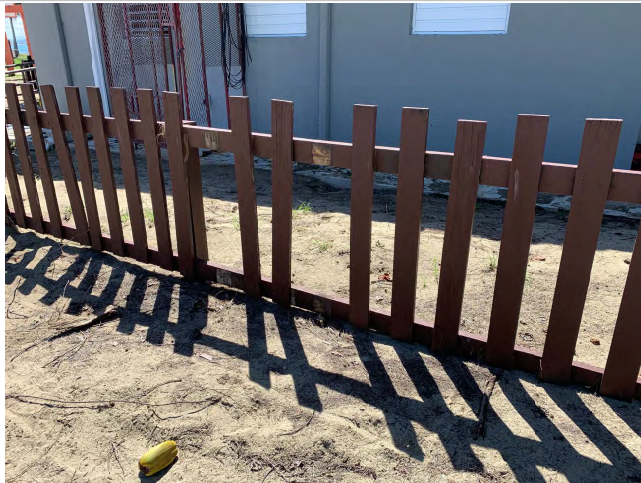
Applicant: Deartment of Natural & Environmental Resources		Damage Inventory # 355545		Category E	
Work Order # 62759		FIPS # 000-UW1XD-00		Date: 10-19-2020 GPS 18.47257, -66.18569	
Site Inspector: Christian Garcia & Raymond Gutierrez		Damage Facility: Balneario de Punta Salinas Administrative Office			
		Photo#			
Outside wood fence around the administrative office got damage during the event with high winds and debris.		Damage Description		Photo#	
		Some sections of the fence that flew away during the event.
