Department of Homeland Security Federal Emergency Management Agency

Project #	123407	PW #	9549	Project Type	Standard
Project Category	G - Parks, Recreational Facilities, and Other Items			Applicant	Department of Natural & Environmental Resources (000-UW1XD-00)
Project Title	Balneario de Punta Salinas			Event	4339DR-PR (4339DR)
Project Size	Large			Declaration Date	9/20/2017
Activity Completion Date	9/20/2024			Incident Start Date	9/17/2017
Process Step	Obligated			Incident End Date	11/15/2017

Damage #355538; Balneario de Punta Salinas Lifeguard Towers

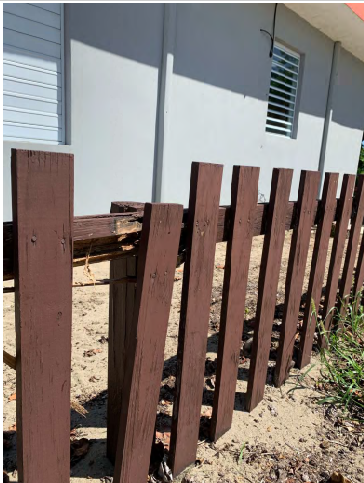
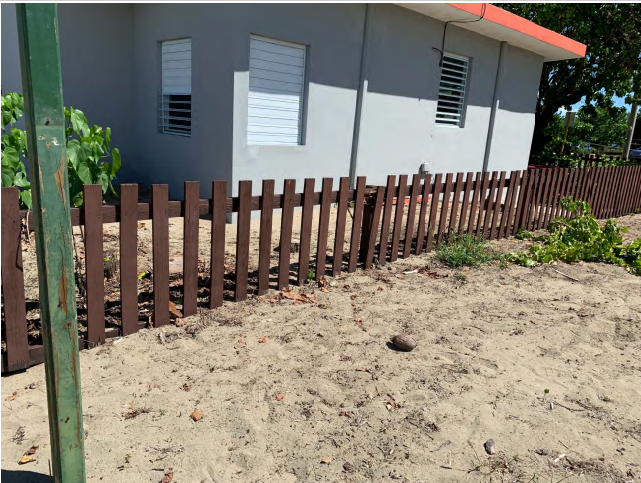
Damage Description:		Photo#			
Others sections of the fence got detached.		Damage Description		Photo#	
		The fence is loose due to the impact of debris and high winds.

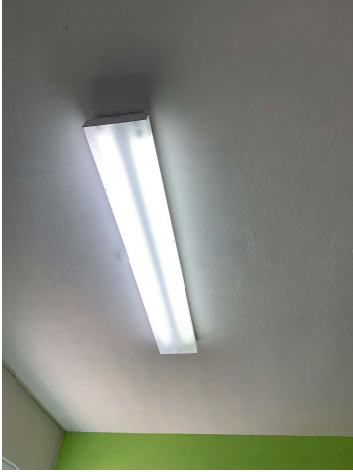
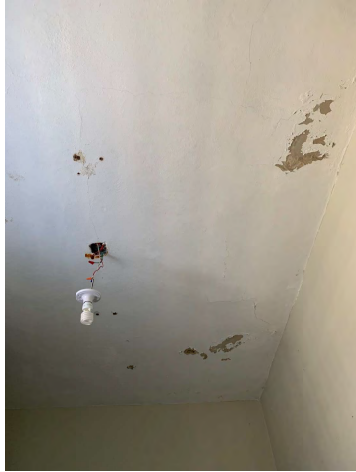
Applicant: Deartment of Natural & Environmental Resources		Damage Inventory # 355545		Category E	
Work Order # 62759		FIPS # 000-UW1XD-00		Date: 10-19-2020 GPS 18.47257, -66.18569	
Site Inspector: Christian Garcia & Raymond Gutierrez		Damage Facility: Balneario de Punta Salinas Administrative Office			
Damage Description:		Photo#		Damage Description	
Interior light fixture is loose due to the leaks of water through the roof during the event and inner components are corroded. Lobby light.				Interior light fixture was flew with winds that enter through the windows. Provisional bulb was installed. Room #1.

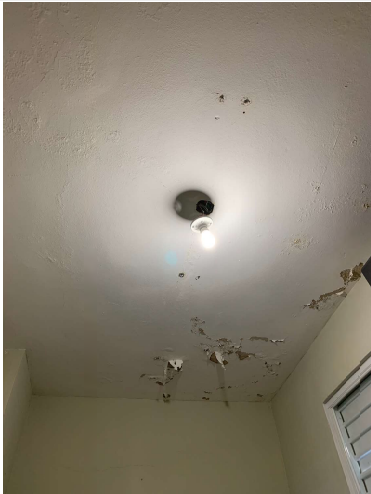
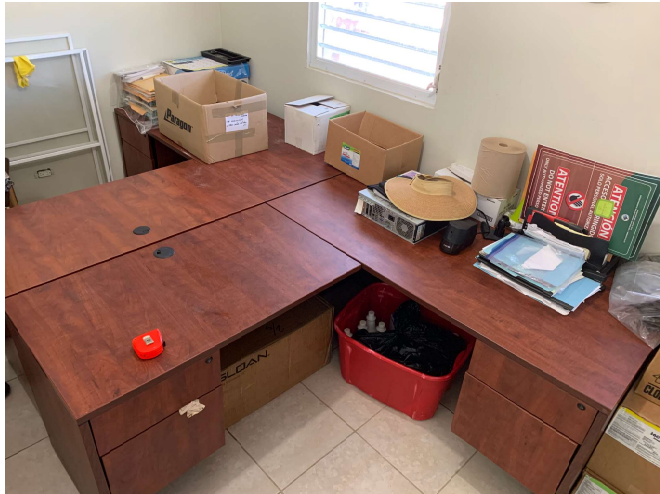
Damage Description:		Photo#		Damage Description	
Interior light fixture was flew with winds that enter through the windows. Provisional bulb was installed. Room #2 and #3.				2 L shape office desk was damage during the event. The office got flooded.

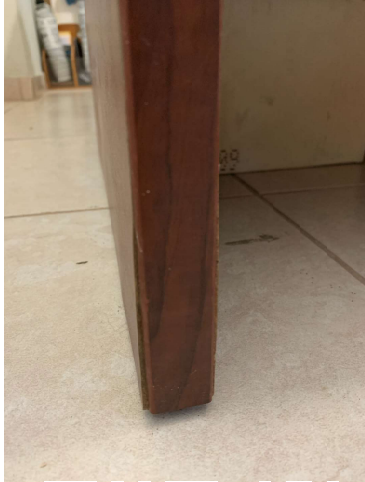
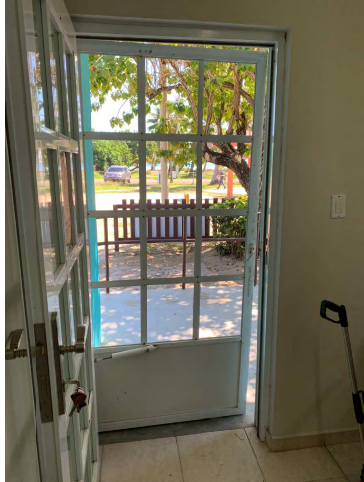
Damage Description:	Photo#	Damage Description	Photo#
Office desk damage due to flood.		Front door got damage due to the high winds, it is loose.

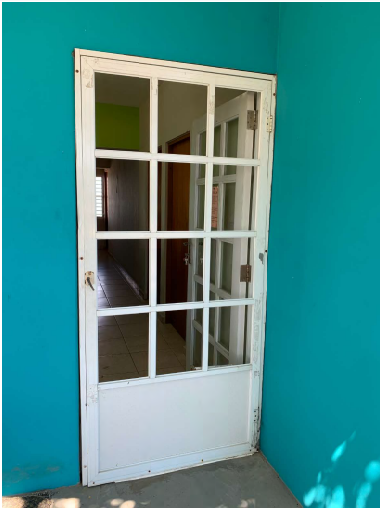
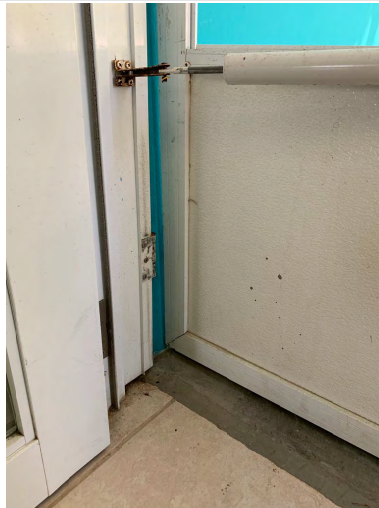
Damage Description:	Photo#	Damage Description	Photo#
Front door screen got loose and broke in some sections from the frame.		Screen door got detached from the base, breaking the frame.

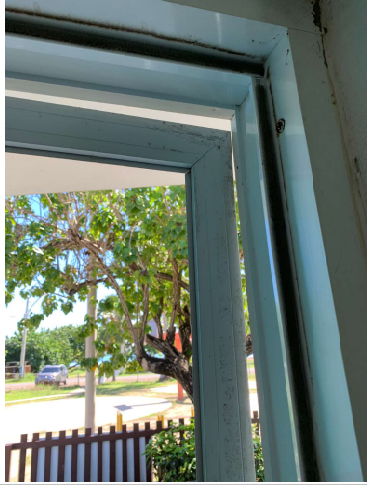
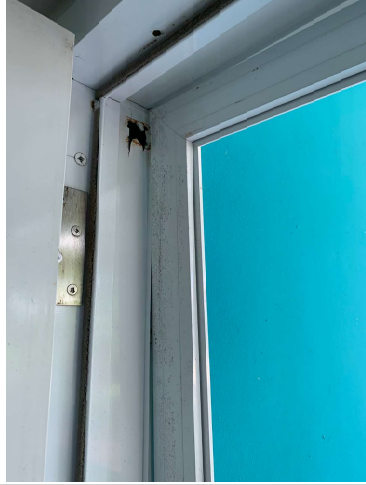
Applicant: Deartment of Natural & Environmental Resources		Damage Inventory # 355545		Category E	
Work Order# 62759		FIPS # 000-UW1XD-00		Date: 10-19-2020 GPS 18.47257, -66.18569	
Site Inspector: Christian Garcia & Raymond Gutierrez		Damage Facility: Balneario de Punta Salinas Administrative Office			
Damage Description:		Photo#		Damage Description	
Screen door was damage due to high winds.				Screen door frame got damage.

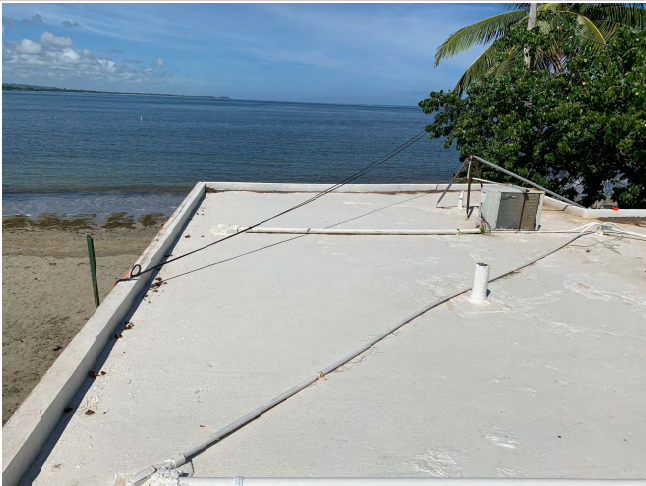
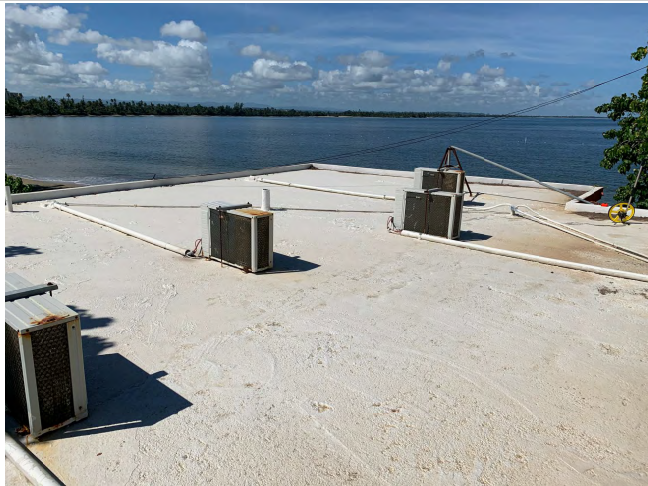
Damage Description:		Photo#		Damage Description	
Roof coating was damage during the event. Applicant have done some provisional repairs with some materials.				Roof coating damage.

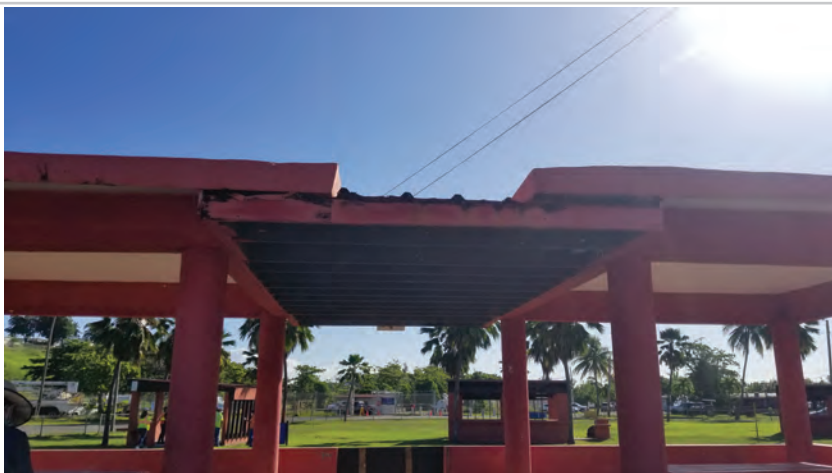
Damage Description:	Photo# 1
Gazebo: 12.3457 CY of Roof - Reinforced Concrete , 40 FT long x 20 FT wide x 5 IN thick, Storm surge

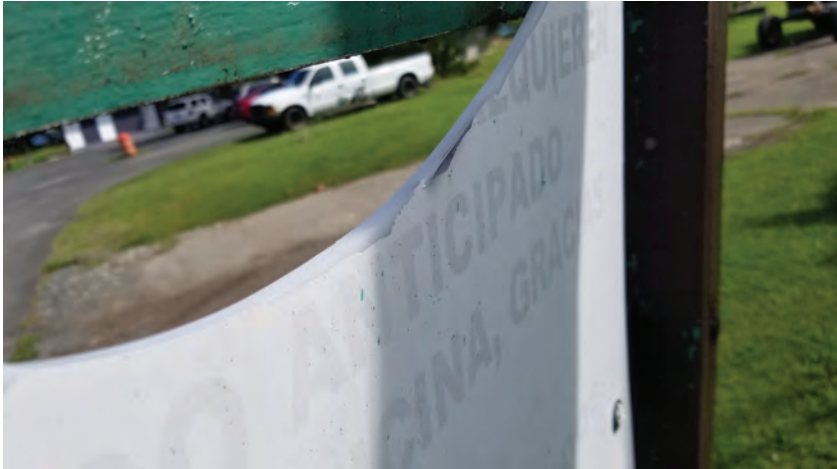
Damage Description	Photo# 2
Activities Room: Signage, 1 each of Sign (Activities Room and Restrooms), 36 IN wide x 25 IN high, storm surge and high winds. (close view).

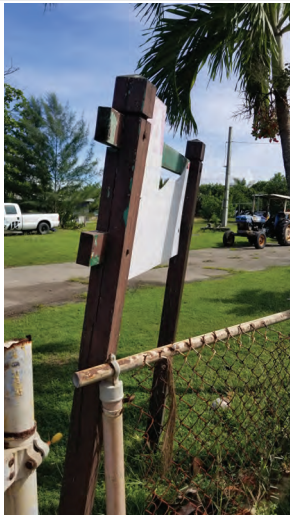
Damage Description	Photo# 4
Activities Room: Signage, 2 each of Wood pole 4 IN x 4 IN P/T, 8 FT long, storm surge and high winds.

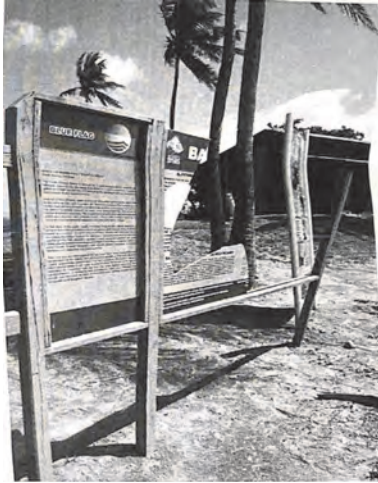
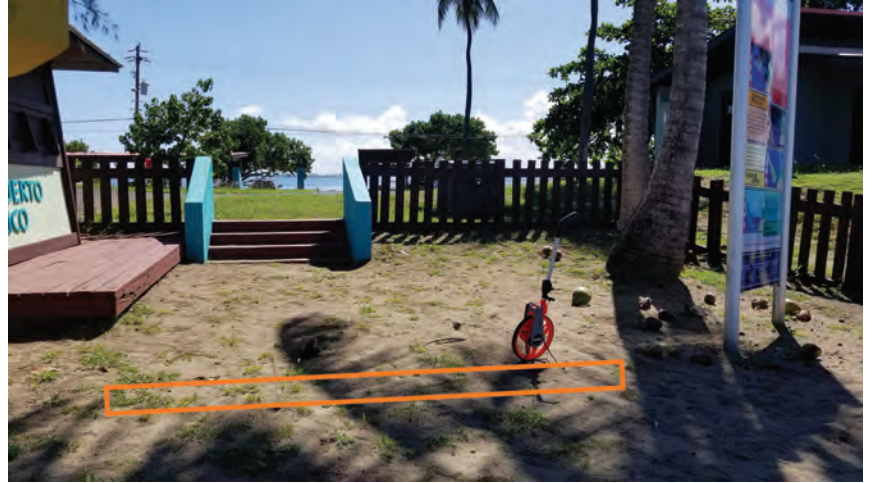
Applicant: Department of Natural & Environmental Resources		Damage Inventory # 355543		Category G	
Work Order# 62759		FIPS # 000-UW1XD-00		Date: Oct 19, 2020	
				GPS 18.471679, -66.185637	
Site Inspector: Axel Torres / Alejandro Colon		Damage Facility: Beach signs and showers			
Damage Description:		Photo# 21		Damage Description	
Regulations, Water Quality: Signage, 2 each of Sign (front) Regulations, (back) Water Quality, 8 FT wide x 4 FT high, storm surge and high winds. Note: The photo was after hurricane Maria and provided by the Applicant.				Regulations, Water Quality: Signage, 2 each of Sign (front) Regulations, (back) Water Quality, 8 FT wide x 4 FT high, storm surge and high winds. Wide view of the site where the sign was located. For the safety of visitors, the sign had to be removed. The orange line indicates where the sign foot print should be.

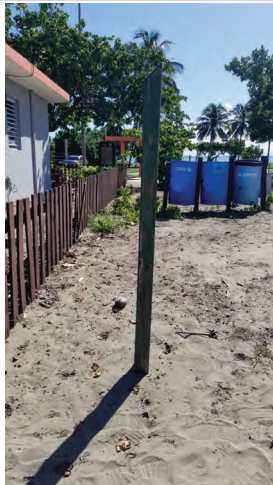
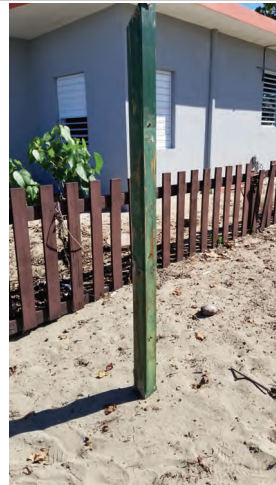
Regulations, Water Quality: Signage, 2 each of Wood Pole 4 IN x 4 IN P/T, 8 FT long, storm surge and high winds				Regulations, Water Quality: Signage, 2 each of Wood Pole 4 IN x 4 IN P/T, 8 FT long, storm surge and high winds

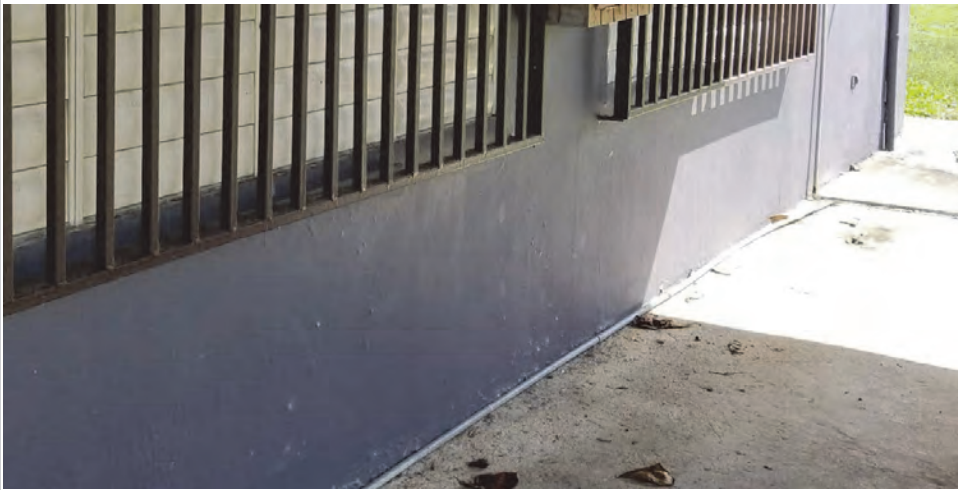
Damage Description:	Photo# 3
Activities Room - 1 each of Walls Cement Plaster (multiple cracks from 1/8 IN to 1/4 IN), 136 FT long, high winds and earthquake.

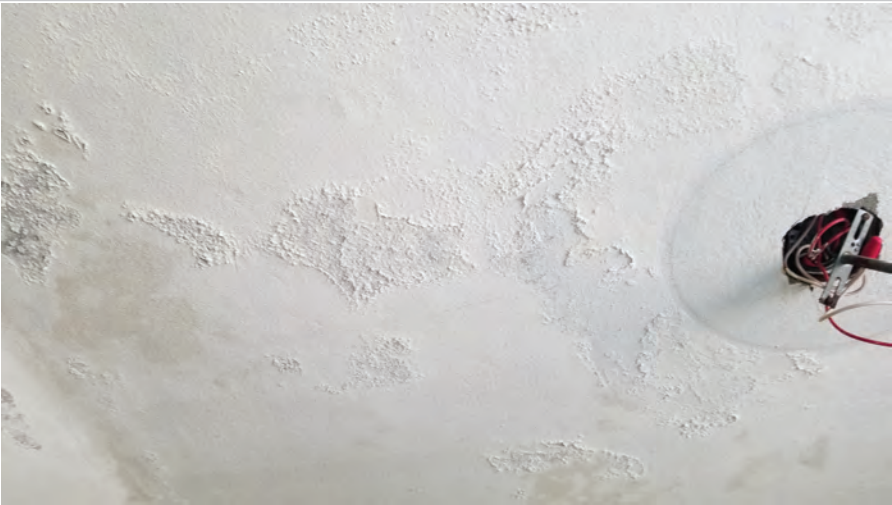
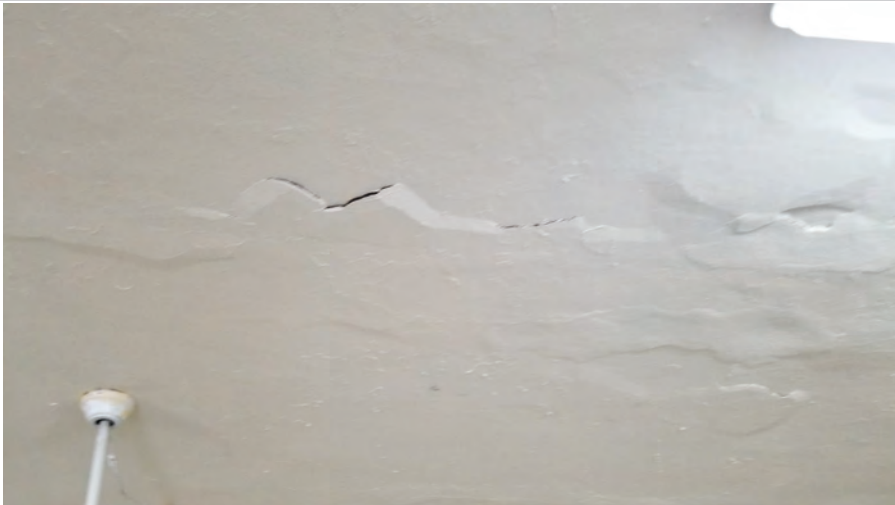
Photo# 7		Photo# 8	
Damage Description:		Damage Description			
Activities Room - 1,092 SF of Ceiling Cement Plaster (multiple cracks and detachment) approximately 50 % damaged, 42 FT long x 26 FT wide, high winds and earthquake.		Activities Room - 1,092 SF of Ceiling Cement Plaster (multiple cracks and detachment) approximately 50 % damaged, 42 FT long x 26 FT wide, high winds and earthquake. (close view)

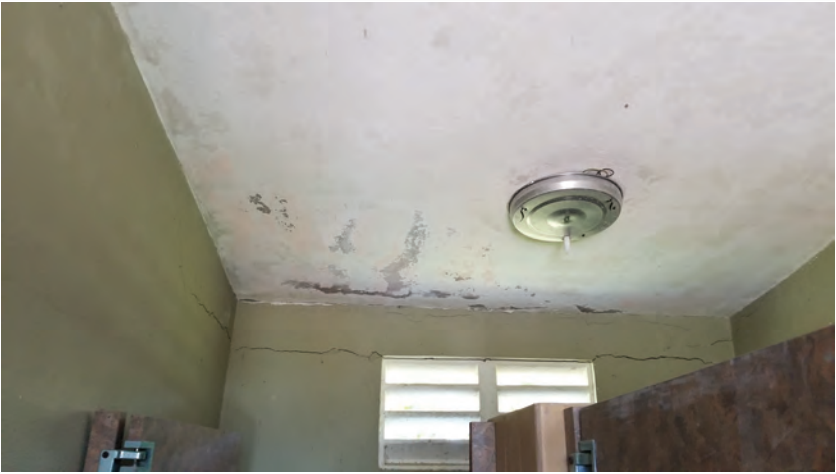
Applicant: Department of Natural & Environmental Resources		Damage Inventory # 355544		Category E	
Work Order # 62759		FIPS # 000-UW1XD-00		Date: Oct 19, 2020 GPS 18.471831, -66.185375	
Site Inspector: Axel Torres / Alejandro Colon		Damage Facility: Restrooms and Trash Cans - 1			
Damage Description:		Photo#		13	
Activities Room Restrooms - 1 each of Walls Cement Plaster (multiple cracks from 1/8 IN to 1/4 IN), 30 FT long, high winds and earthquake.

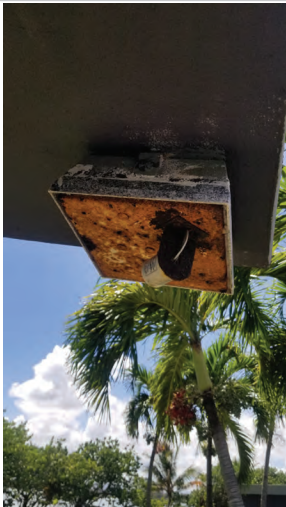
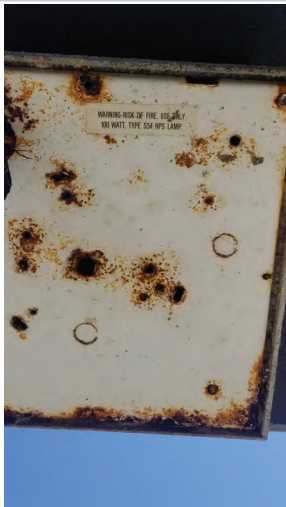
Damage Description:		Photo# 19	
Activities Room Restrooms - 4 each of ceiling pack type S-54 HPS 100 W Lightning (Ceiling), 12 IN long x 12 IN wide, wind blown debris and high winds.

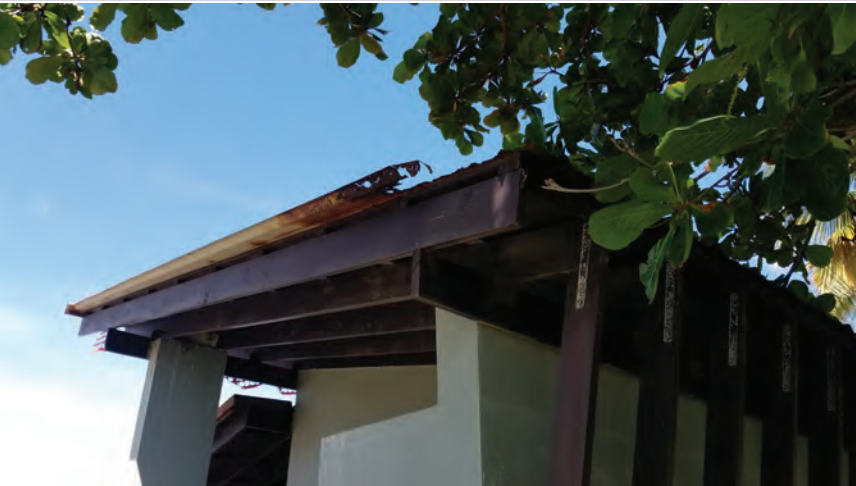
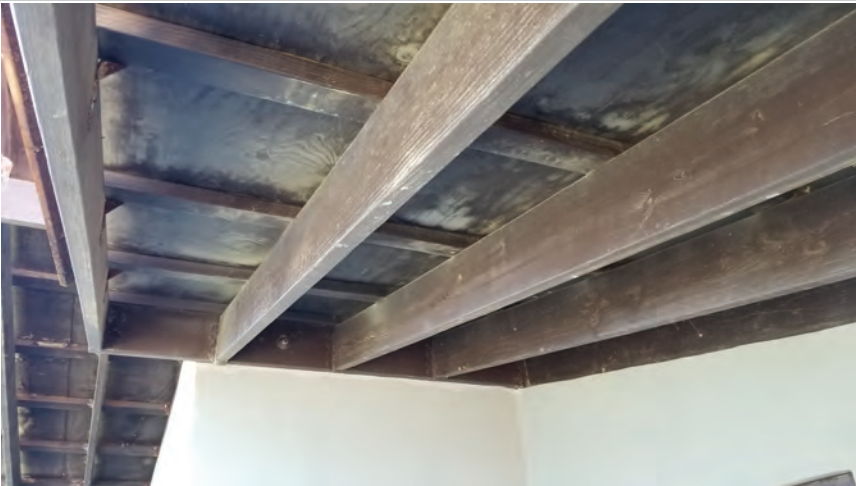
Damage Description:		Photo# 23		Damage Description	
Men Restrooms - 858 SF of Roof (Plywood 3/4 IN P/T), 33 FT long x 26 FT wide, wind blown debris and high winds				Men Restrooms - 858 SF of Roof (Plywood 3/4 IN P/T), 33 FT long x 26 FT wide, wind blown debris and high winds. (close view).

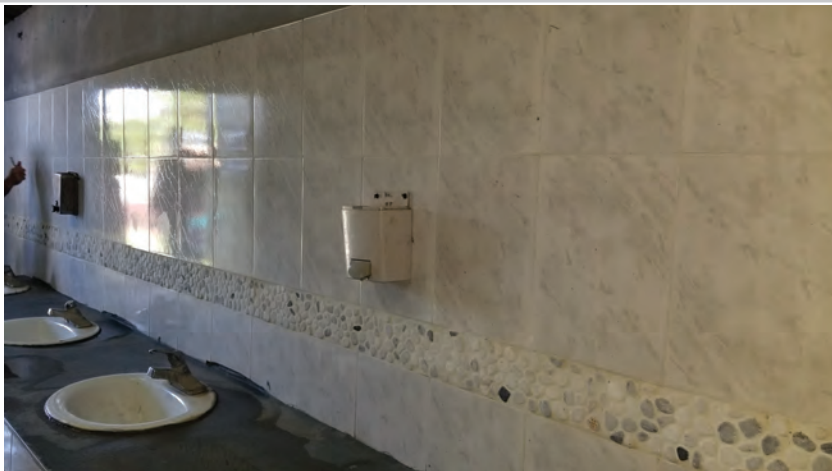
Damage Description:	Photo# 1
Men Restrooms - 396 SF of Walls Ceramic Tile (size 10 IN x 14 IN). Area #1 (22 FT L x 6 FT H), Area #2 (18 FT L x 3 FT H) , 31 FT long x 6 FT high, high winds and earthquake.

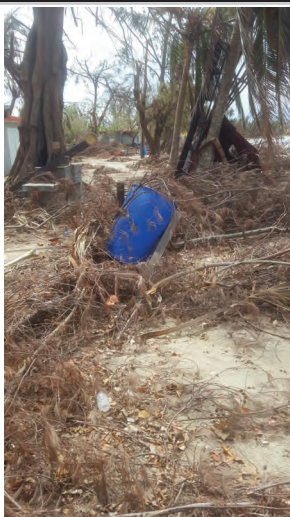
Damage Description:	Photo# 3
Trash Cans: 50 each of Trash Cans, 55 gallons, storm surge and high winds.

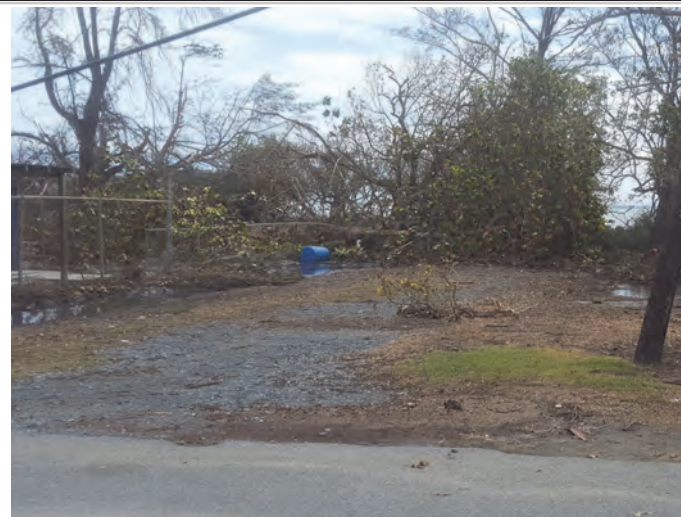
Damage Description	Photo# 4
Trash Cans: 50 each of Trash Cans, 55 gallons, storm surge and high winds

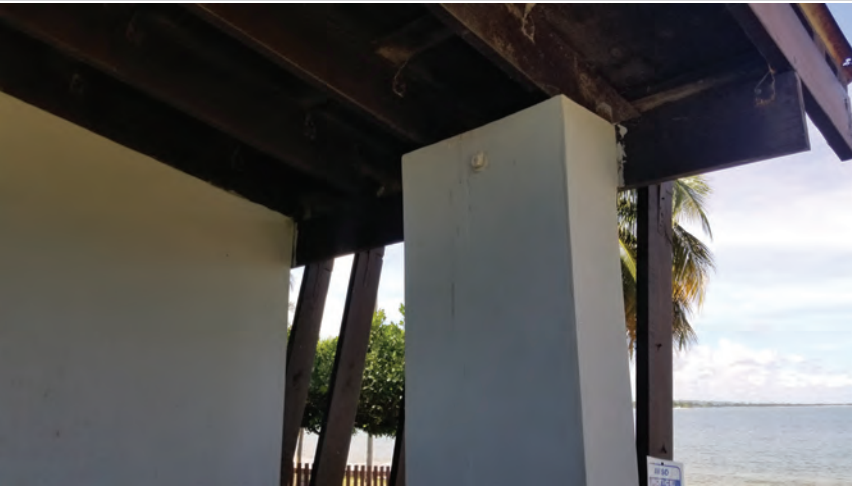
Damage Description:		Photo# 11		Damage Description	
Women Restrooms - 680 SF of Roof (Plywood 3/4 IN P/T), 40 FT long x 17 FT wide, wind blown debris and high winds.				Women Restrooms - 680 SF of Roof (Plywood 3/4 IN P/T), 40 FT long x 17 FT wide, wind blown debris and high winds.

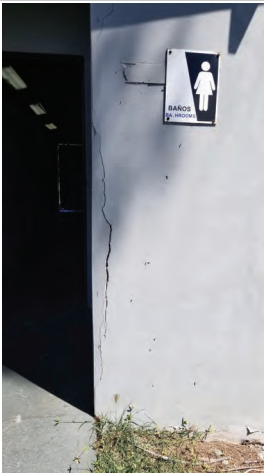
Applicant: Department of Natural & Environmental Resources		Damage Inventory # 355544		Category E	
Work Order # 62759		FIPS # 000-UW1XD-00		Date: Oct 19, 2020 GPS 18.471831, -66.185375	
Site Inspector: Axel Torres / Alejandro Colon		Damage Facility: Restrooms and Trash Cans - 2			
Damage Description:		Photo#		13	
Women Restrooms - 1 each of Walls Cement Plaster (multiple cracks from 1/8 IN to 1/4 IN), 164 FT long, high winds and earthquake.
