**SUBASTA FORMAL 22J-11819
PARA EL SERVICIO DE DEMOLICIÓN DE ESTRUCTURA Y RECOGIDO DE
ESCOMBROS DEL CDT DE MAUNABO, ADSCRITO AL DEPARTAMENTO DE SALUD
DEL GOBIERNO DE PUERTO RICO**

ASUNTO: ESTUDIO DE ASBESTO Y PLOMO

ASBESTOS CONTAINING MATERIALS INSPECTION REPORT

CDT Maunabo

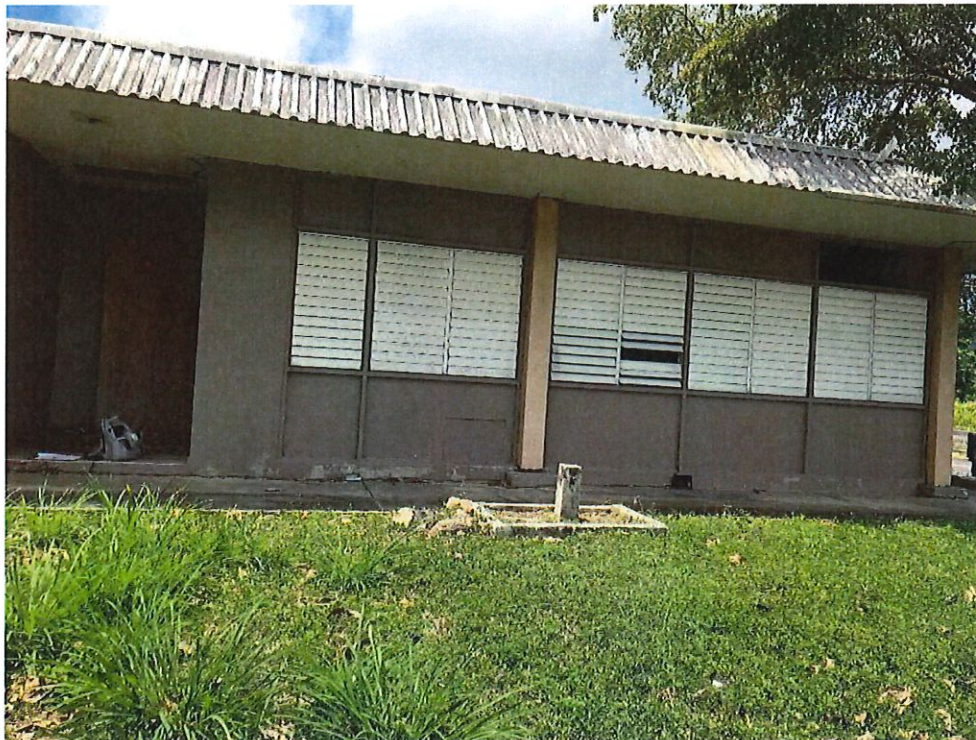
Photo Number 2 – Exterior Walls
