PROJECT: **ATRIUM REPAIR, REMEDIATION, AND/OR REHABILITATION 2021-002**

MARCH 19, 2021

355 AVENUE FRANKLIN DELANO ROOSEVELT,
SAN JUAN, P.R. 00918

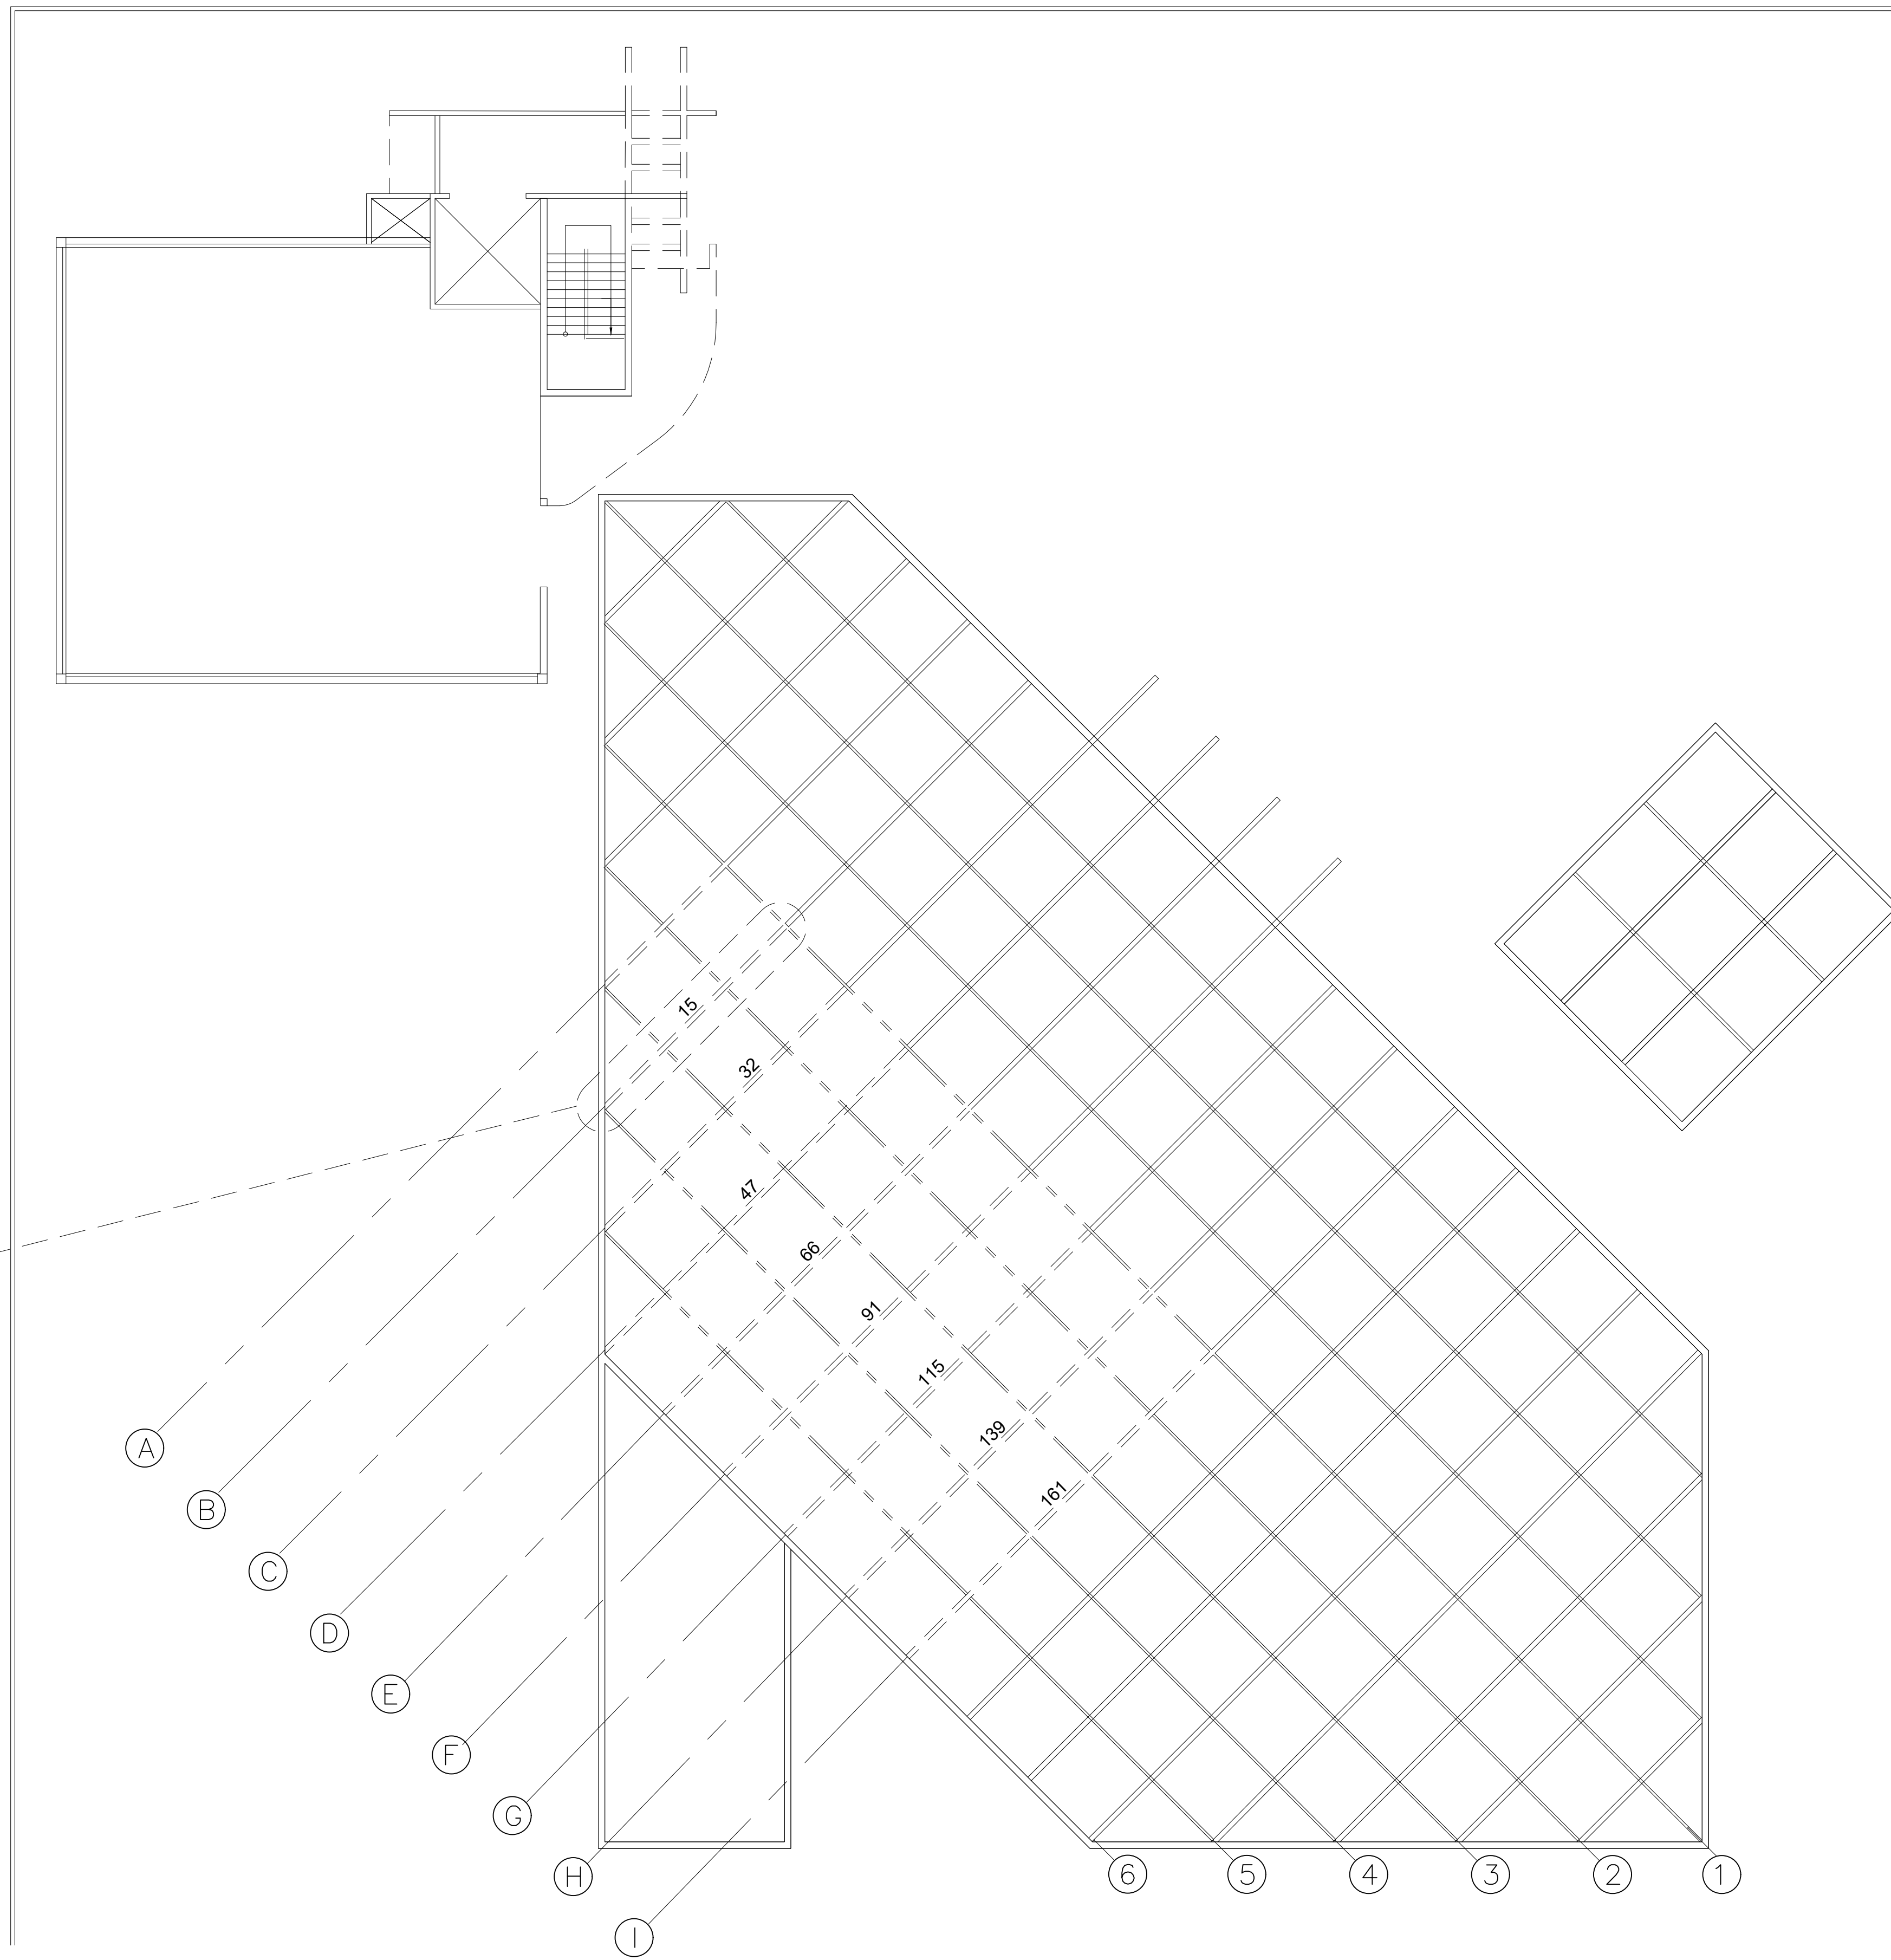
CONDITION ASSESSMENT ROOF PLAN TRUSS TOP

THE NUMBERS IN THIS DRAWING REPRESENTS THE PHOTOS OF THE FINDING IN THE APPENDIX A: TABLE OF FINDINGS.

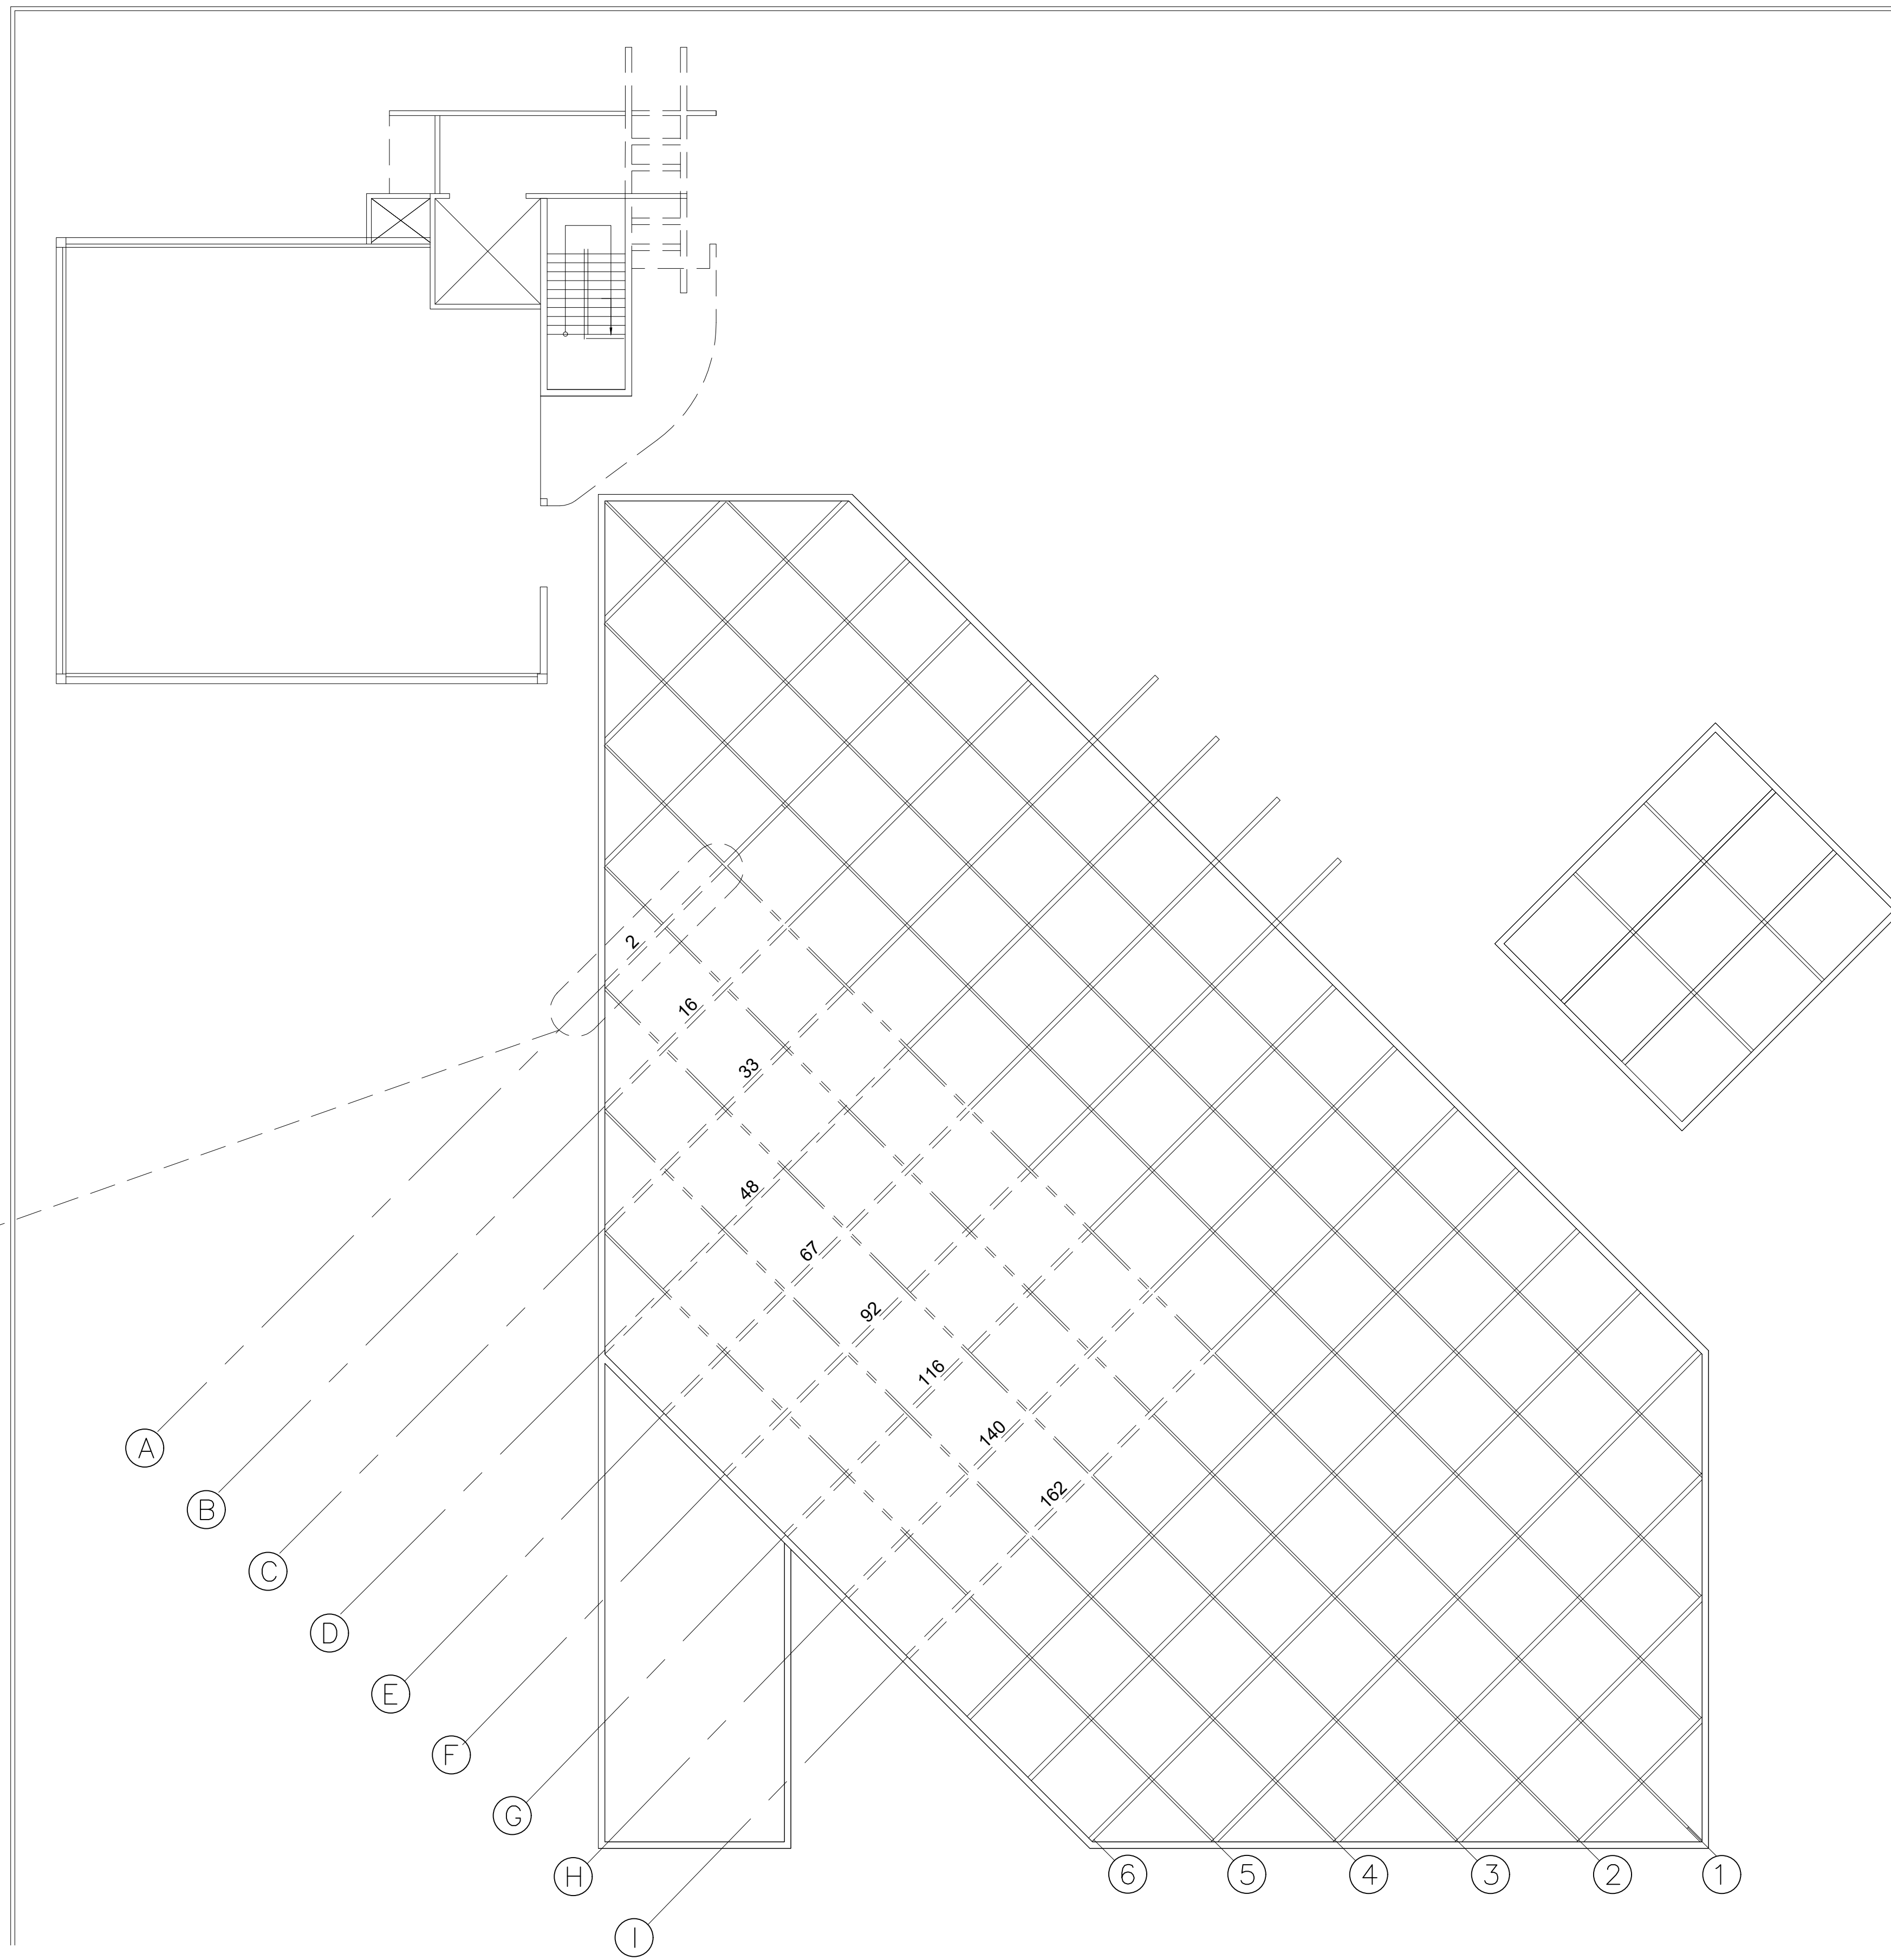
CONDITION ASSESSMENT ROOF PLAN TRUSS BOTTOM

NOTE:
 THE NUMBERS IN THIS DRAWING REPRESENTS THE PHOTOS OF THE FINDING IN THE APPENDIX A: TABLE OF FINDINGS.

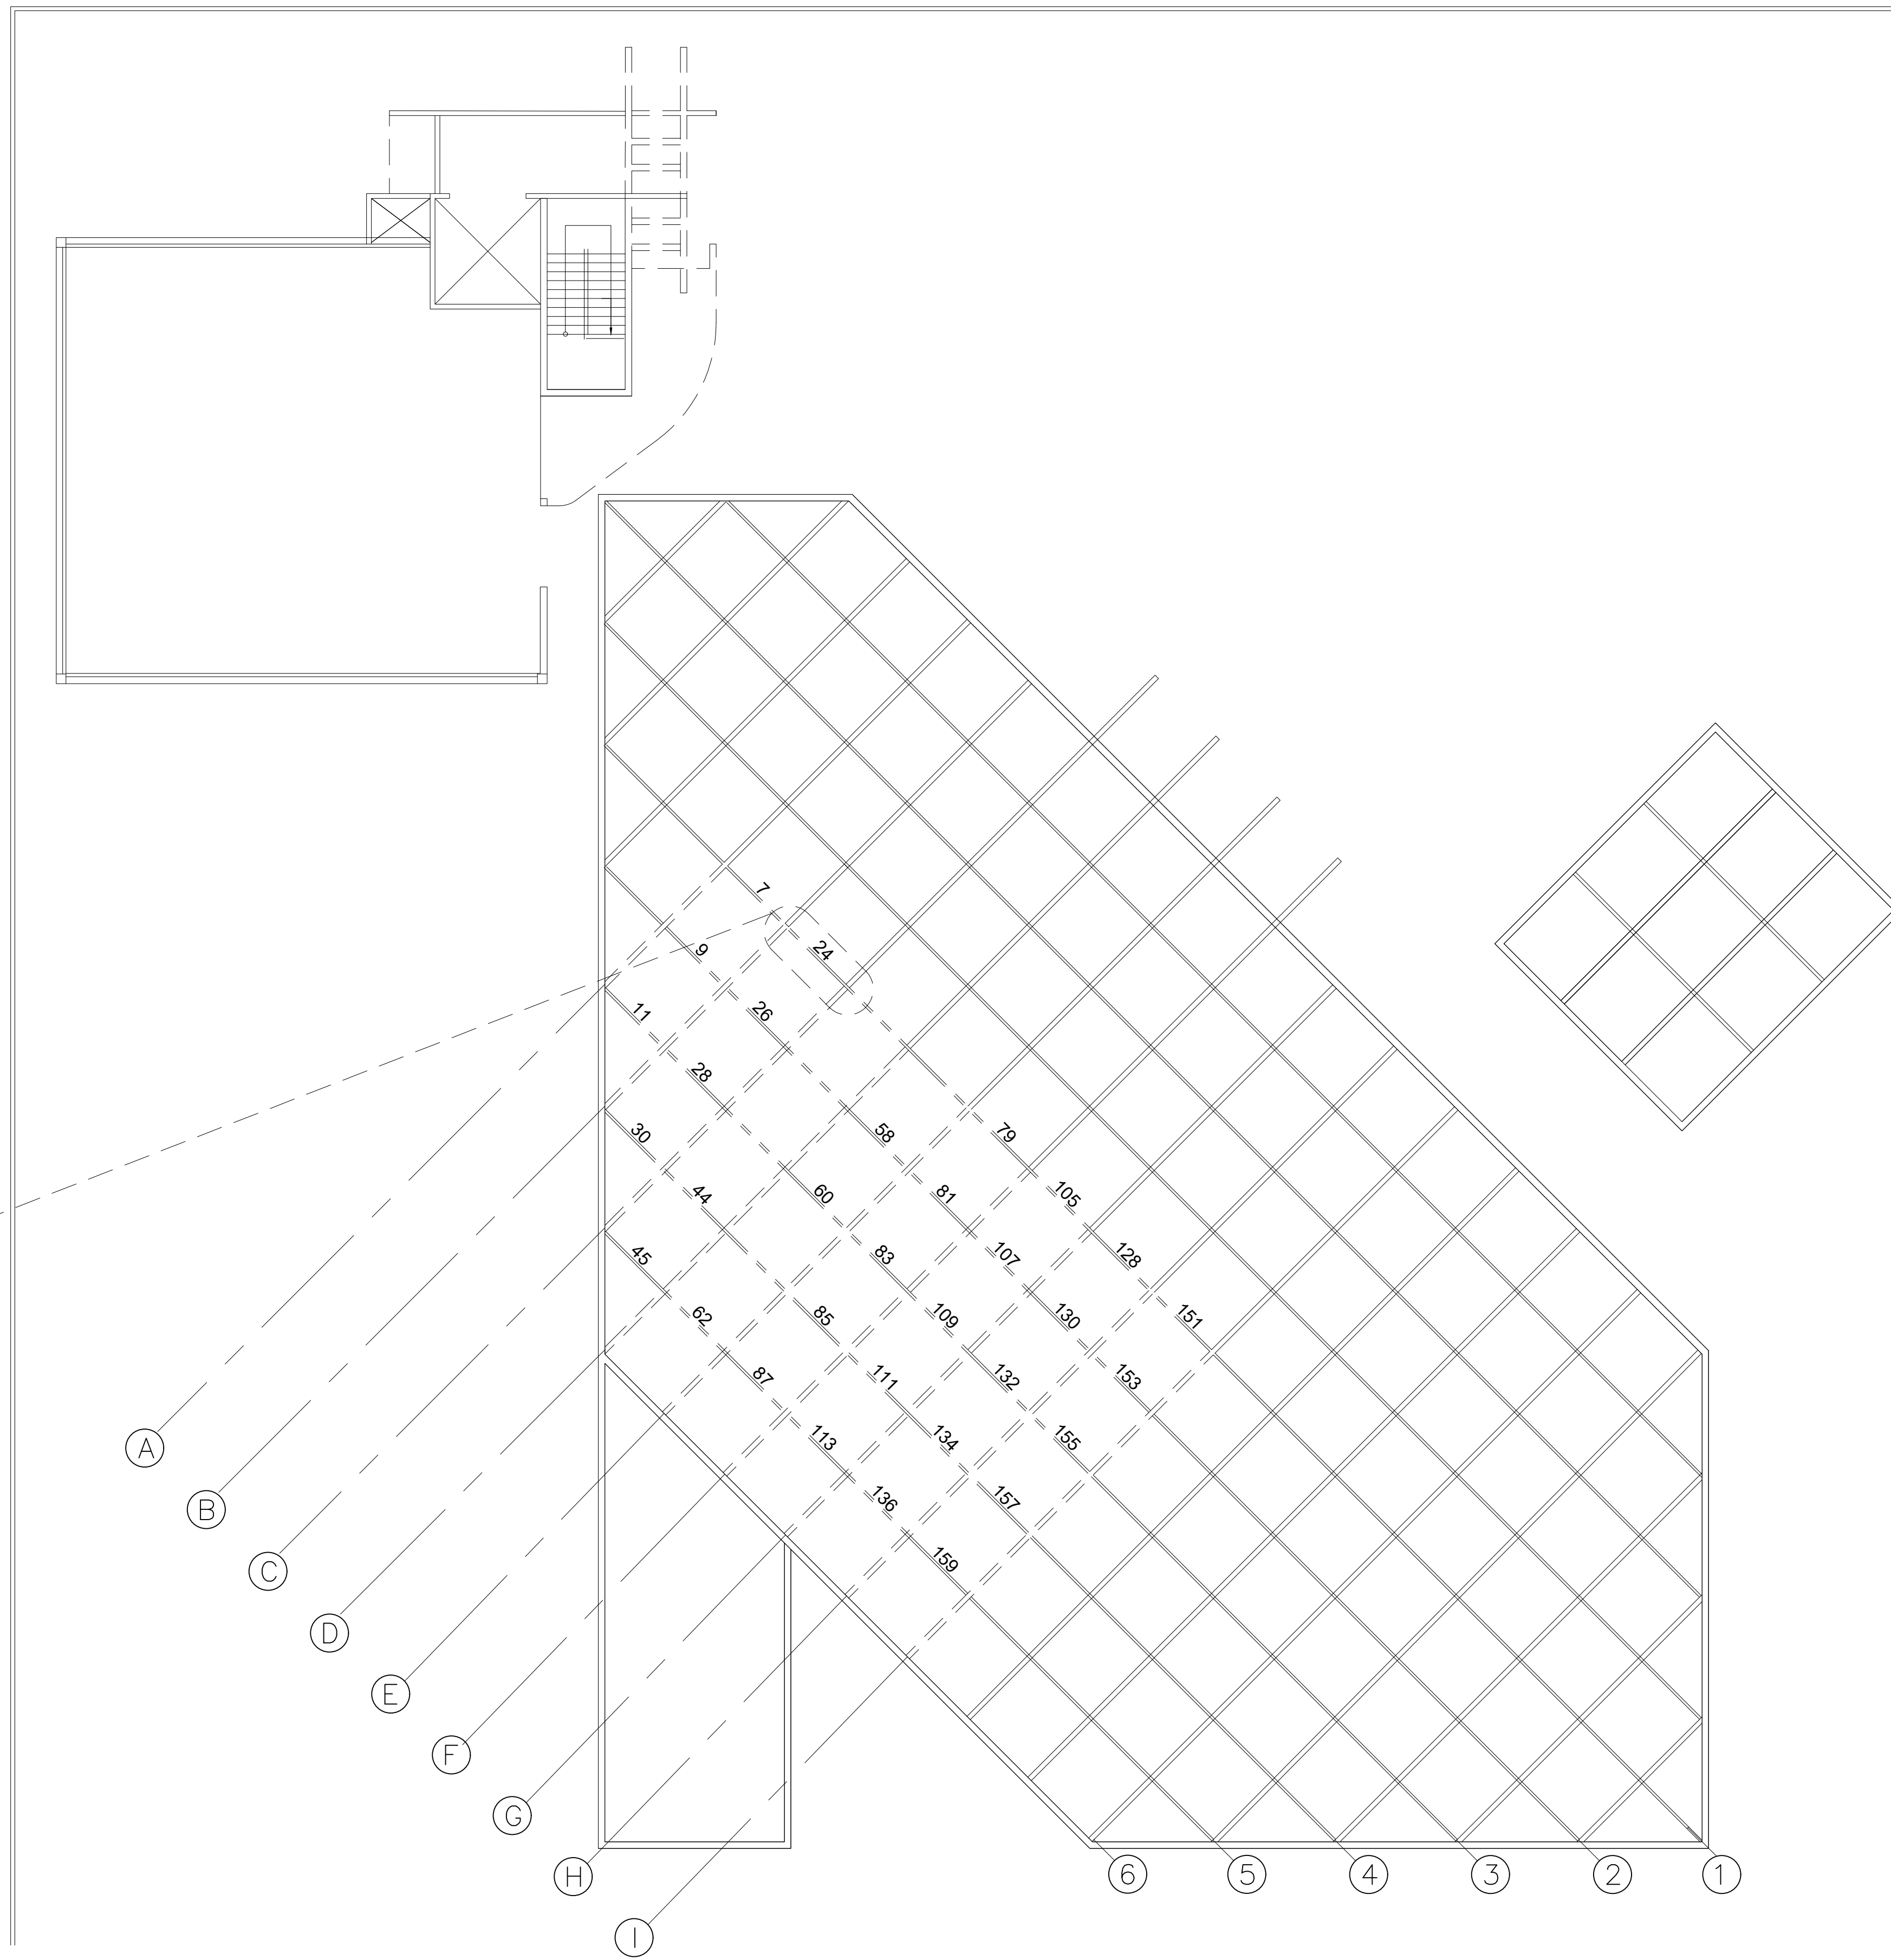
CONDITION ASSESSMENT ROOF PLAN TRUSS TOP

NOTE:
 THE NUMBERS IN THIS DRAWING REPRESENTS THE PHOTOS OF THE FINDING IN THE APPENDIX A: TABLE OF FINDINGS.

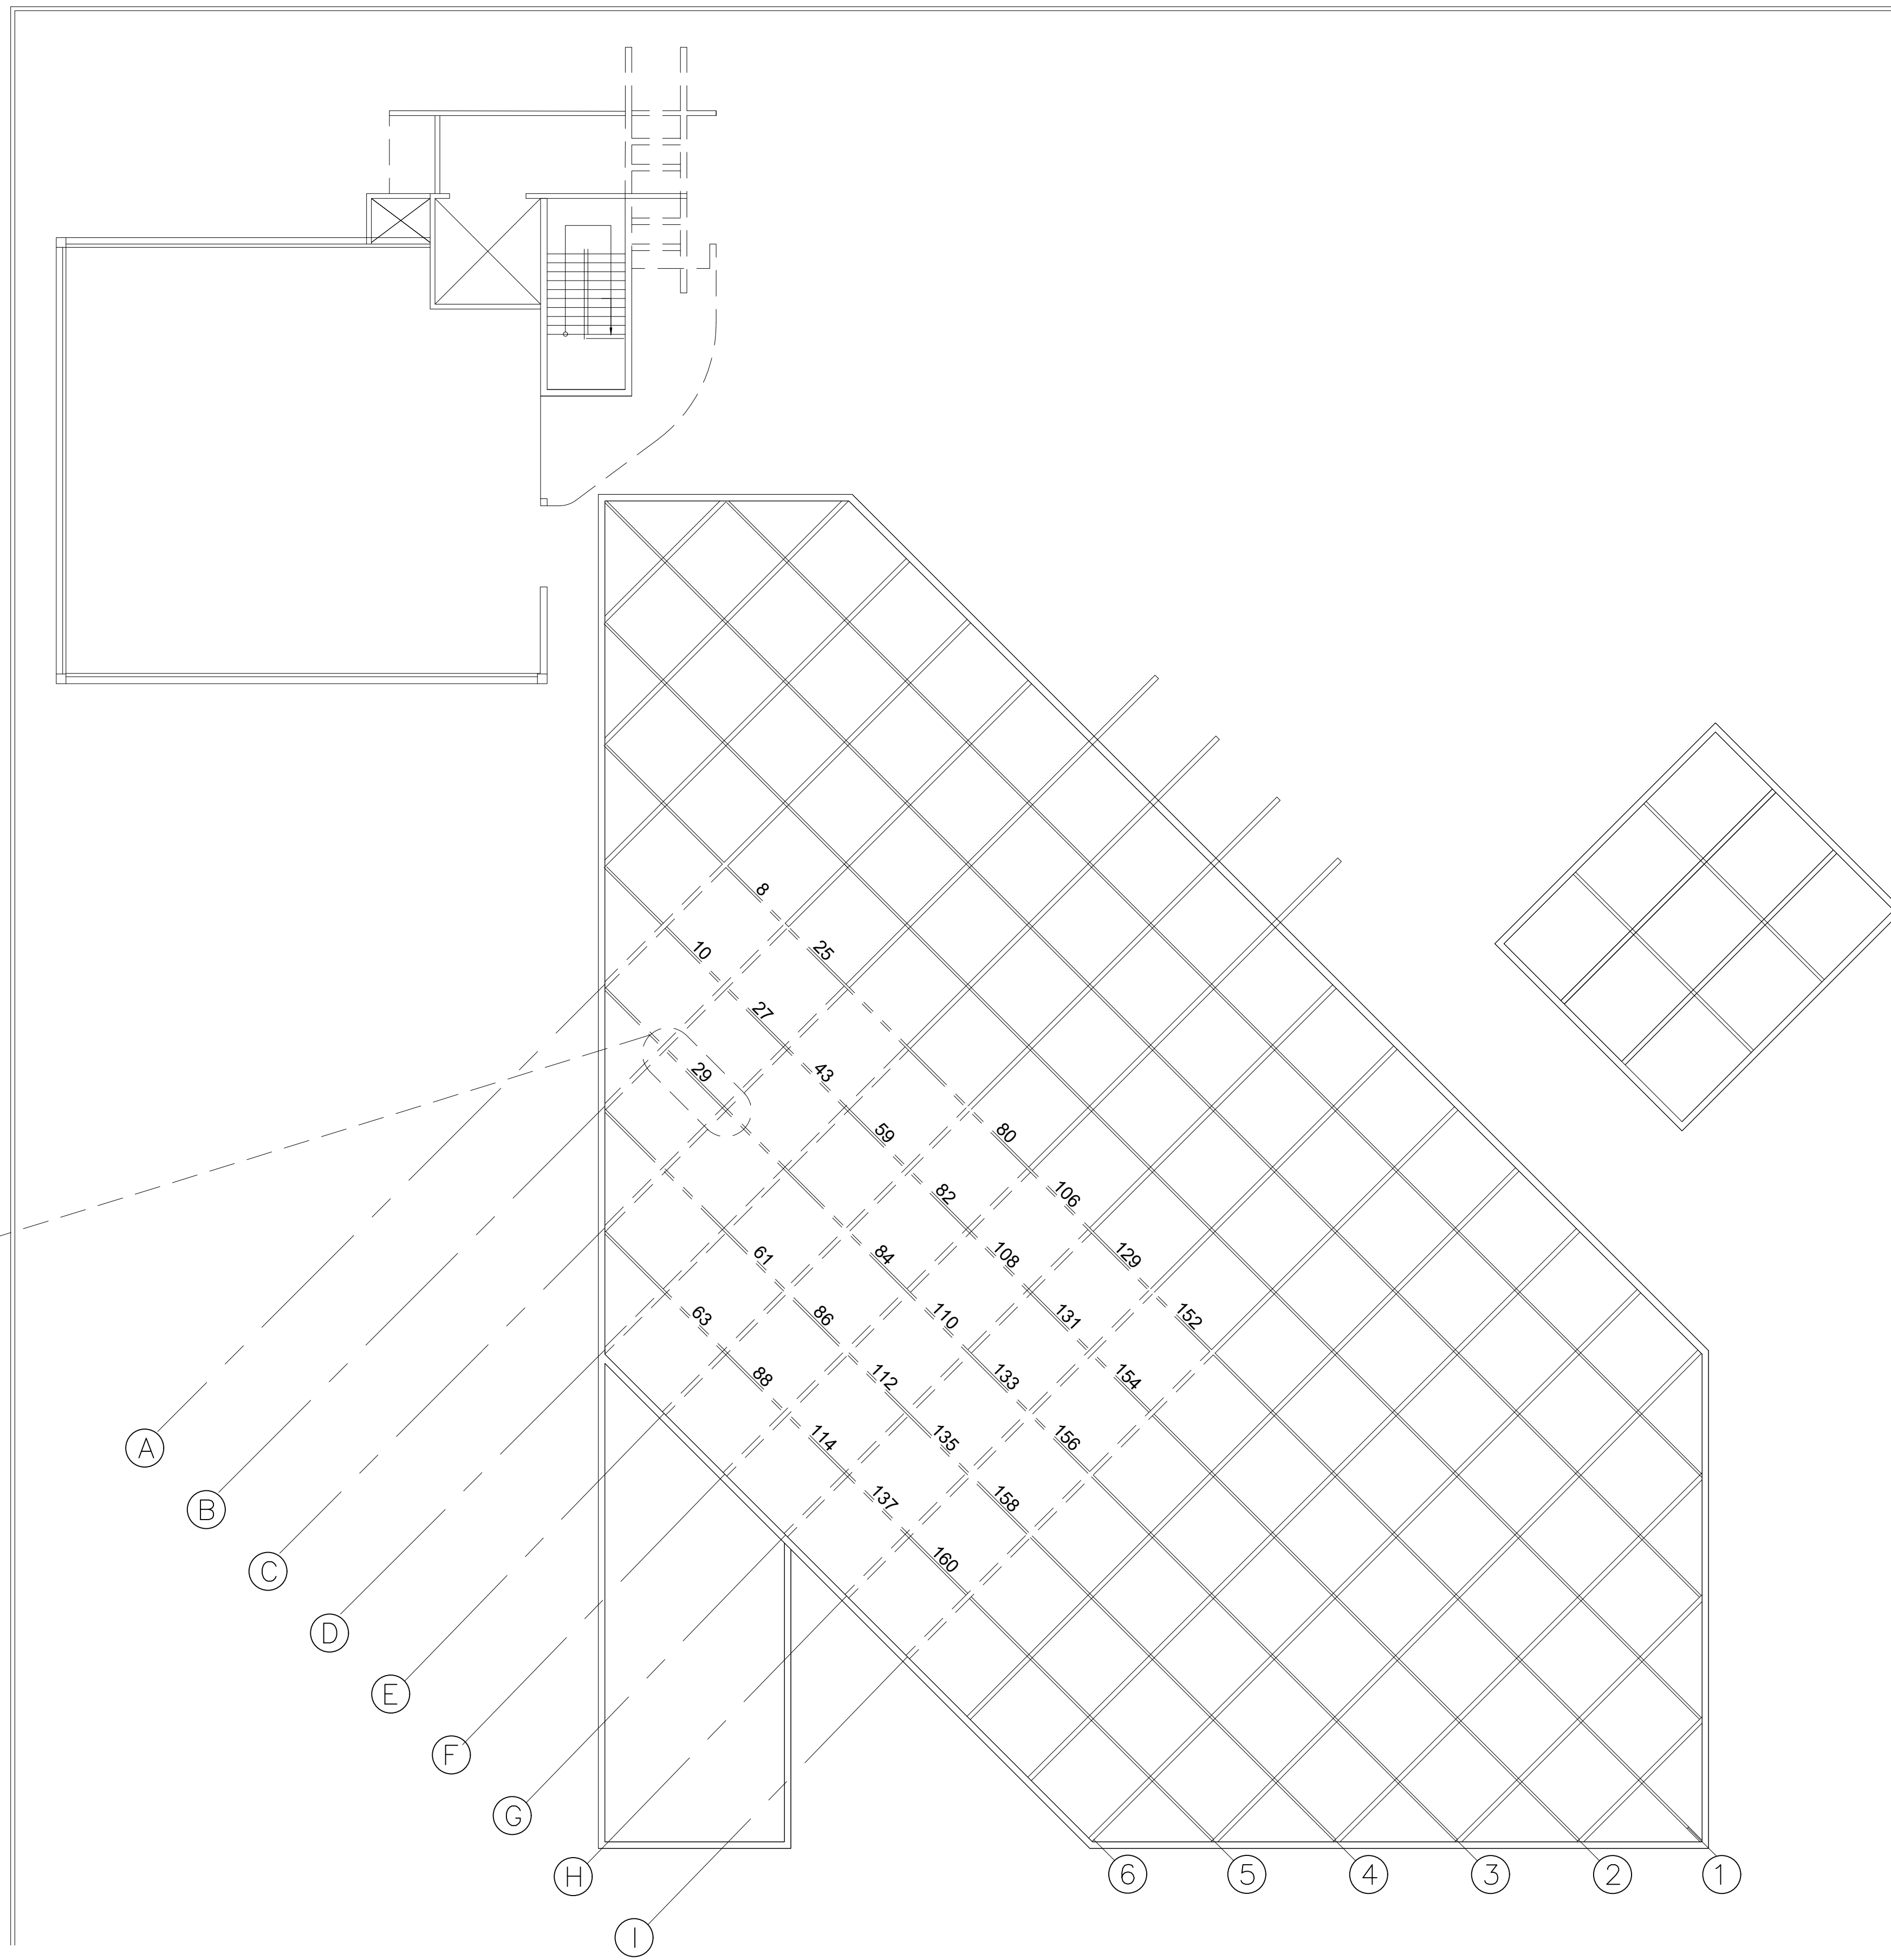
CONDITION ASSESSMENT ROOF PLAN TRUSS BOTTOM

NOTE:
 THE NUMBERS IN THIS DRAWING REPRESENTS THE PHOTOS OF THE FINDING IN THE APPENDIX A: TABLE OF FINDINGS.

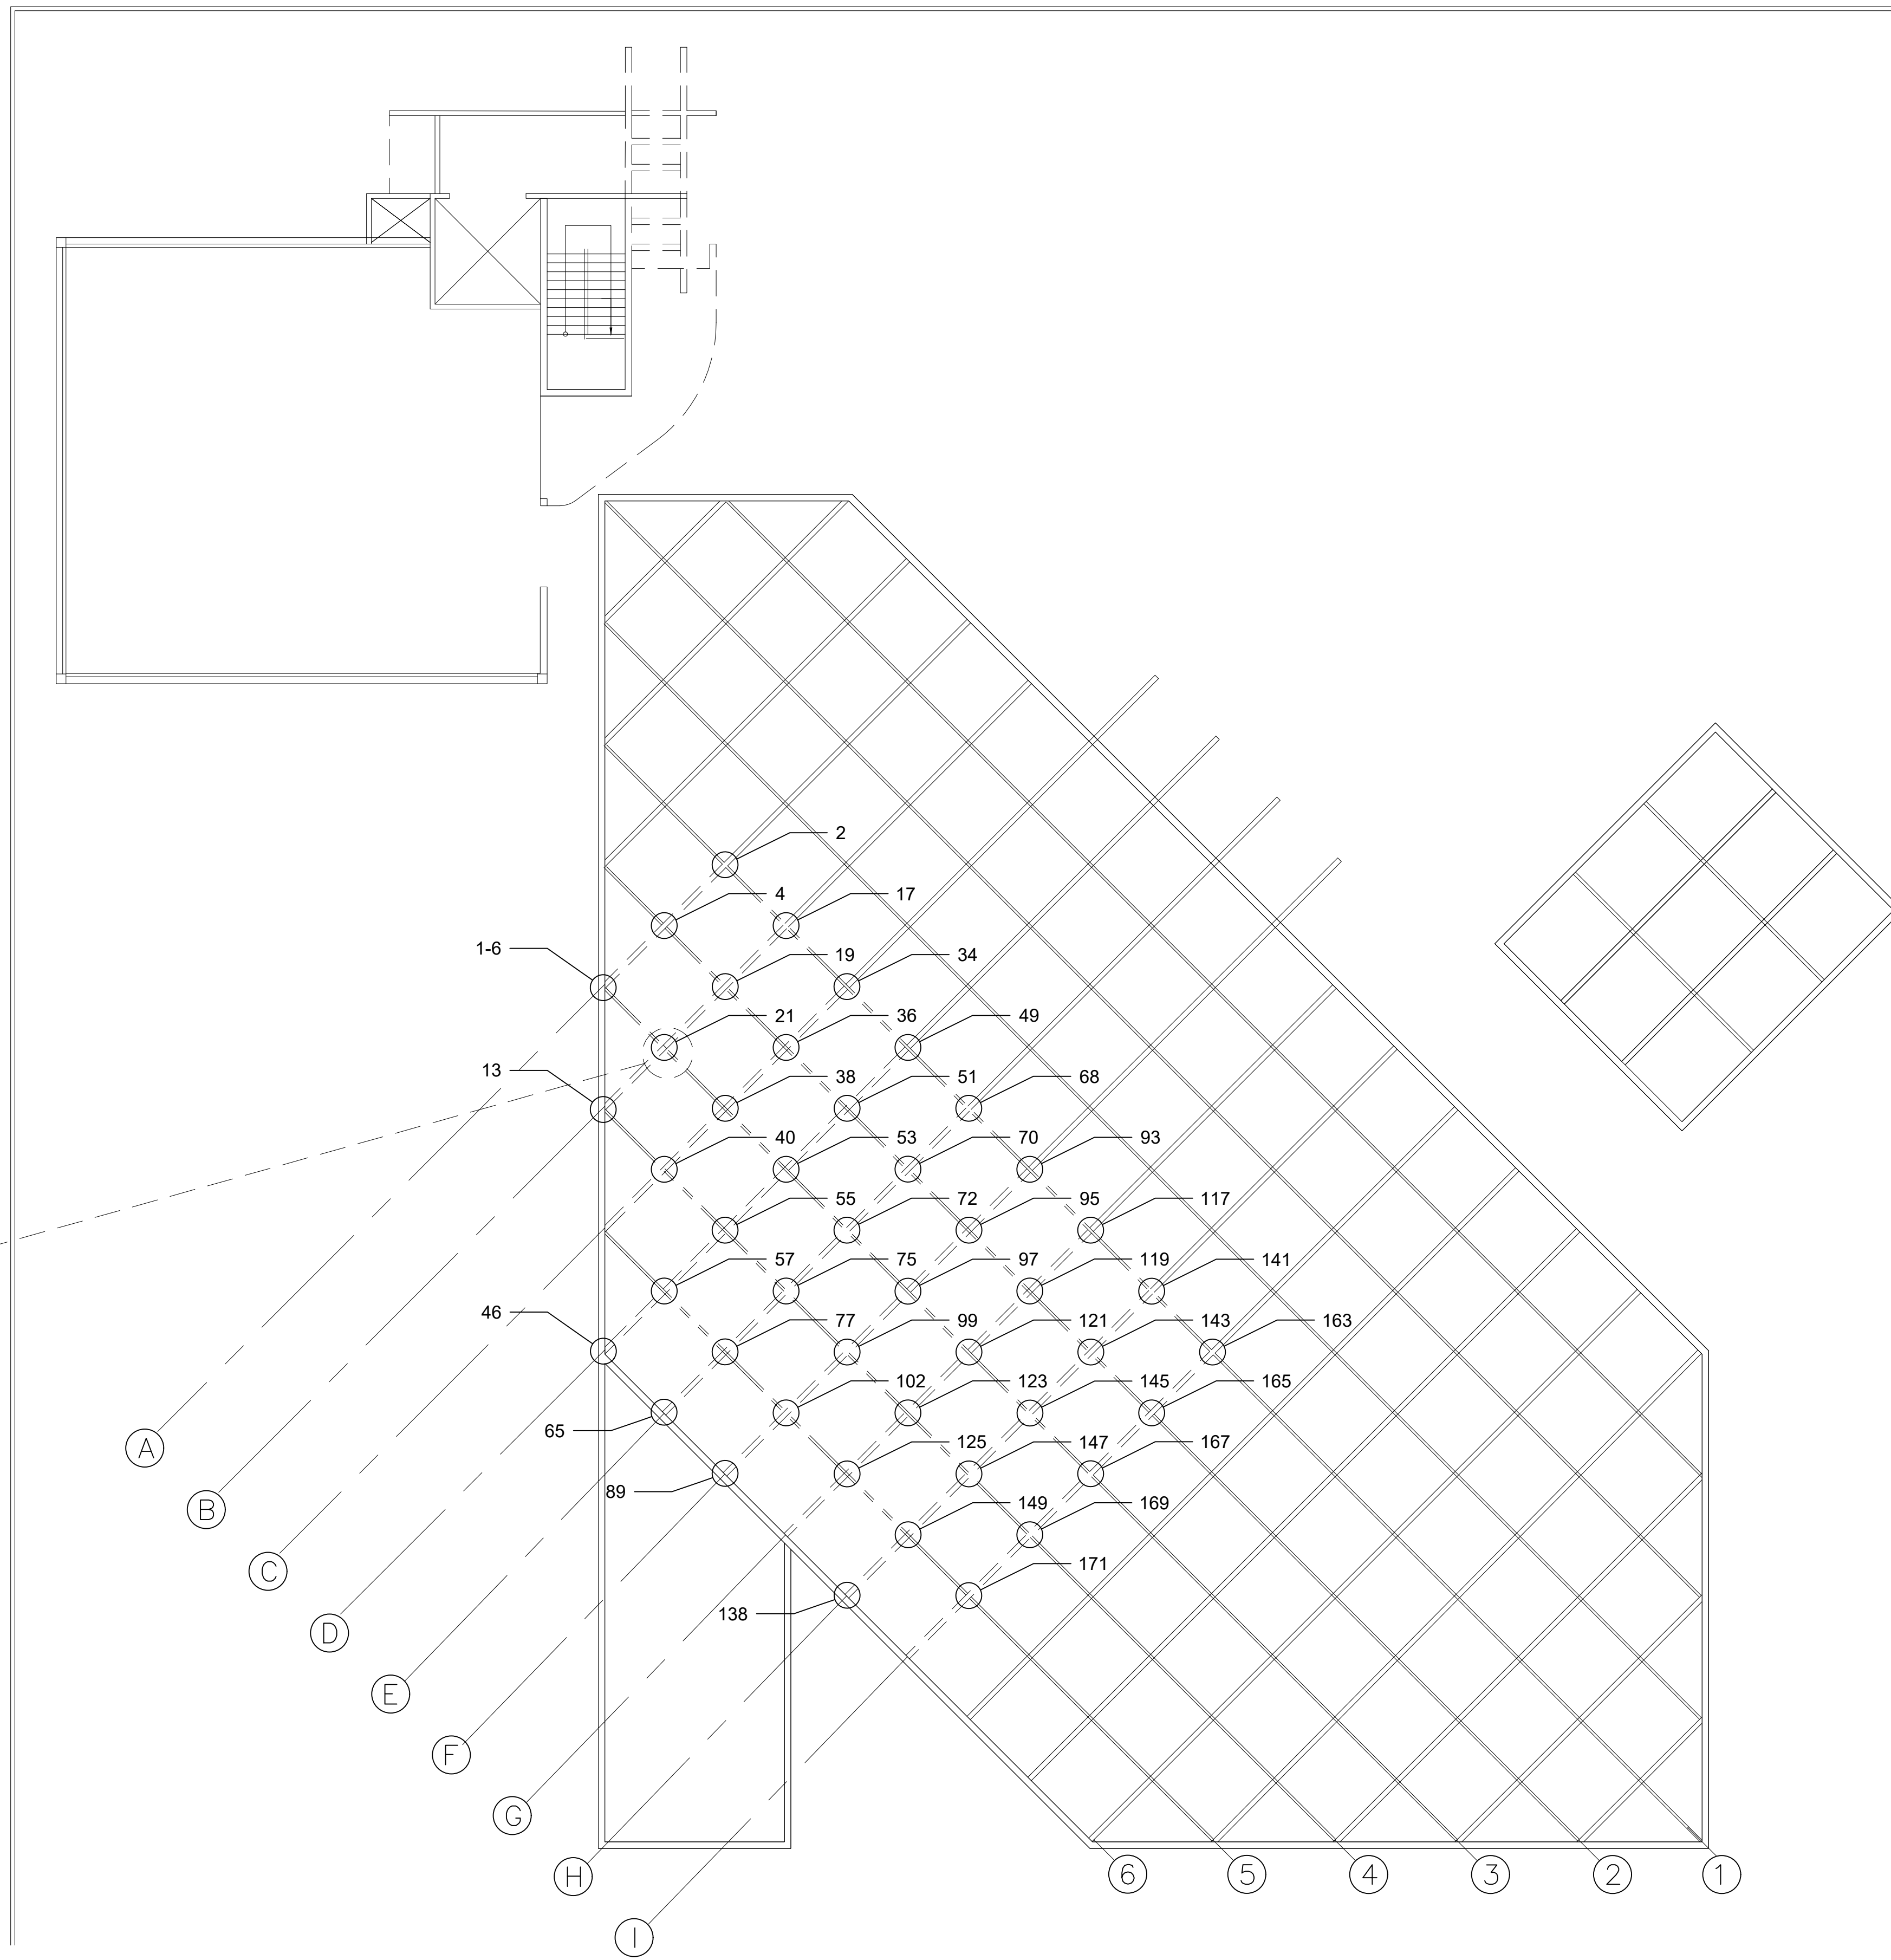
CONDITION ASSESSMENT ROOF PLAN CONNECTION TOP

THE NUMBERS IN THIS DRAWING REPRESENTS THE PHOTOS OF THE FINDING IN THE APPENDIX A: TABLE OF FINDINGS.

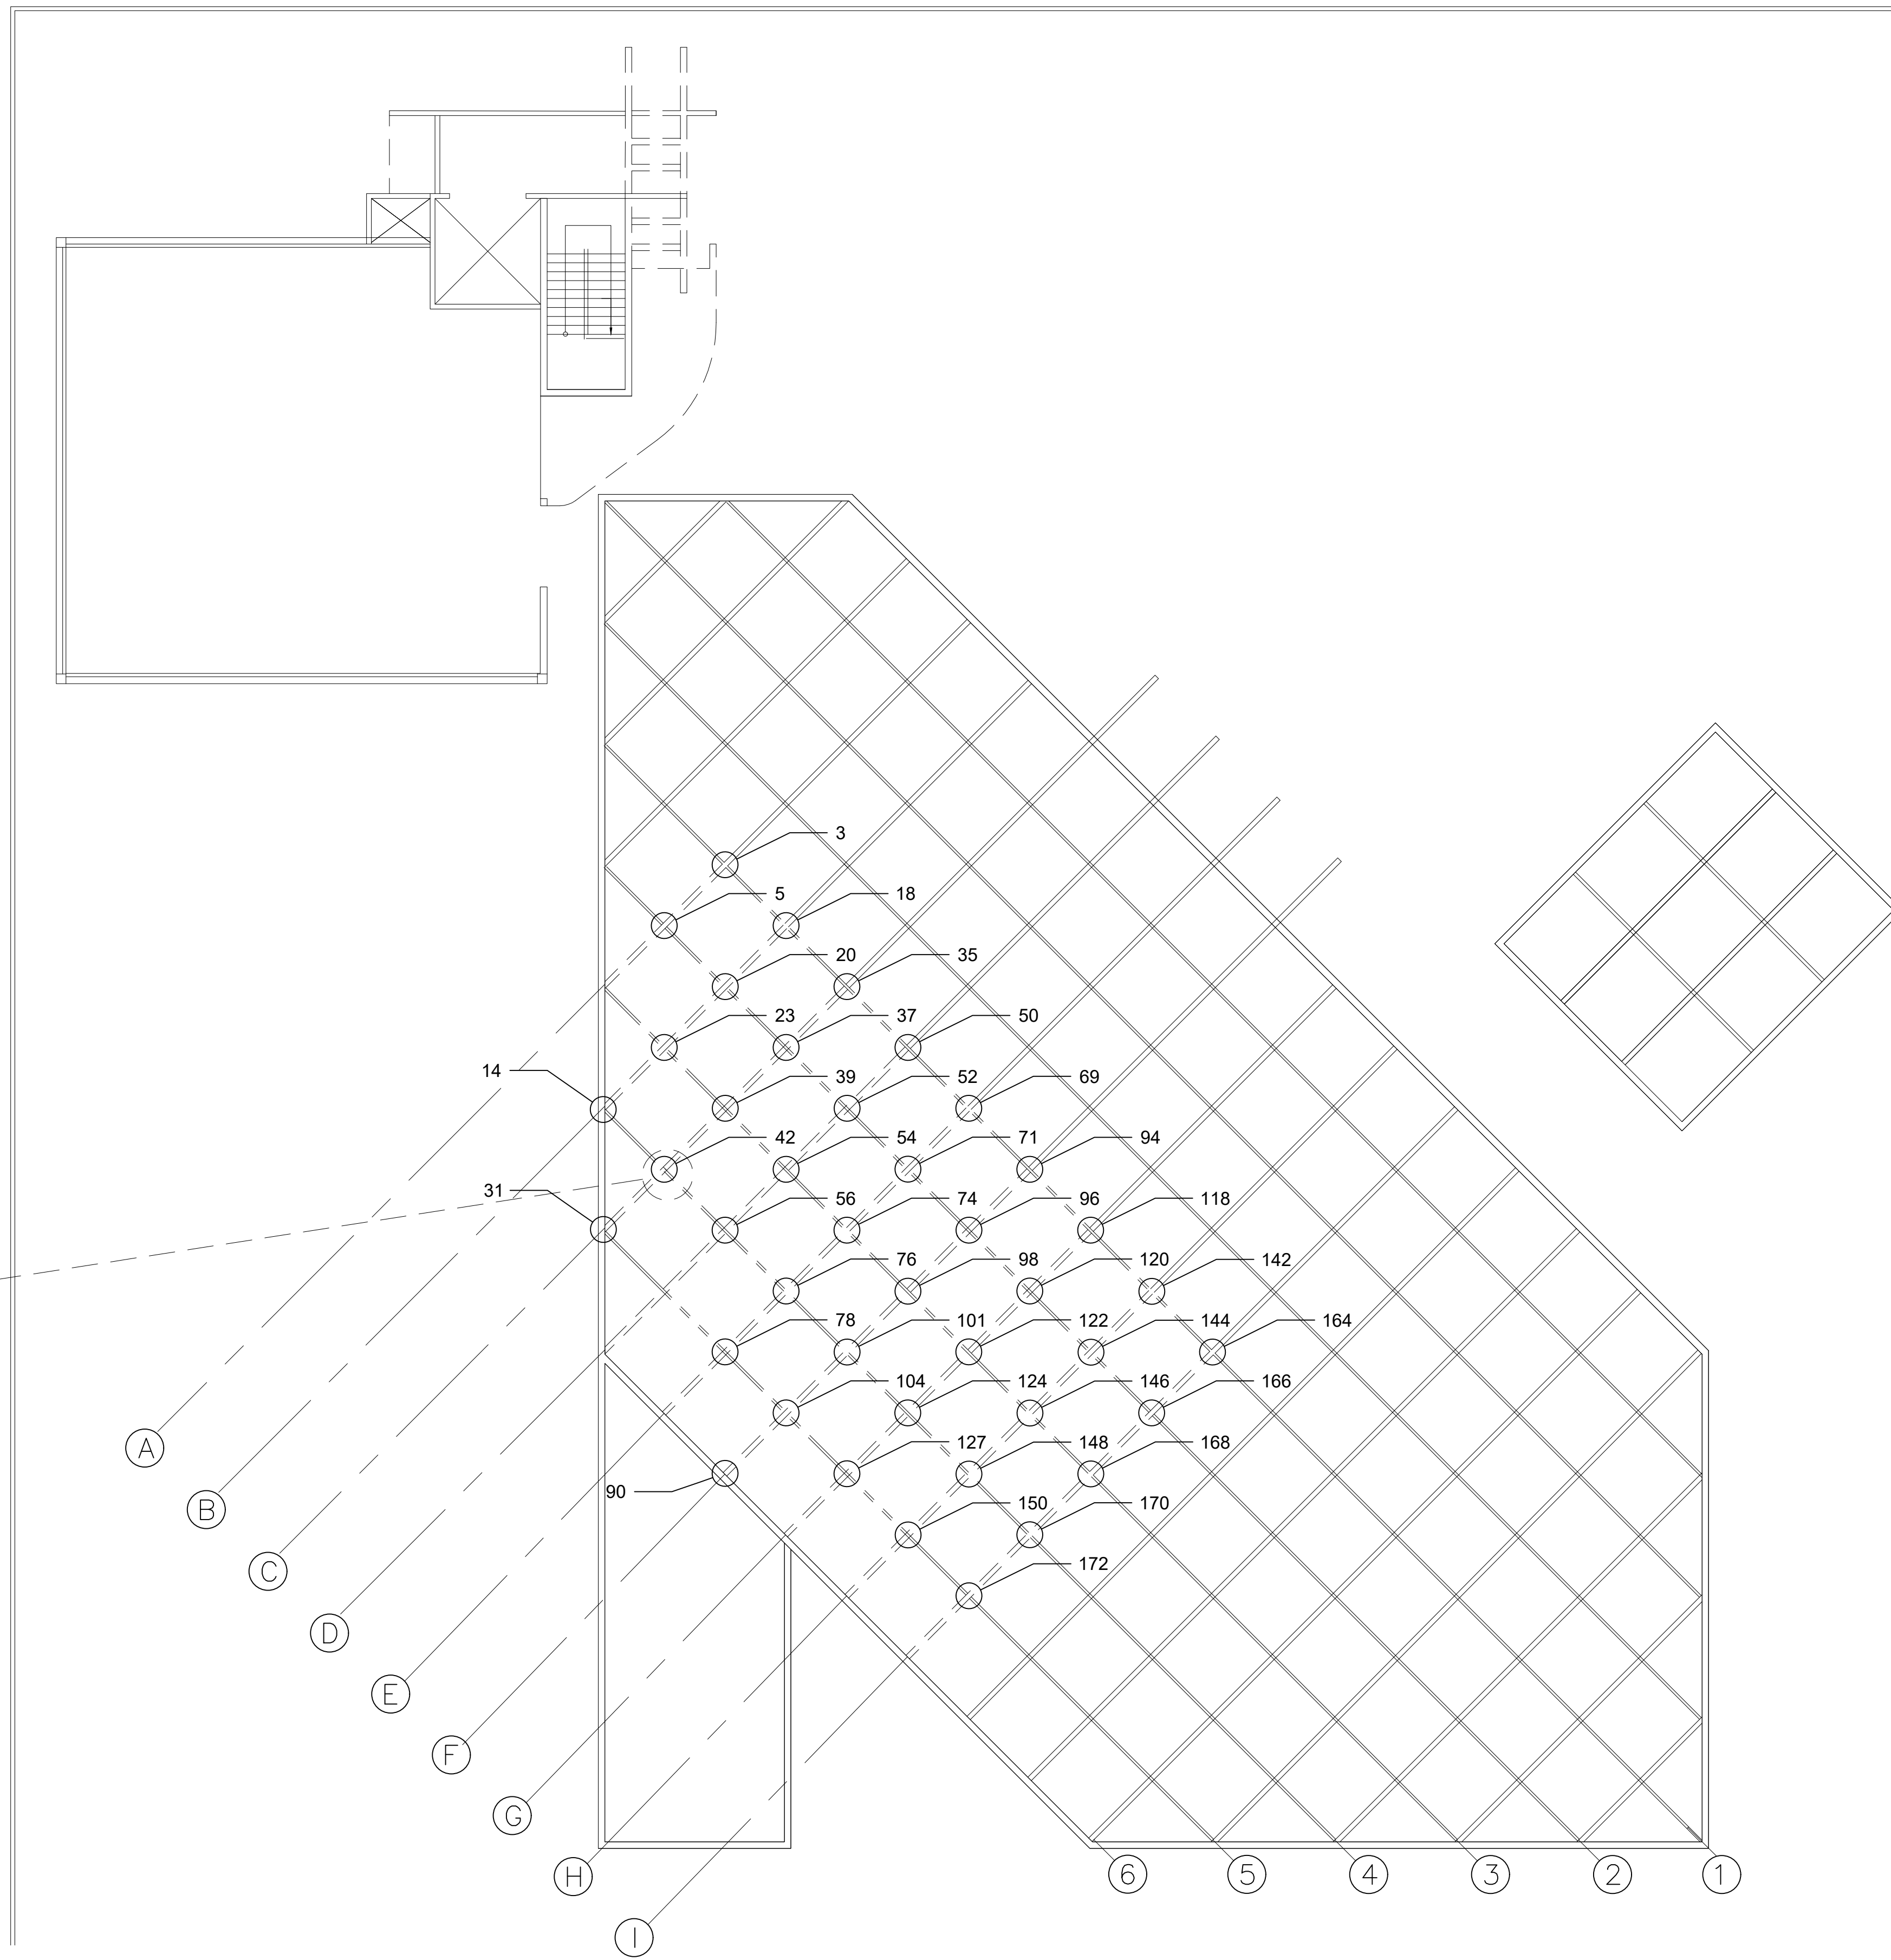
CONDITION ASSESSMENT ROOF PLAN CONNECTION BOTTOM

NOTE:
 THE NUMBERS IN THIS DRAWING REPRESENTS THE PHOTOS OF THE FINDING IN THE APPENDIX A: TABLE OF FINDINGS.
