PROJECT: **ATRIUM REPAIR, REMEDIATION, AND/OR REHABILITATION 2021-002**

MARCH 19, 2021

355 AVENUE FRANKLIN DELANO ROOSEVELT,
SAN JUAN, P.R. 00918

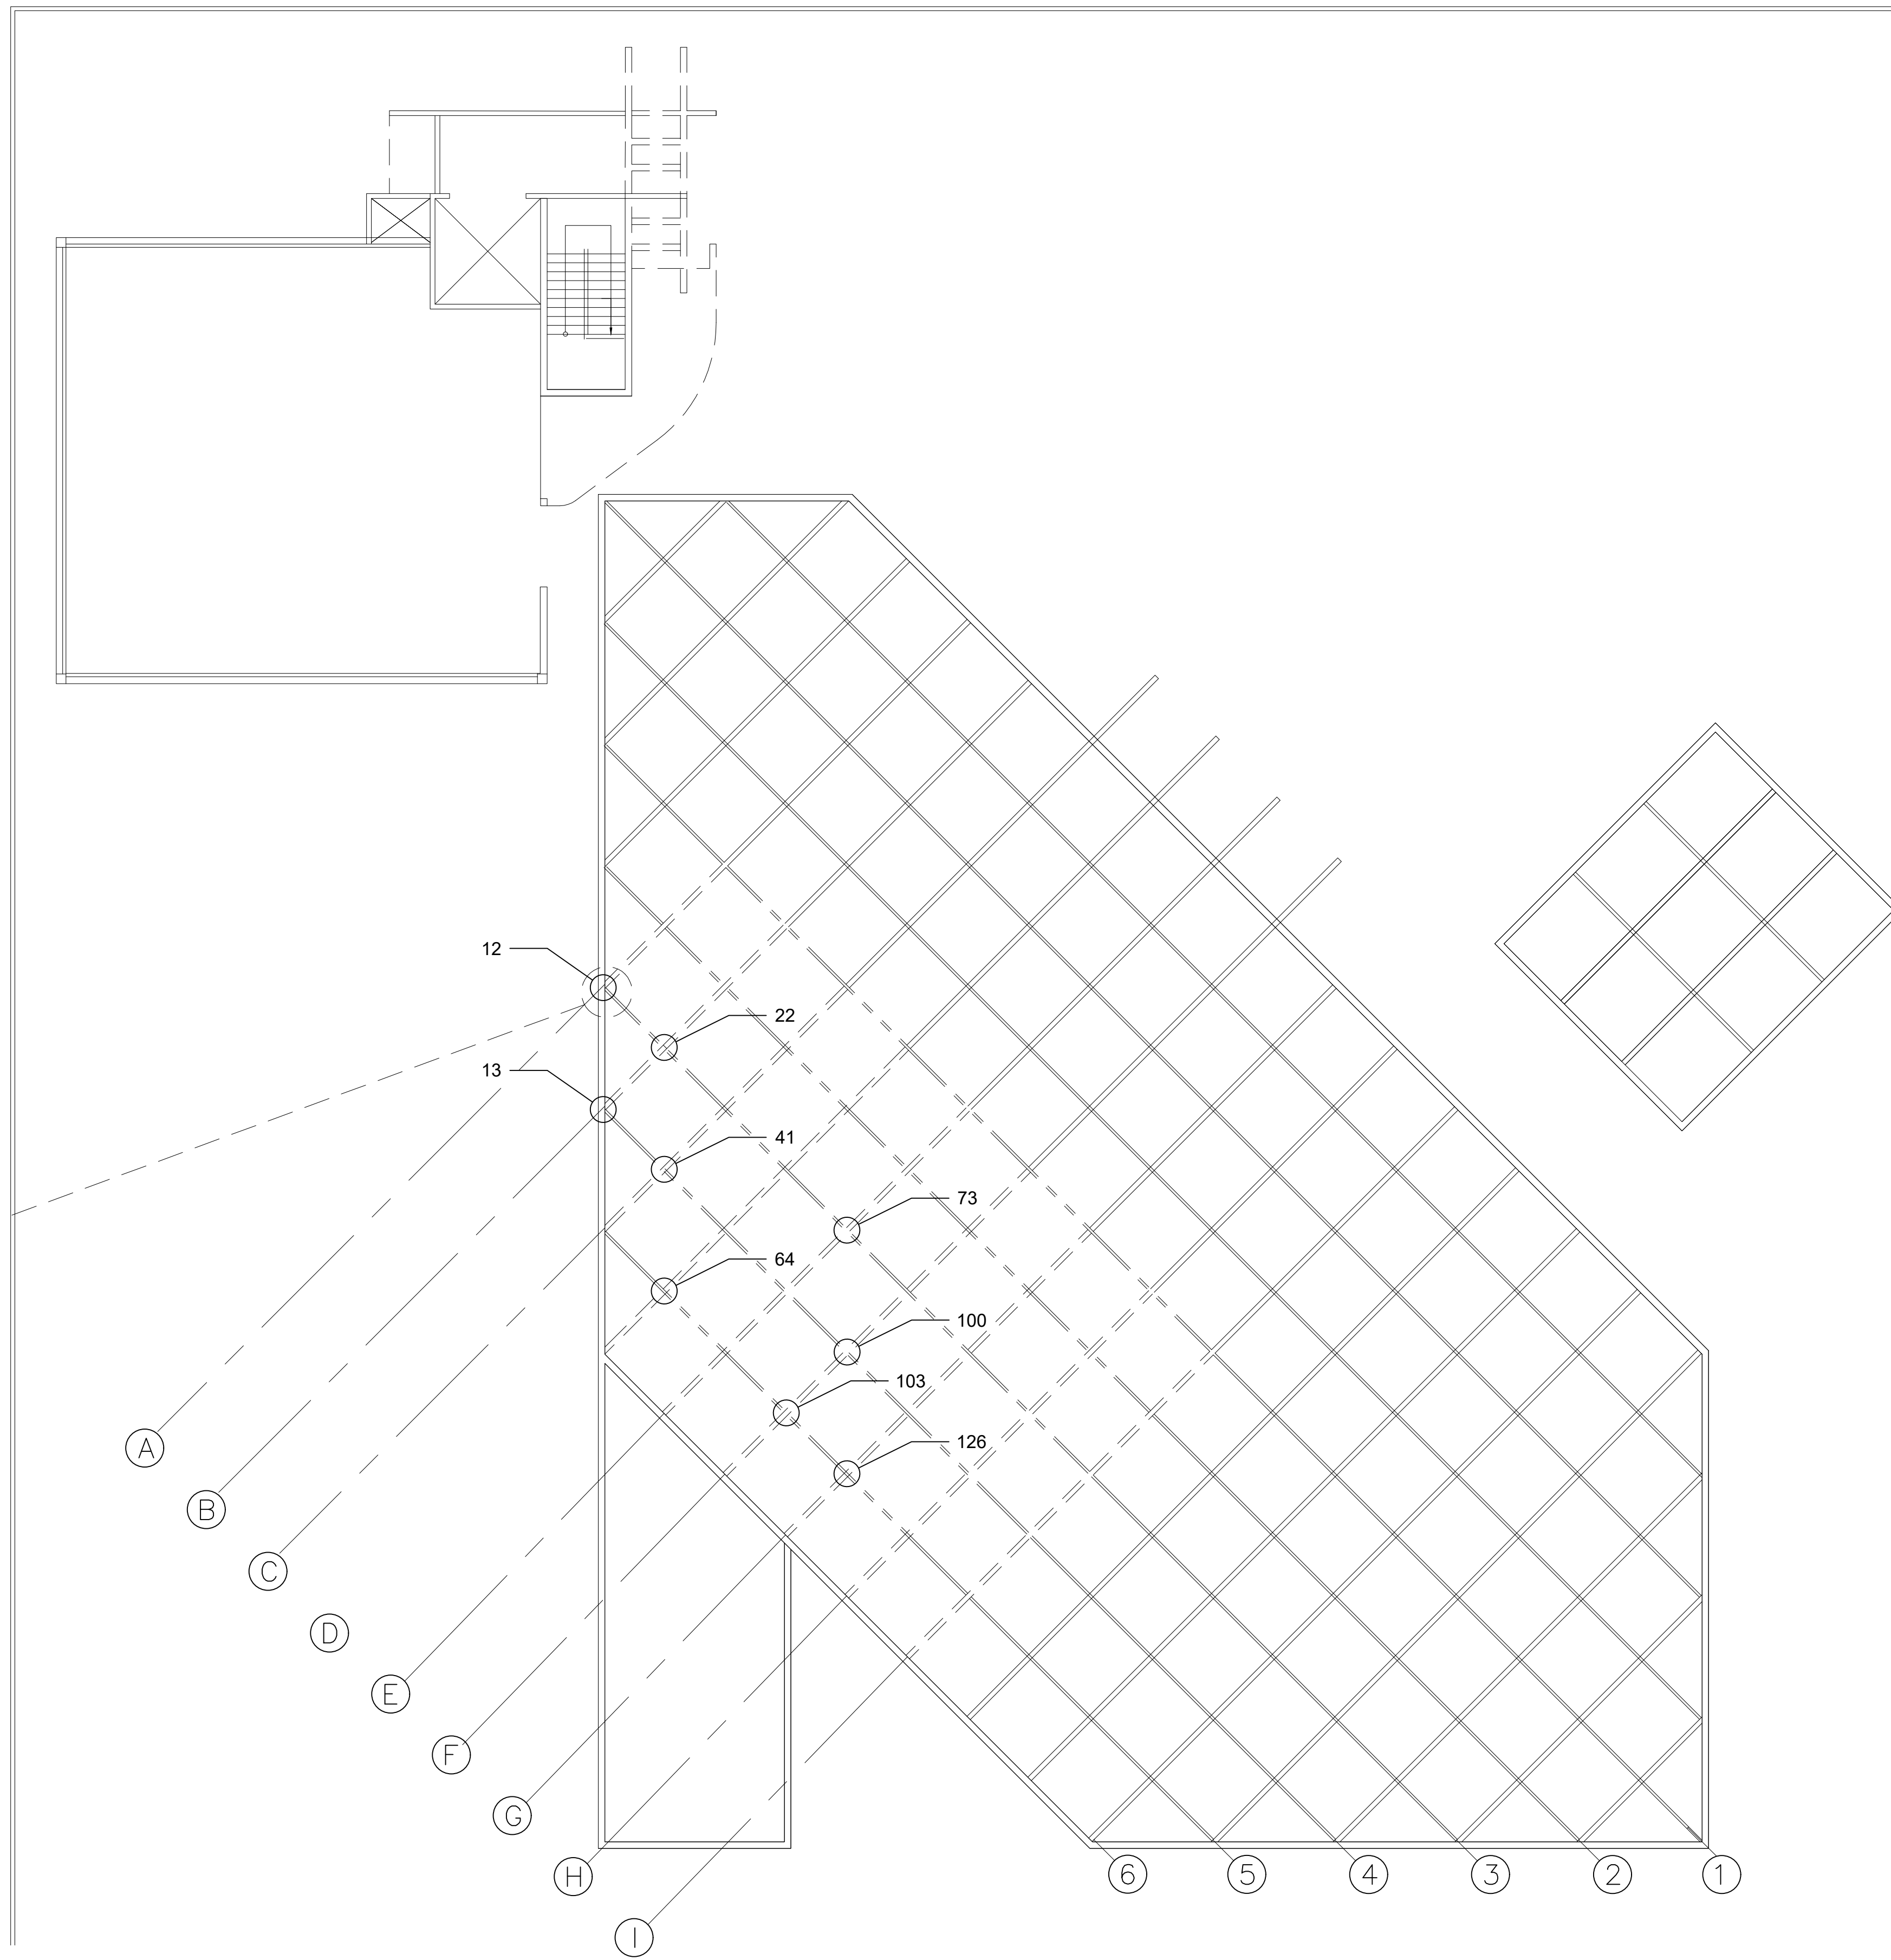
CONDITION ASSESSMENT ROOF PLAN JOIST WEB MEMBERS

NOTE:
 THE NUMBERS IN THIS DRAWING REPRESENTS THE PHOTOS OF THE FINDING IN THE APPENDIX A: TABLE OF FINDINGS.
