**SUBASTA FORMAL 22J-11819
PARA EL SERVICIO DE DEMOLICIÓN DE ESTRUCTURA Y RECOGIDO DE
ESCOMBROS DEL CDT DE MAUNABO, ADSCRITO AL DEPARTAMENTO DE SALUD
DEL GOBIERNO DE PUERTO RICO**

ASUNTO: ESTUDIO DE ASBESTO Y PLOMO

ASBESTOS CONTAINING MATERIALS INSPECTION REPORT

CDT Maunabo

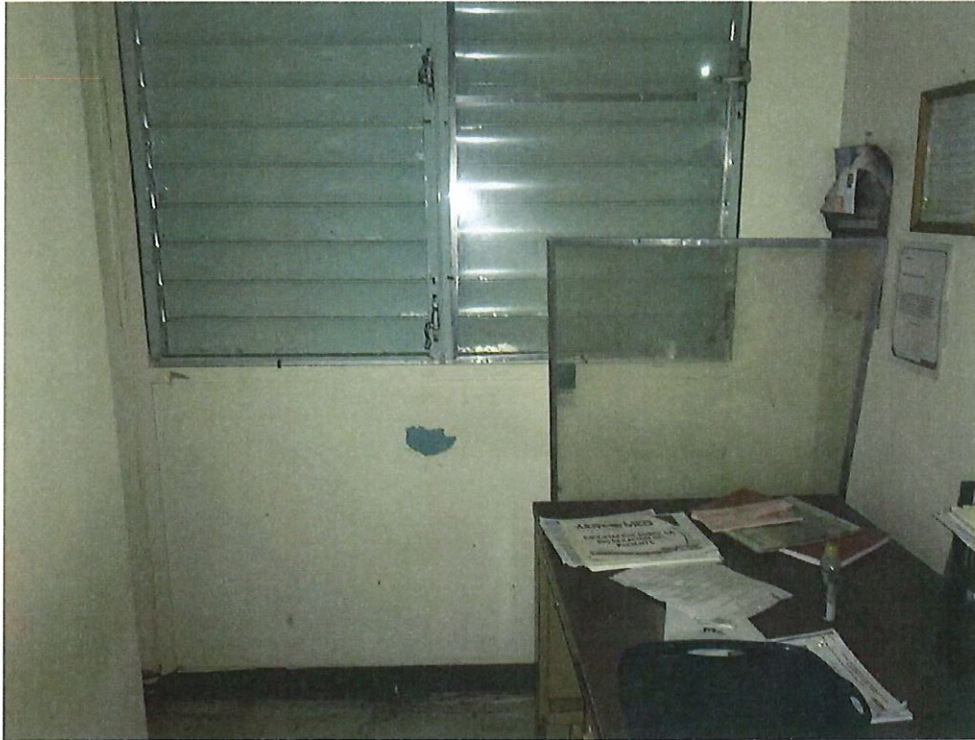
Photo Number 1 –Interior walls

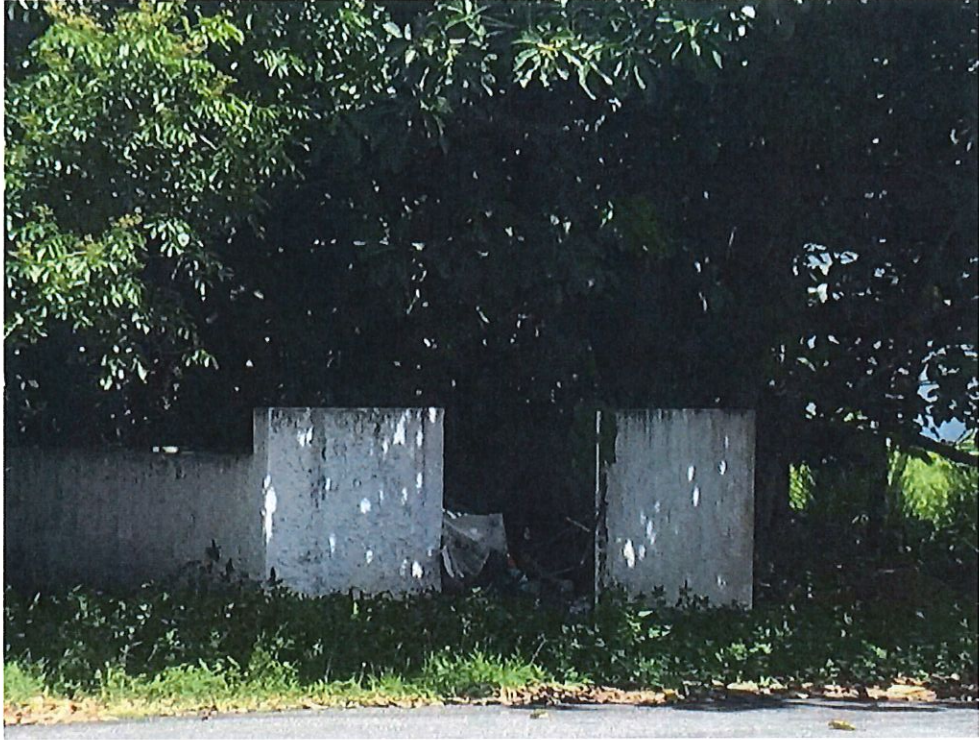
Photo Number 5 – Satellite Buildings (Garbage Station)
